LESSONS LEARNT
BY ACCIDENT

LOOKOUT!

MARCH 2009 ISSUE TWELVE

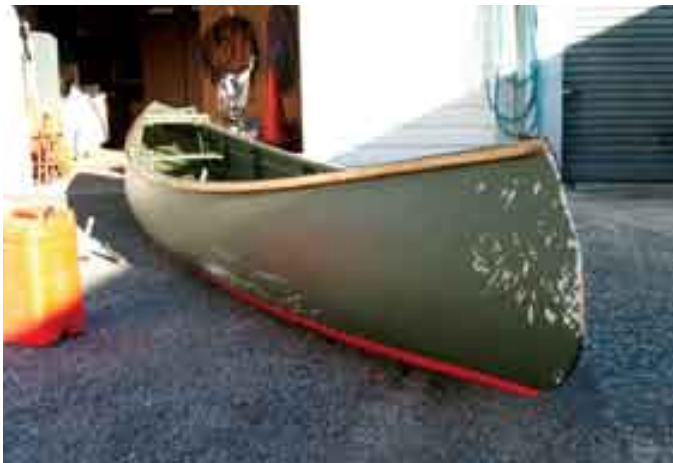
▲ CANADIAN OR OPEN-TOPPED CANOES ARE POPULAR FOR RECREATIONAL USE AND DUCK SHOOTING, AS THEY ARE CAPABLE OF CARRYING HEAVY OR BULKY LOADS AND EQUIPMENT. THEY ARE LESS RESILIENT TO THE EFFECTS OF SWAMPING THAN CLOSED-TOP KAYAKS.

1. Neither man wore a lifejacket, which was an exception for them both. They were both known to be fastidious in their use of lifejackets, but had failed to carry them on this occasion. Maritime law requires that lifejackets be carried and be easily accessible. They must be worn when there is any increased risk.

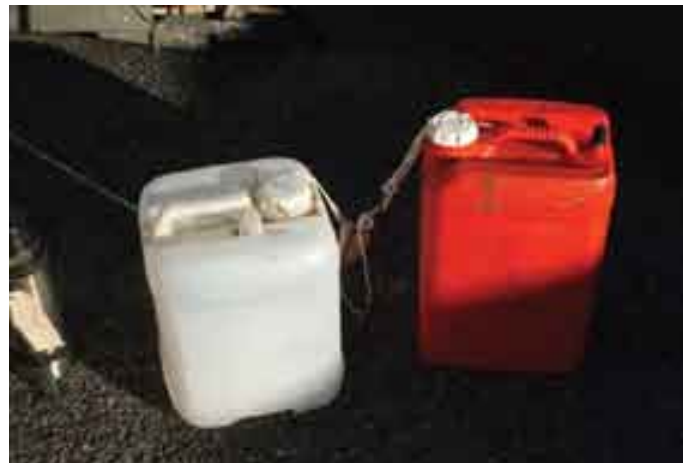
The first man managed to calm his companion, but by then the canoe was being blown toward the opposite shoreline, which was rugged and uninhabited. The pair decided to cut loose two 20 litre containers from under the canoe seats, which had been used as additional buoyancy, and abandon the canoe.

▲ THESE 20 LITRE CONTAINERS FROM UNDER THE CANOE SEATS, USED AS ADDITIONAL BUOYANCY FOR THE CANADIAN CANOE, WERE CUT LOOSE FOR FLOATATION WHEN THE CANOE ROLLED.

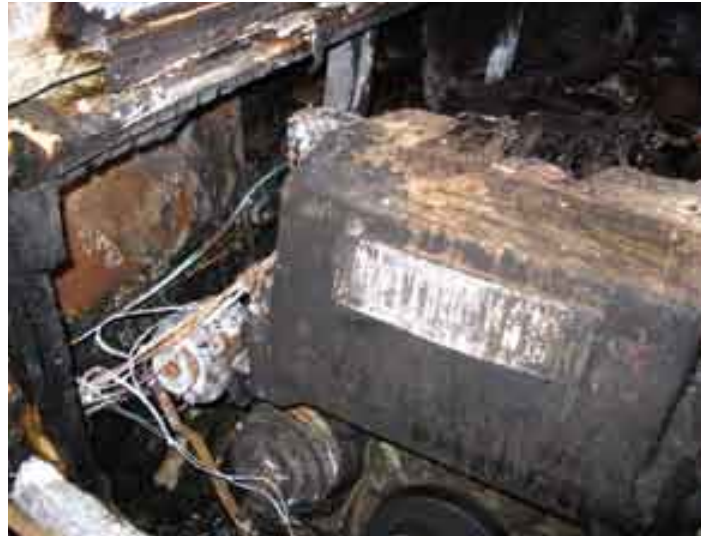
▲ THE STARBOARD ENGINE FIRE WAS "ELECTRICAL" WHEN IT BEGAN, BUT PROGRESSED INTO A GENERAL FIRE, WITH A VARIETY OF SUBSTANCES, INCLUDING FOAM RUBBER, PLASTIC, WIRE INSULATION, OIL, METAL, GREASE AND DEBRIS, WOOD AND PAINT.

1. The exact cause of the fire cannot be determined, although it is thought to have been an electrical fire originating near the alternator and a bundle of wires leading to a battery bank. The fire may have been fed by the scavenge fans, and by the sudden rush of oxygen when the skipper opened the engine bay cover.

3. The recommended complement of extinguishers for a boat of this size would be two 4.5 kg or 9 litre portable

extinguishers or two suitable dry powder equivalents, with one positioned near the engine bay, and the other in an easily accessible space away from the machinery.

4. In the absence of a fixed fire-fighting system, a covered hole or port can be cut to allow access to the engine bay. An extinguisher can then be dispersed into the enclosed area, without opening the cover, which avoids providing a fresh oxygen source to the flames.

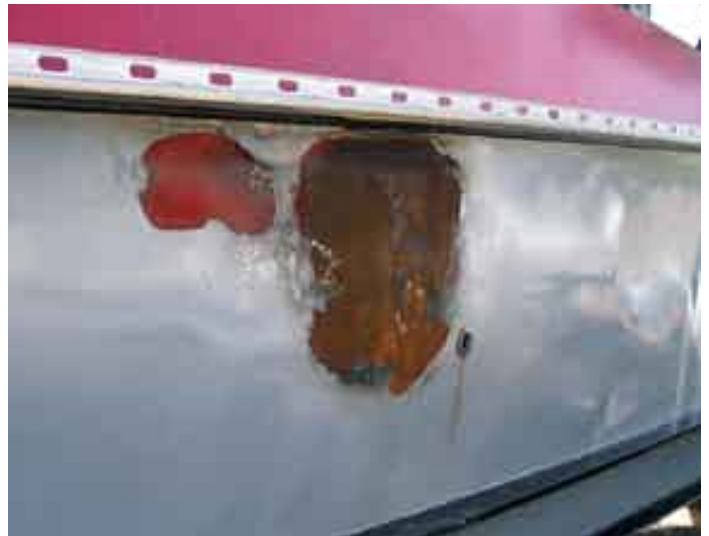
▲ A HEAVY OXIDATION PATTERN WAS VISIBLE ON THE OUTSIDE OF THE HULL AS A RESULT OF THE FIRE.

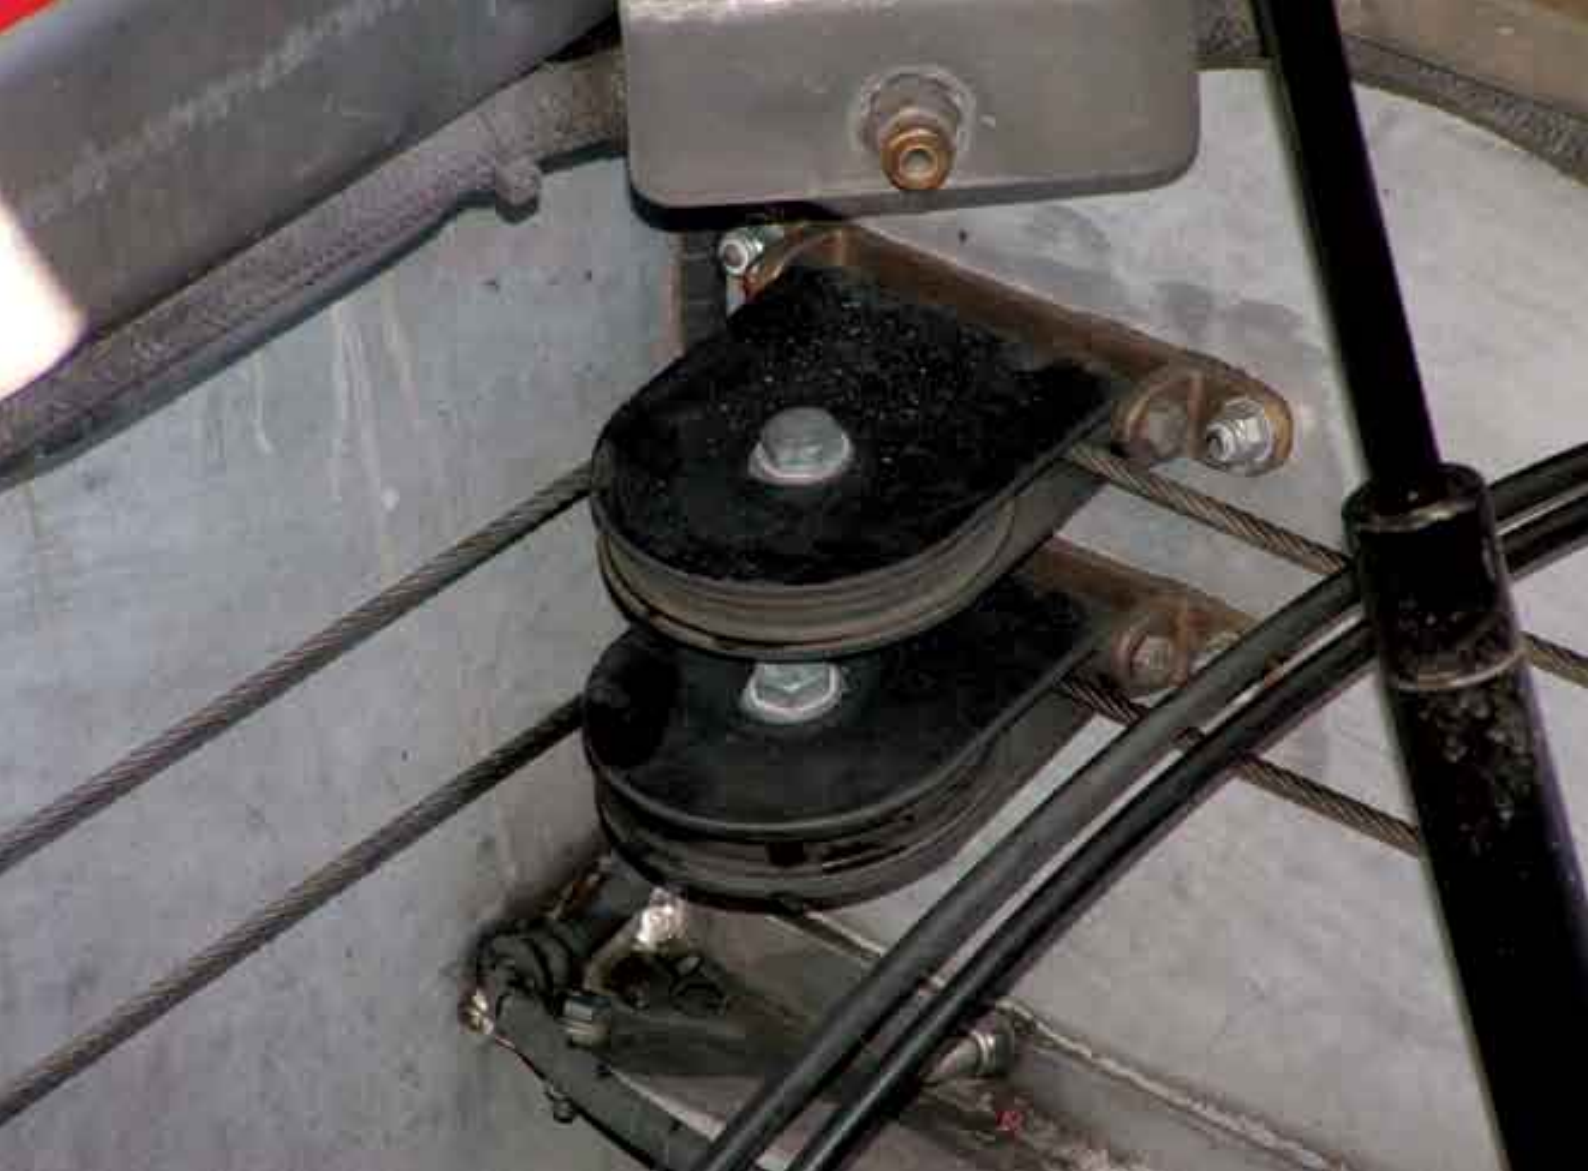
▲ THESE 75MM DIAMETER STEERING CABLES ARE COMMONLY USED IN JETBOATS. THEY ARE TOO SMALL AND FALL BELOW THE RECOMMENDED MINIMUM SIZES.

1. The operator's maintenance schedule required that the steering cable be replaced every 1,000 hours, whether it showed signs of wear or not. This cable had completed 941 hours and, a few days earlier, a junior mechanic had noticed a couple of broken strands on the cable. Checking with his superiors, he had been told that, as the cable was soon due for replacement, it would be fine for a few more days.

2. The pulleys the cable ran around were found to be smaller than recommended by the cable manufacturer, and this was later the subject of a Maritime New Zealand Safety Bulletin *Issue 17, Small Craft Wire Cable Steering Controls*. However, the relationship between cable wire and pulley diameter is a complex issue. New Zealand industry engineers are currently testing alternative systems that may allow smaller diameter pulleys to be safely used on jetboats.

In the interim, the jetboat operator has reduced the cable replacement time from 1,000 hours to 500 hours. They have improved the cable inspection requirements, including the need to pay close attention to the normally hidden section behind the pulley. This requires turning the steering lock fully both ways, and using a mirror on an extension pole with a torch, to carefully check for any broken strands. If any broken strand is detected, the boat is immediately removed from service and the steering cable replaced.

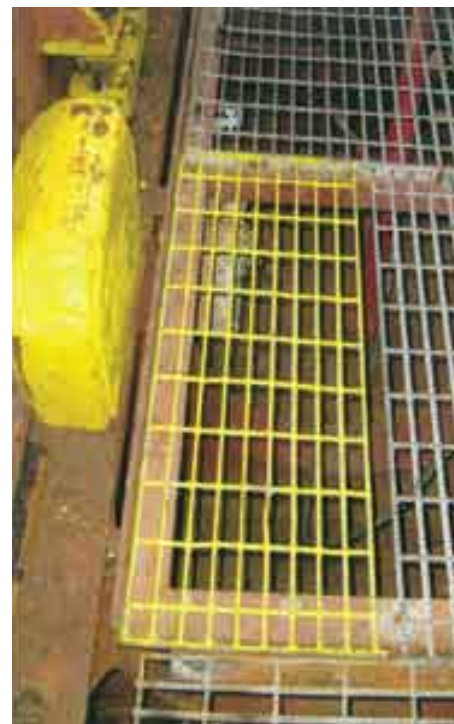
A design fault was identified with these grates that allowed them to be incorrectly placed once shifted, leaving them unstable and insecure.

▲ THE GRATES WERE ORIGINALLY DESIGNED SO THAT THEY WOULD ONLY BE SECURE IF THEY WERE PLACED CORRECTLY, HOWEVER, THE DESIGN MADE IT EASY FOR THE GRATE TO BE INADVERTENTLY REPLACED BACK-TO-FRONT.

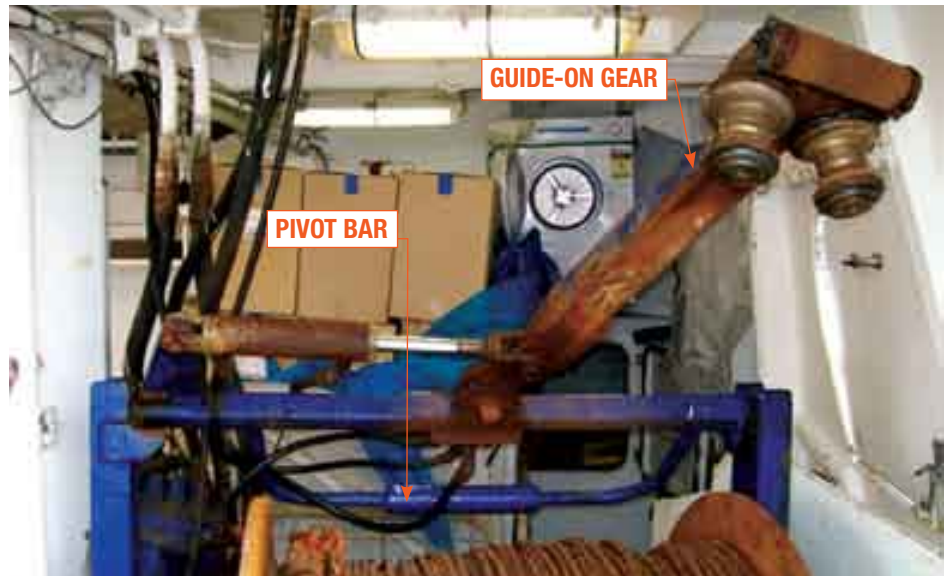
On this occasion the pivot bar may have failed, and struck the mate in the chest. He walked off the deck suffering extreme pain and was later transferred to hospital for x-rays.

▲ DOWNWARD MOVEMENT ON THE PIVOT BAR LIFTS THE GUIDE-ON GEAR ASSEMBLY.

1. The mate says he saw the swivels approaching, and slowed the winch and raised the guide-on gear to allow them to pass before increasing winch speed again. His view is that the pivot bar did not fail until the speed came on. The manual controls put the mate in a potentially hazardous situation.

- changing to a remote winch control similar to that found on several other vessels of a similar type and size operated by this company.

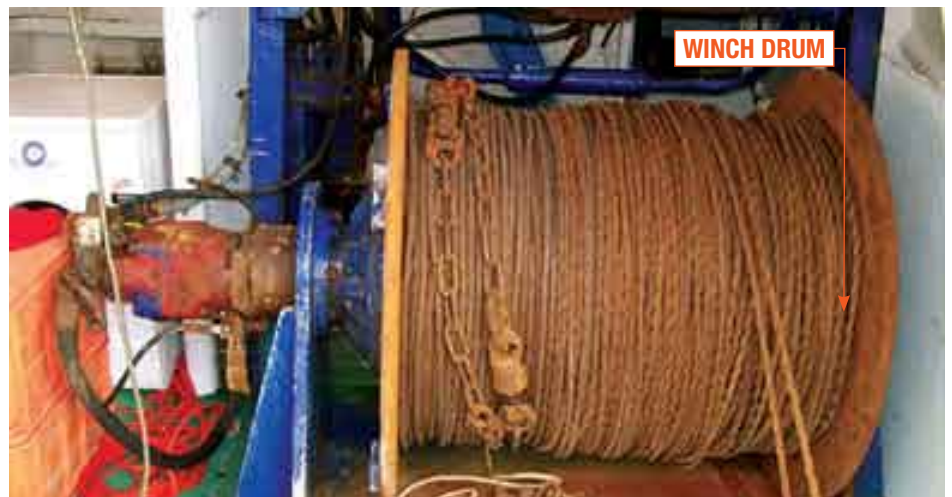
▲ THE OPERATOR MUST STAND BEHIND THE WINCH AND MONITOR THE WIRE LEVEL, AS WELL AS THE SPEED AND AMOUNT OF WIRE RETRIEVED SO FAR.
