Accident Report
Amaltal Enterprise
Serious Harm Injury
East Coast of New Zealand on
10 February 2005
Class A

REPORT NO.: 96 367

VESSEL NAME: *AMALTAL ENTERPRISE*

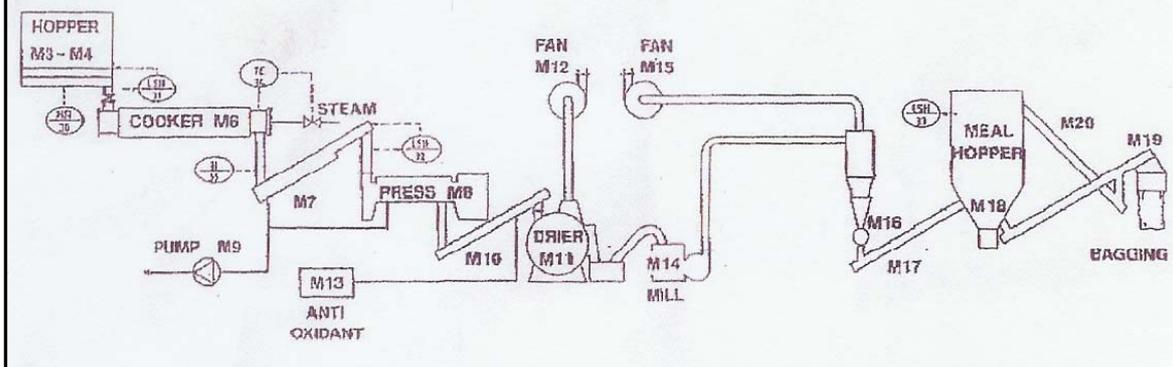
Diagram1- Fish meal Plant

When the fish are processed in the upper factory deck, the raw material is collected in a hopper in the fish meal plant. To simplify the process, the raw material is moved by rotating augers and lifted to the fish meal plant cooker where it is cooked (*See Diagram 1*). Steam is piped through the centre of the auger, which cooks the material as it passes through the cooker (*See Photograph 1*). It then goes through a drain screw. The drain screw sits beneath the cooker at the forward end. It has a coarse perforated screen in its base, which allows the free water to drain from the cooked fish product while transporting it to the press.

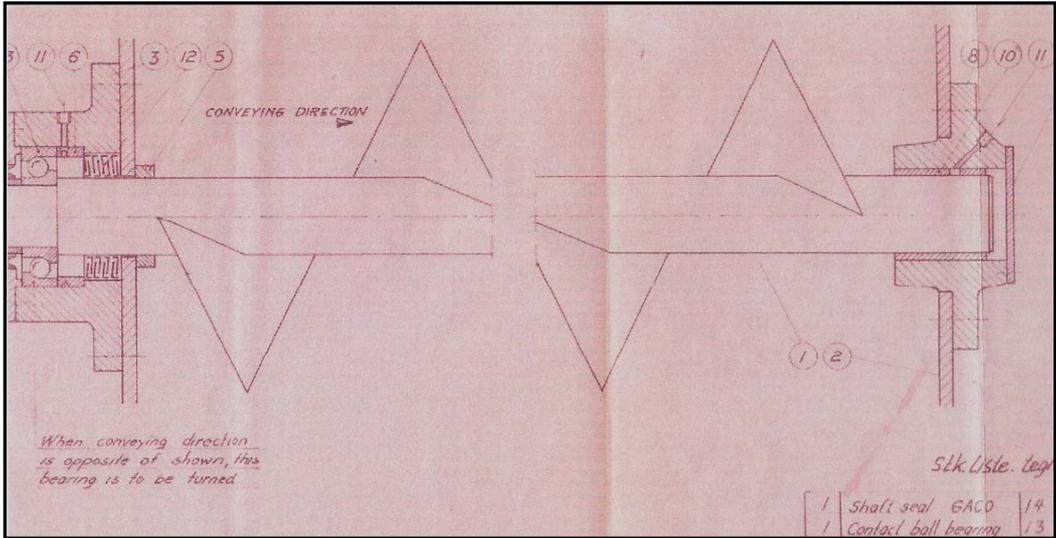
Diagram 2 – Drawing of Drain Screw

They found that the fish meal in the cooker had blocked the drain screw. Crewmember 2 deduced that the blockage had occurred after the drain screw had stopped rotating. The drain screw and other machinery in the factory deck and meal plant are driven by an hydraulic pump. Crewmember 2 believed this pump had stopped temporarily at some stage, thereby allowing a build up of fish meal in the cooker that, in turn, caused the blockage. The investigation was unable to determine the cause of this stoppage.

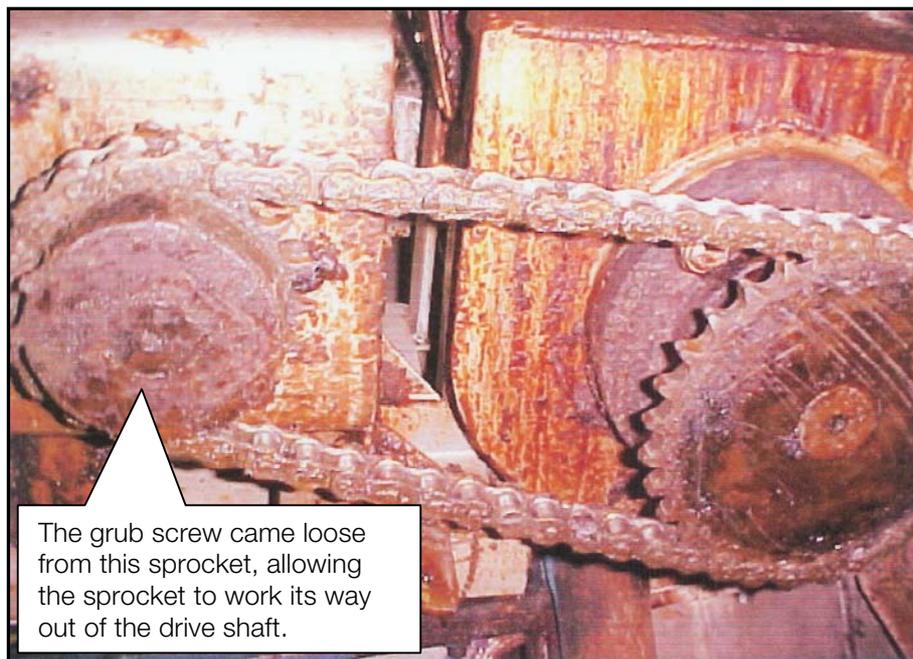
Photograph 2

At about 0930 hours, Crewmember 1 went to find the Chief Engineer as he was having problems with the drain screw drive (See *Photograph 2*). On returning to the meal plant the Chief Engineer and Crewmember 1 shutdown and isolated the cooker and the drain screw. They found that a drive sprocket had come loose and the drive key had dropped out (See *Diagram 4*).

Drain Screw drive – the drive is hydraulically driven through a set of sprockets

The Chief Engineer reinstated the drive and guard and then started the cooker and drain screw. He spent the next fifteen minutes monitoring the cooker. Once the Chief Engineer and Crewmember 1 were happy with how the plant was running, the Chief Engineer returned to his normal duties.

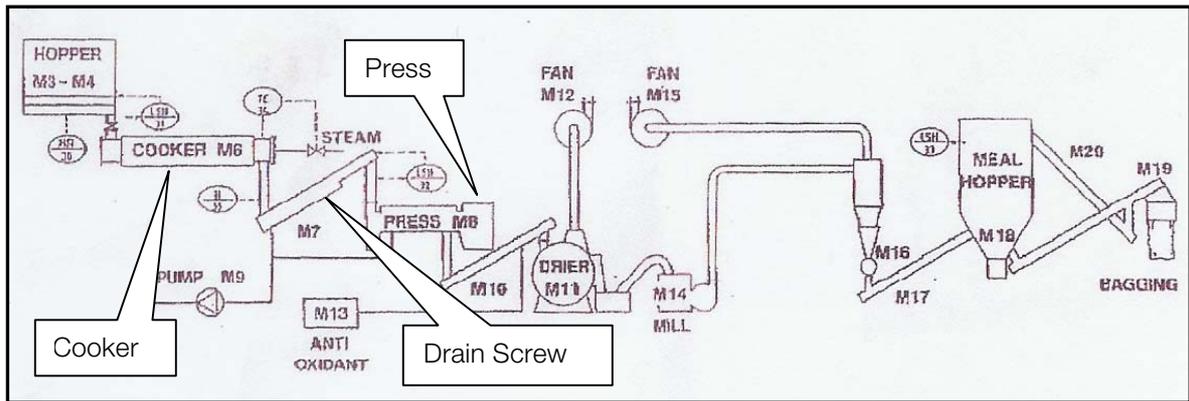
Diagram 5 – Stord Bartz Fish meal Plant

At about 1045 hours, Crewmember 1 noticed that no fish meal was being processed through the cooker to the press (See *Diagram 5*). He tried to open the end cooker hatch cover (See *Photograph 3*) but heard the sound of steam escaping and decided therefore to close the cover again.

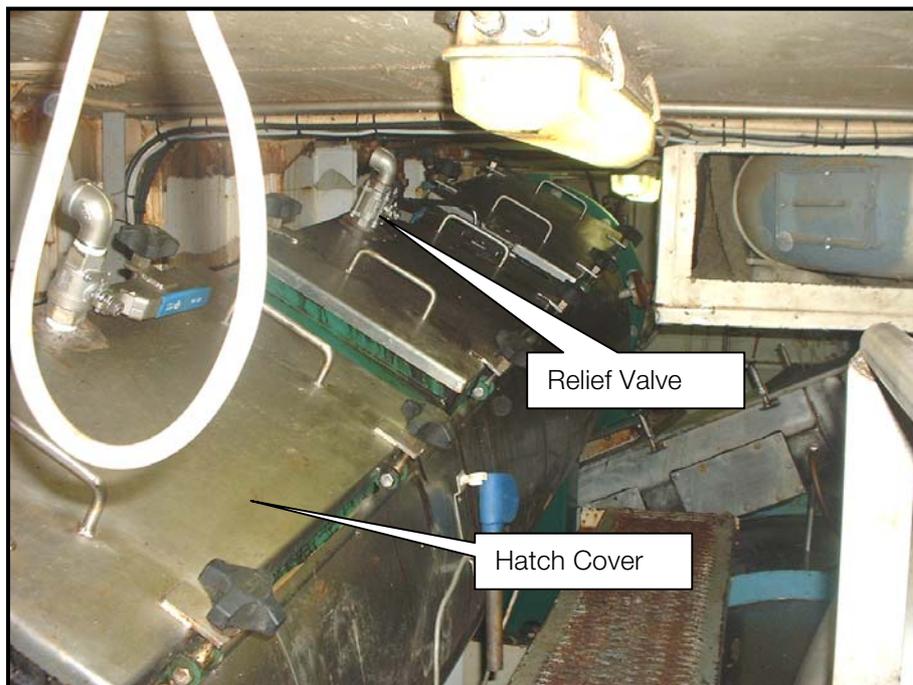
Photograph 3 – Cooker & Hatch Covers

Both crewmembers checked that the supply of steam and power to the cooker had been isolated. Crewmember 2 asked Crewmember 1 if he had opened the inspection hatch at the top of the cooker. Due to language difficulties, the response of Crewmember 1 was not very clear but Crewmember 2 believed Crewmember 1 had released any build up of steam within the cooker after opening the hatch cover.

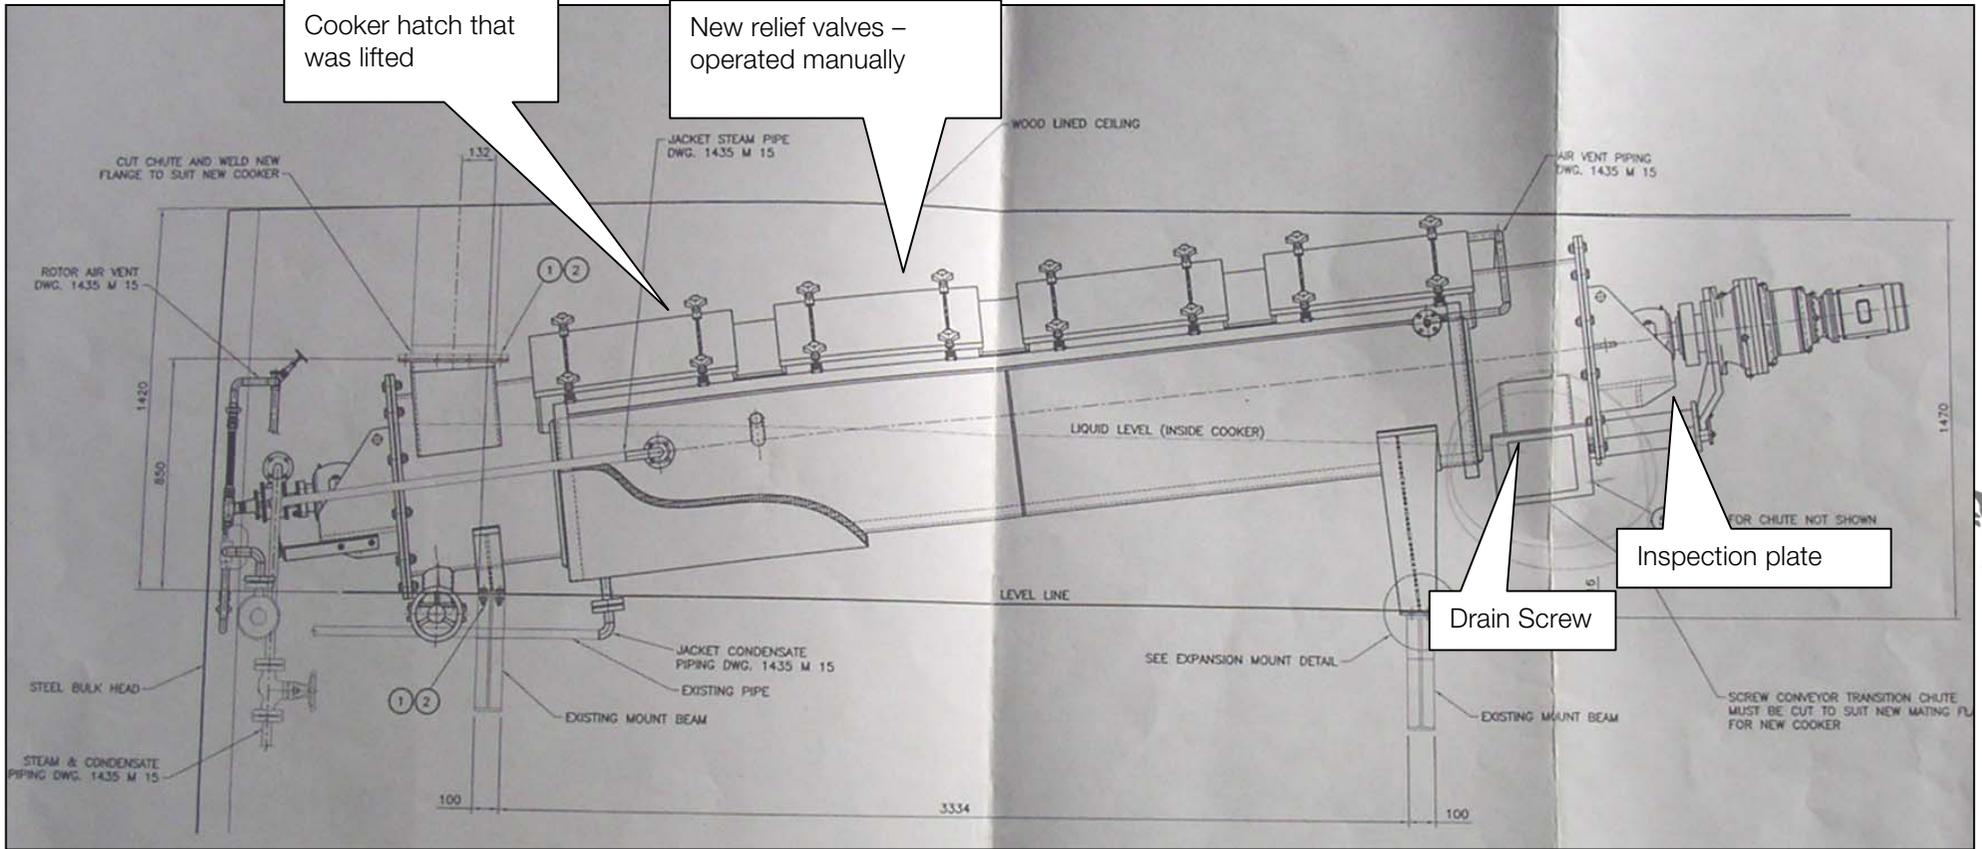
Diagram 3 – Fish Meal Plant Cooker

Crewmember 2 opened the side inspection plate (See *Diagram 3*) of the cooker and started to dig out the blockage of fish product, using a screwdriver.

After clearing the blockage, a quantity of steam that had built up within the cooker, suddenly vented from the drain screw opening. The steam struck Crewmember 2, who was unable to get clear in time, causing severe burns to his body.

Since the accident, two one-inch relief valves have been installed in way of the hatch covers to the cooker (See *Photograph 3*). These are located above the drain screw, where the pressure or steam tends to collect due to the raised angle of the cooker at this point (see *Diagram 3*). Hoses are attached to the relief valves to direct steam away from the crew. Meal men have been instructed to make sure the relief valves are opened manually, to ensure the release of any steam, before removing the inspection plates to the cooker.
