Accident Report

Aoraki

Fatality – Southern Ocean,
Campbell Plateau on
7 September 2004

Class A Final Draft

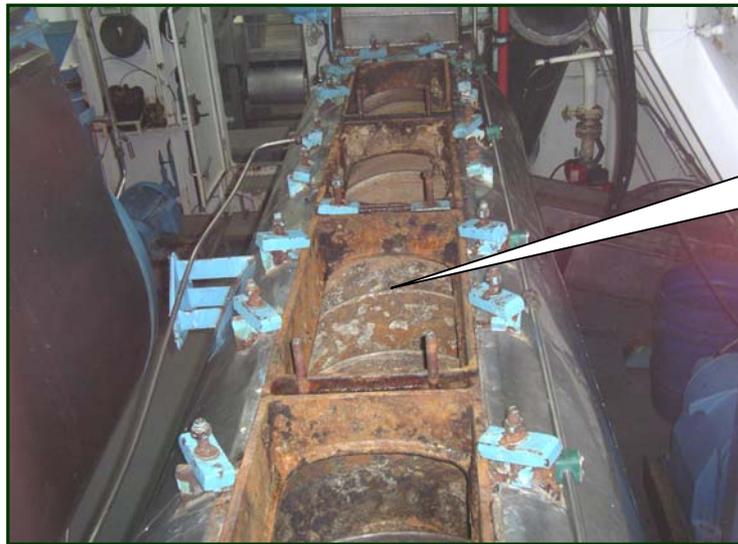
Photograph 1

Chamber in which both Mr Hope's legs were caught.

The cooker with its top plates lifted to show the auger inside

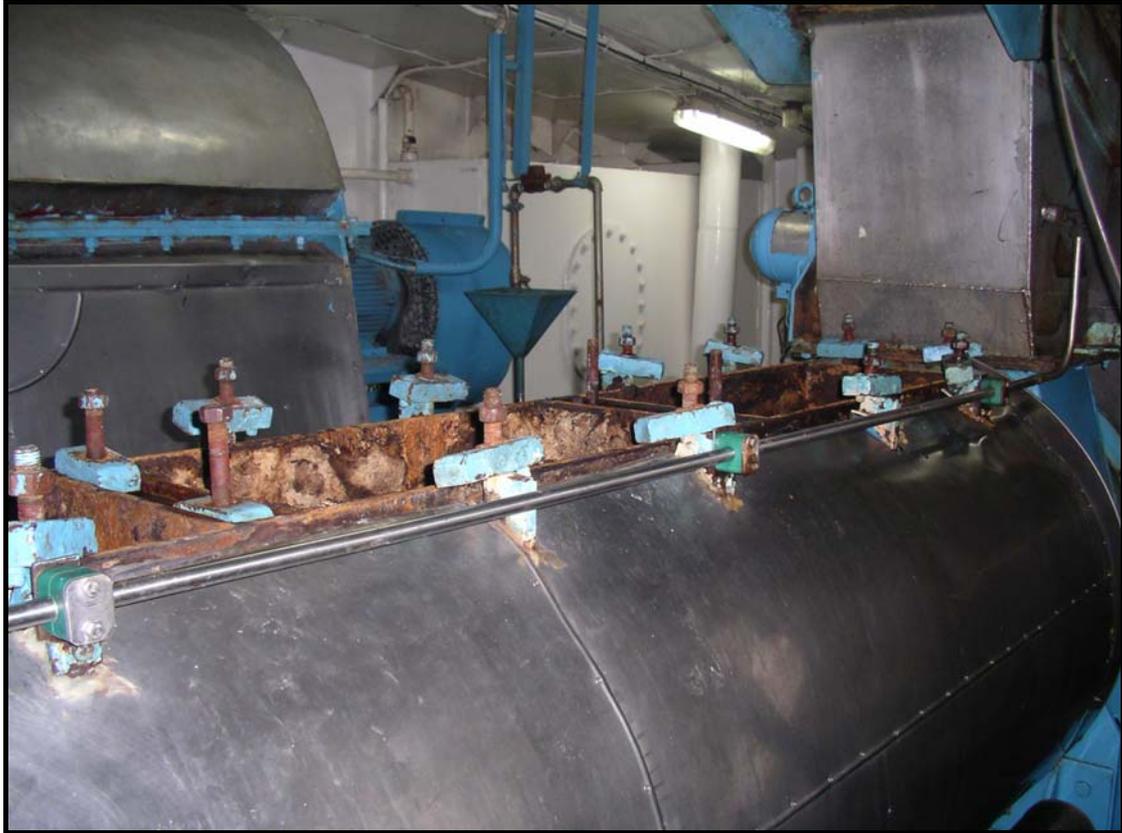
- The cooker did not have an adjacent working platform on which to stand. This required Mr Hope to either stand or sit on top of the cooker to clean inside.

Photograph 2
The cooker view from the side

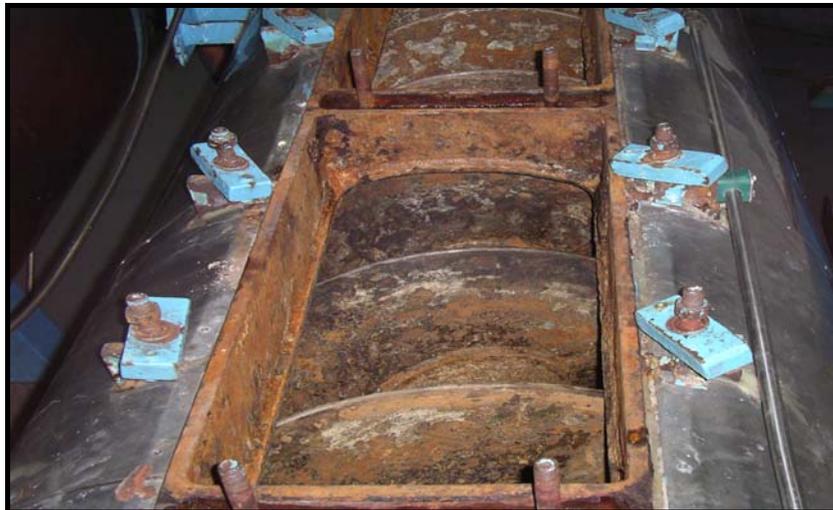
- Mr Hope's foot slipped into the auger as he turned around to clean the next chamber of the cooker.
- Mr Hope did not turn off the auger while he was cleaning this machinery.

Photograph 3
The auger in which Mr Hope was trapped

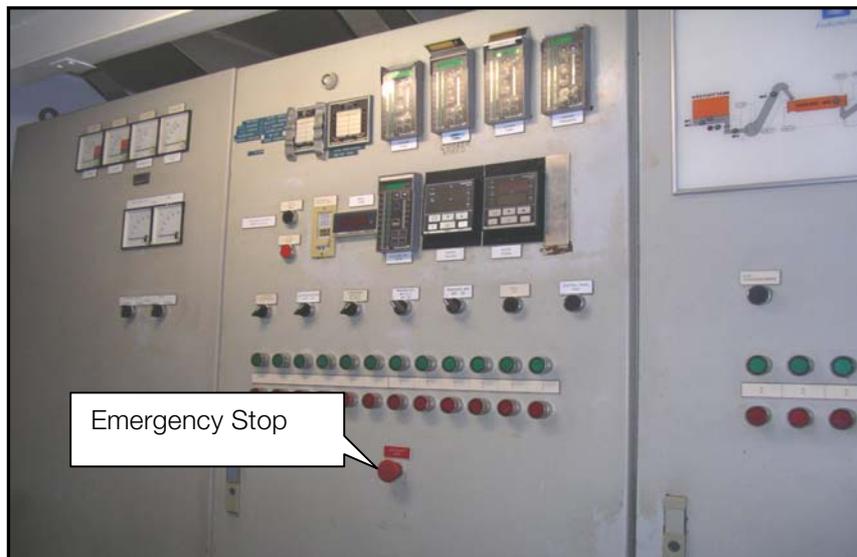
- The auger continued to rotate inside the cooker until the factory hand turned it off using the stop button in the control room.

Photograph 5
Control Room & Emergency Stop

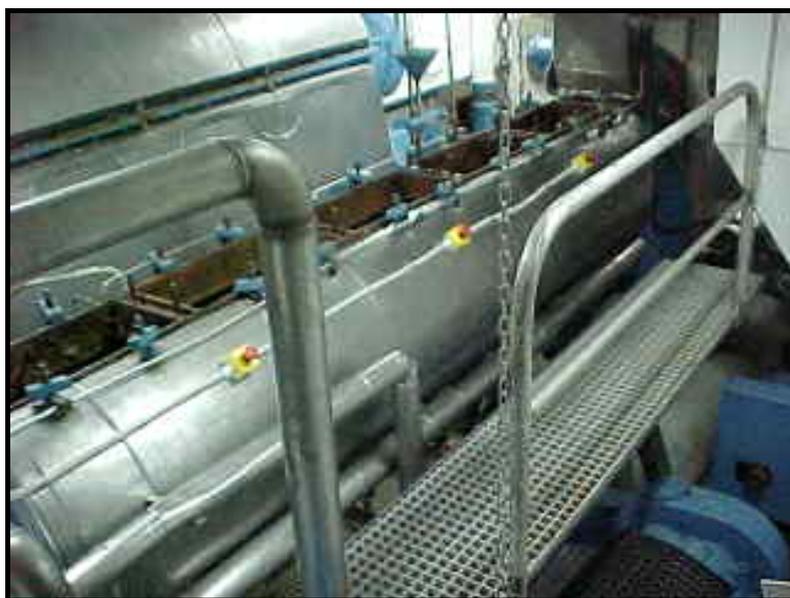
Photograph 6
The Cooker with Newly Erected Platform and Emergency Stops

In the days following the accident, a platform was erected adjacent to the cooker and emergency stop buttons attached to the side of the cooker.
