Incident Report  
Close Quarters  
*Arahura & Robert James*  
14 August 2005  
Class B

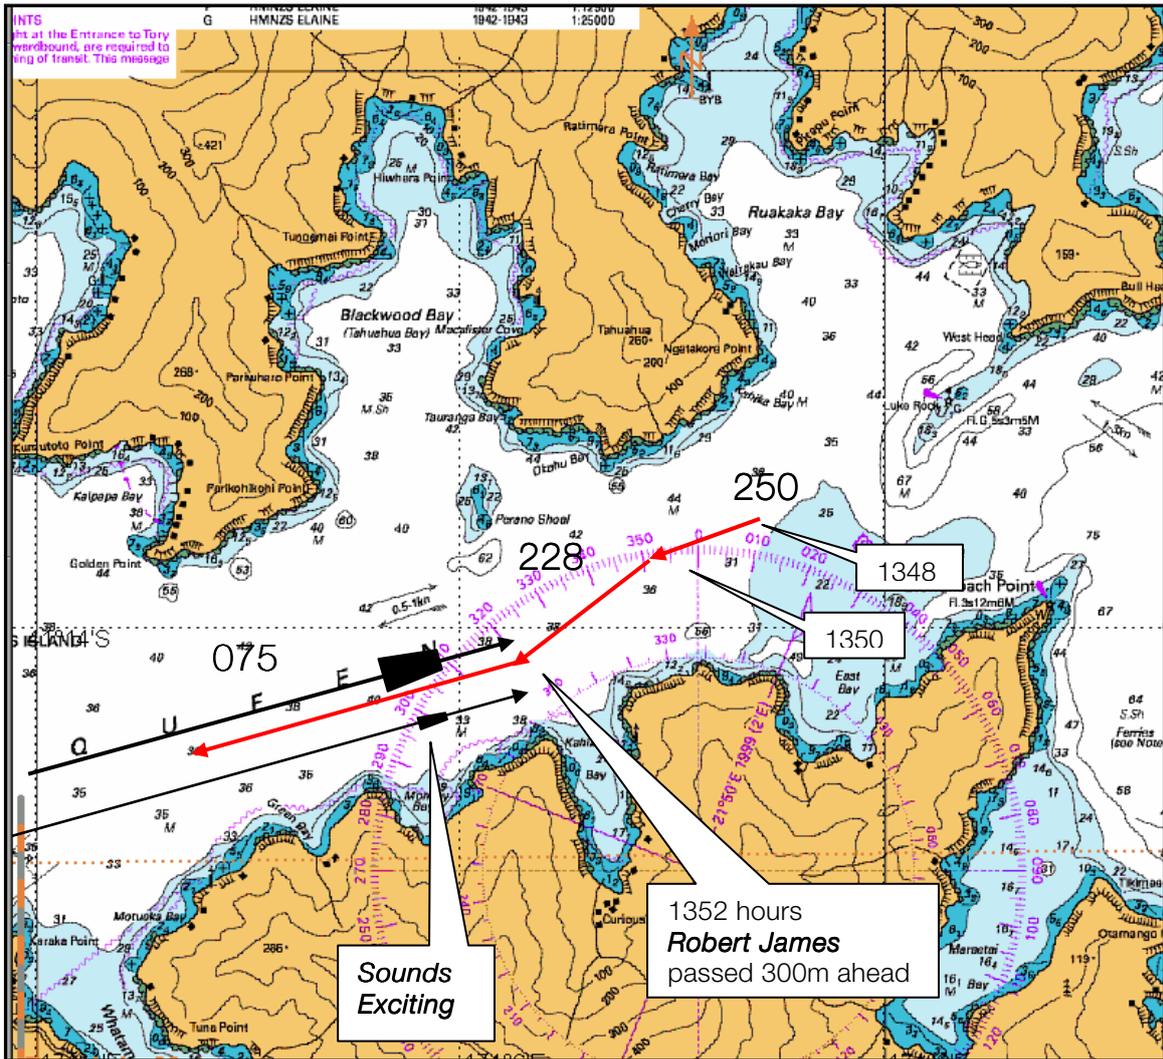
Figure 1  
 Queen Charlotte Sound chart extract from Land Information New Zealand (LINZ) Chart NZ 6153

At 1348 hours New Zealand Standard Time (NZST), on Sunday 14 August **2005**, whilst transiting Queen Charlotte Sound on passage to Wellington, the Inter-island ferry **Arahura** sighted the recreational motor-launch **Robert James** ahead. **Arahura's** course at this time was 075°(T) at a speed of 19.9 knots over the ground (See Figure 1). The weather was fine, the sea calm and the visibility good.

**Arahura** sighted **Robert James** about 15 degrees off her port bow and slowly crossing ahead from port to starboard, at a fine angle. **Robert James** was on a course of about 250°(T) at a speed of about 6 knots, as assessed by a radar plot on **Arahura** (See Figure 1).

At 1350 hours, **Arahura** sounded five short and rapid blasts to warn the launch, which was the give way vessel, of the need to keep clear. Instead of altering course to starboard however, **Robert James** altered course to port onto a heading of 228°(T) thereby increasing her angle of approach across the bow of **Arahura** (See Figure 1).

The Master of **Arahura** thought that **Robert James** had taken the action of altering course to starboard as the commercial water taxi, **Sounds Exciting**, was coming up on the starboard side of **Arahura** at speed, at a distance off the ferry of about 60-80 metres (See Figure 1).
