Class B Accident Report

Aratere & Kent Close Quarters

Wellington Harbour on 1
October 2004

REPORT NO: 04 3559

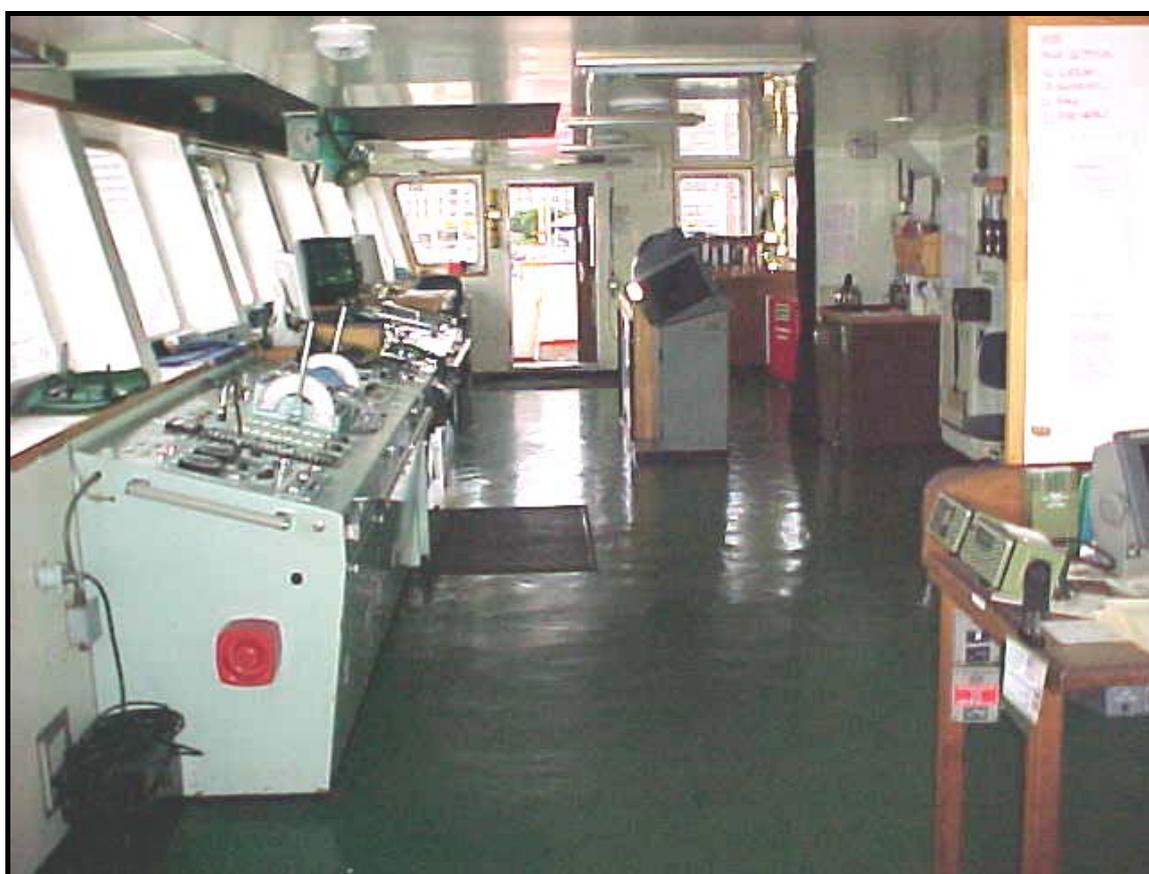
PHOTOGRAPH 1 - BRIDGE OF *KENT*

The weather was a light northerly breeze of 10 knots, fine and clear. It was forty seven minutes before predicted high water springs and charted information indicates a flood tide of approximately 0.1 knots was running at the time. *Kent* was being steered by automatic pilot. The Master and Watchkeeping Officer were on the bridge, but there was no helmsman present. The Master monitored the automatic steering.

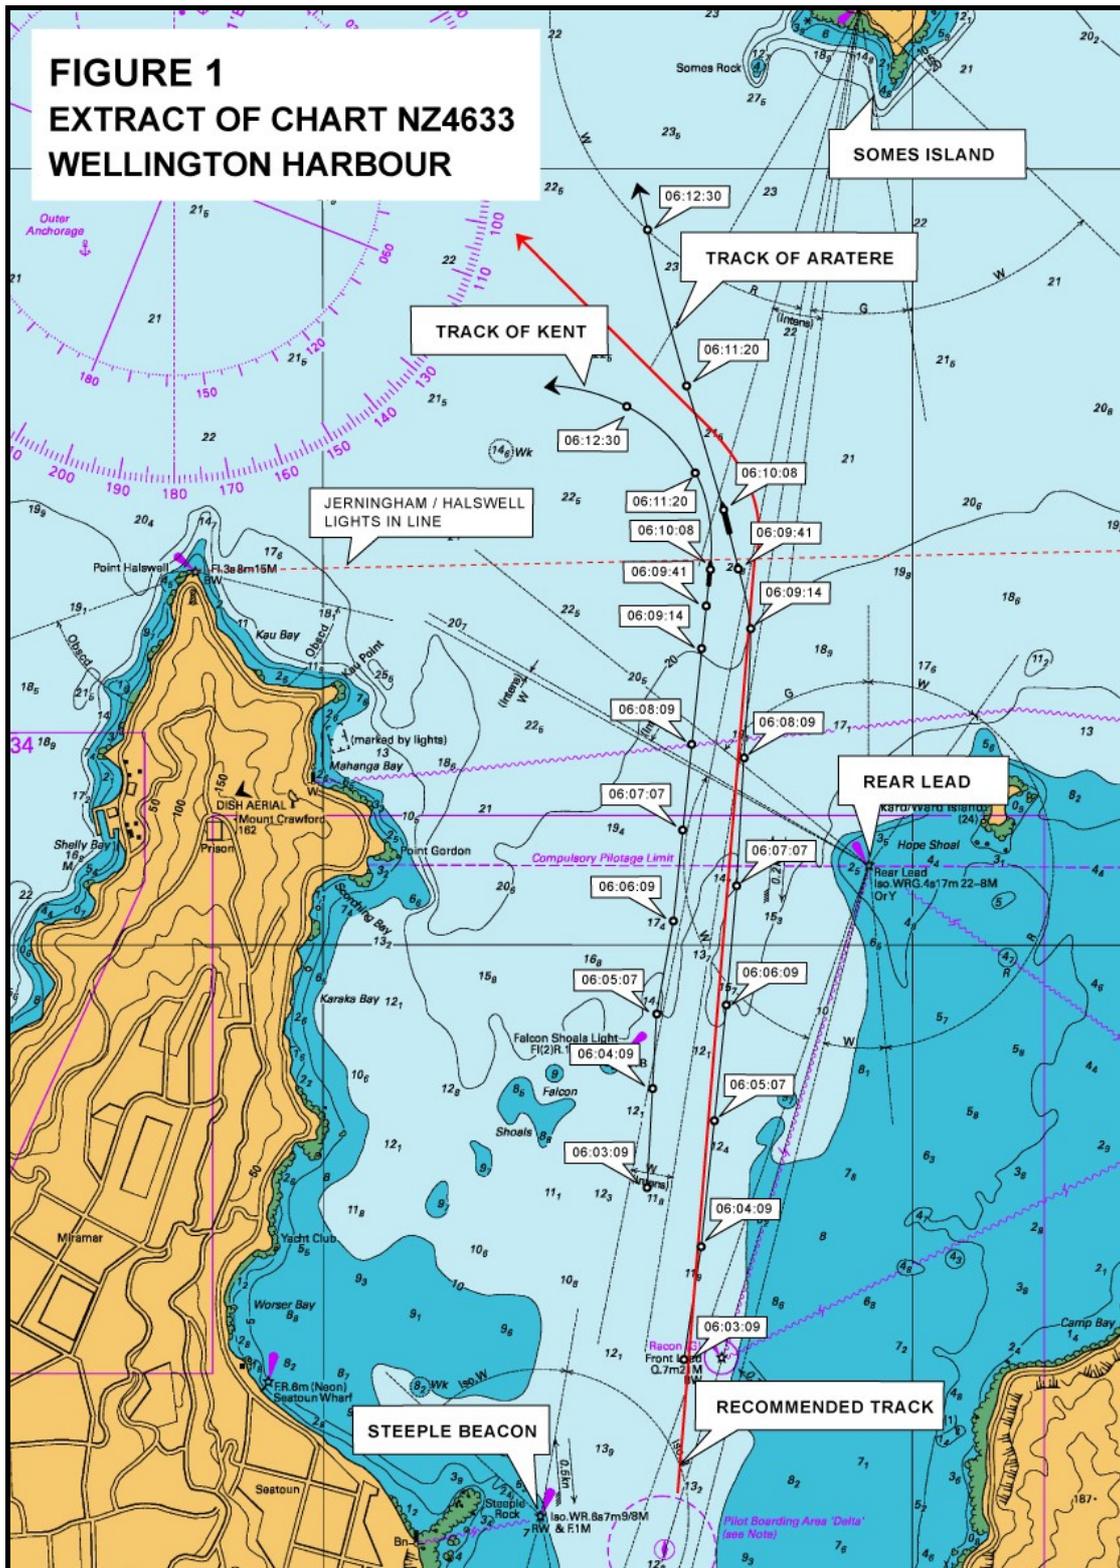
FIGURE 1 – CHART EXTRACT

At approximately 0559 hours, shortly before passing Steeple Beacon (*See Figure 1 – Chart Extract of Wellington Harbour, showing a plot of Aratere and Kent, based on VDR [Voyage Data Recorder] information from both vessels*), **Kent** altered course to port onto a course of 006°(T), moving towards the western side of the navigable channel to give **Aratere** more sea room (*See chart extract for Kent positions 06:03:09 to 06:05:07*).

At 0609 hours, when the stern of **Aratere** was just forward of **Kent's** bow and **Aratere** was pulling away at a relative speed of 5 knots, **Aratere** commenced turning to port. The Quartermaster was instructed to steer 345°(T), an alteration of 20 degrees to port from her previous course of 005°(T). The recommended wheel over position on this leg of a vessel's inward passage (which was used by **Kent**) is when Point Halswell and Point Jerningham are in line (*See chart extract*). The Master of **Aratere** stated in his interview with the MSA Investigator, a week after the incident, that **Aratere** was two cables north of this transit before he commenced altering course to port. He stated he had delayed making the alteration because of the presence of **Kent**, but did not wait until **Kent** altered to port, which occurred at 0610 hours, as he did not wish to approach any closer to Somes Island (*See chart extract*), which was ahead of him.

When **Aratere** made the alteration of course to port, VDR information indicates the 10 metre sounding contour, to the south of Somes Island, was situated 1.38 miles distant. At a speed of 19 knots, this would have taken **Aratere** four minutes to cover.

If *Aratere* had delayed altering course until *Kent* had started to alter, after reaching the recommended wheel over position on the Halswell/Jerningham transit line, *Aratere* would have had a distance to run to the 10 metre contour south of Somes Island of 1.06 miles, which would have taken just over 3 minutes to cover at a speed of 19 knots.

However, reference to the radar images taken from *Aratere*'s VDR information shows she was in fact 1.8 cables south (*MSA emphasis*) of the Jerningham/Halswell transit line when the above alteration of course to port became apparent on the radar images (*See chart extract, position of Aratere at 06:09:14*). At the time when the Master altered course 20° towards *Kent*, the stern of *Aratere* was just forward and some 260 metres to starboard of *Kent*'s bow. This occurred one minute before *Kent* reached the recommended wheel over position.

The chart plot shows that the CPA, between the bow of *Kent* and the stern of *Aratere*, was 125 metres. Information from the shore-based surveillance radar at Beacon Hill Signal Station, situated at the entrance to Wellington Harbour, indicates that the separation was 137 metres.

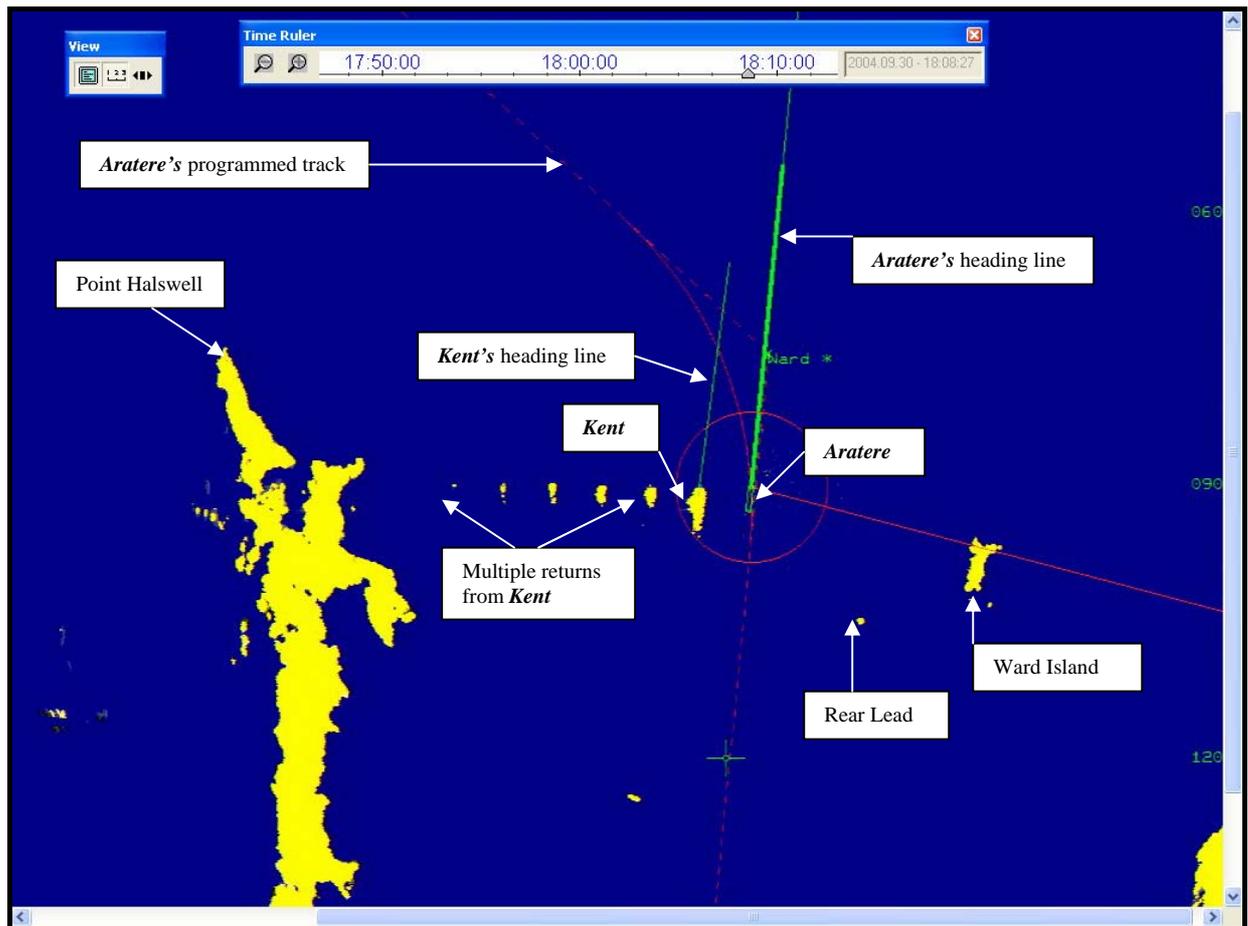
FIGURE 2

Figure 2 above, represents *Aratere's* VDR radar picture taken at 06 08 27 hours (NZST), when her Master gave the order to steer 340°. This equated to an alteration of 25° to port of the course she was steering at that time (005°). At this stage, *Kent* is only just abaft *Aratere's* port beam. The echo from *Kent* is extended by returns from the side lobes as well as the main radar beam.
