Accident Report

Fire & Subsequent Foundering

Ava

8 February 2007

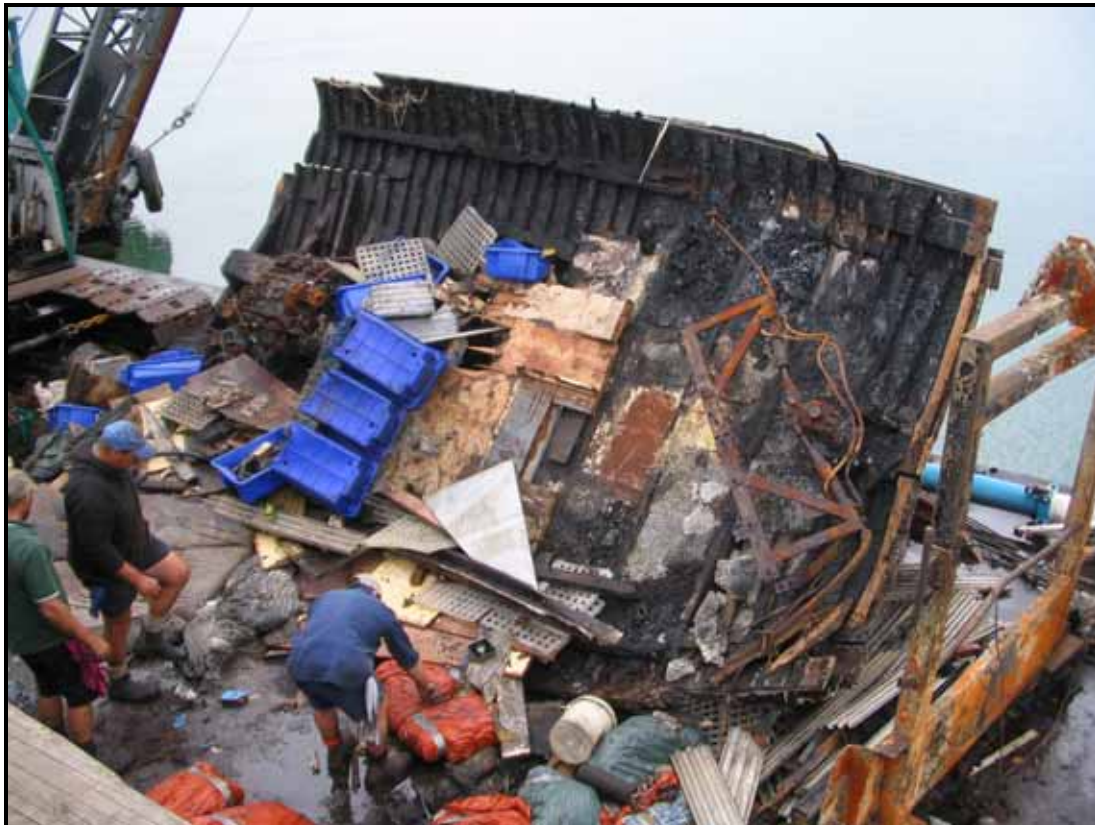
Photograph 2

Aft section of hull (engine room and lazarette) on barge after salvage

Ava suffered major fire damage during this incident; the extent of this damage causing her to sink. The vessel was salvaged a few days later. The salvage necessitated the remains of the vessel being cut into small sections in situ before being raised, and brought back to Auckland

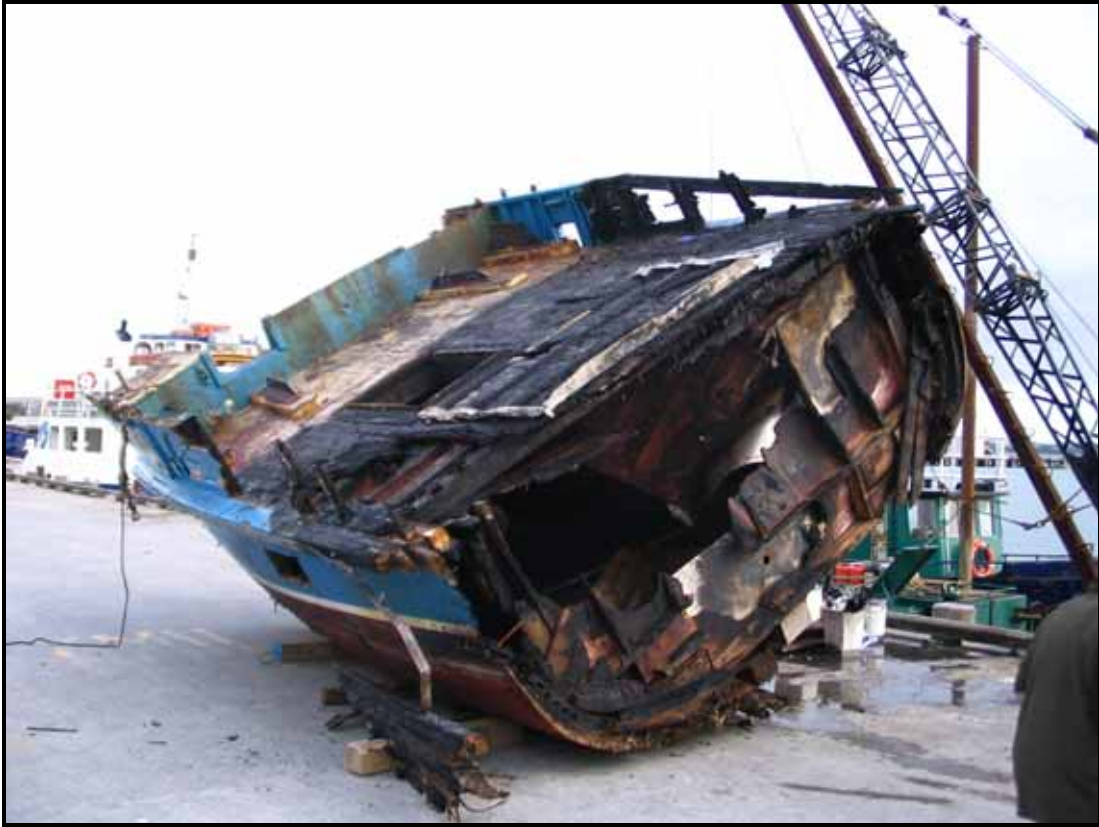
Photograph 3
Forward section of hull (fish hold) after salvage
