Accident Report

Big Johnson

Capsize resulting in

Pania Reef, Napier on 14 October 2004

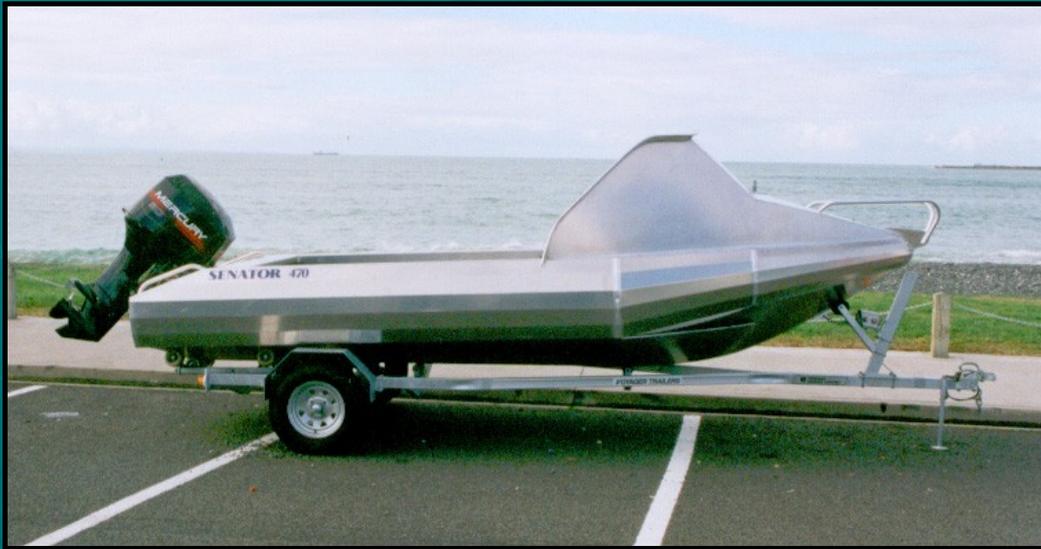
VESSEL SIMILAR TO *BIG JOHNSON*
