Accident Report  
Collision with Submerged Object  
*Black Diamond*  
28 July 2006  
Summary Report

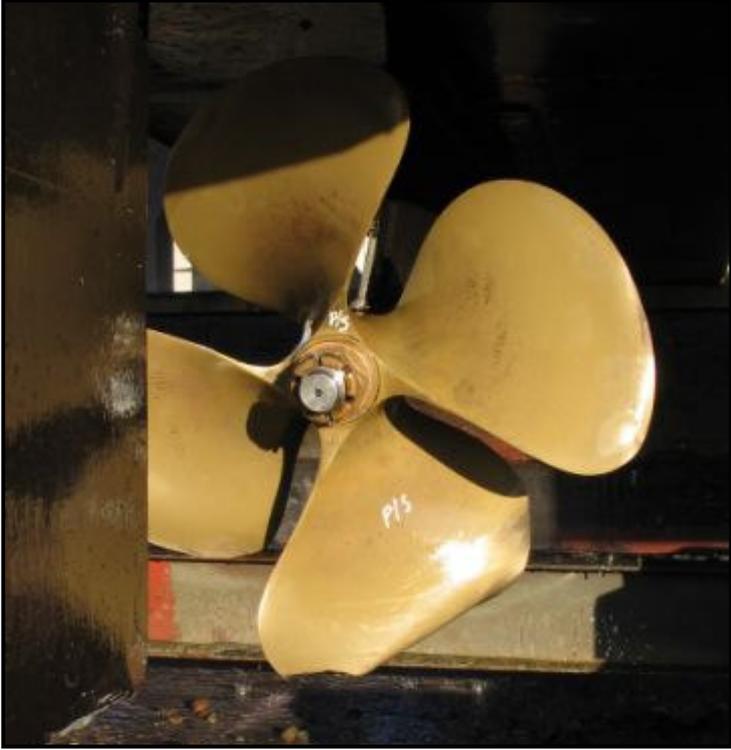
**Figure 2**  
Port propeller

When the vessel returned to port the passengers disembarked. The vessel was then slipped. It was found that **Black Diamond** had sustained serious damage to the port propeller (See *figure 2*), rudder, shaft and engine.

It is not known what ***Black Diamond*** struck. It may have been a submerged log, or other objects. The Skipper did not visually sight anything before or after striking the object. There was no disturbance on the surface of the water to indicate the presence of any underwater reef or rock close to the surface.

The absence of any damage to the hull of the vessel coupled with the under keel clearance at the time of the accident is indicative of the vessel having struck an unknown floating object.
