Accident Report

# **Cygnets II & Unnamed Senator Collision**

Witts Rock, Cook Strait on 17 April 2004

# 04 3453

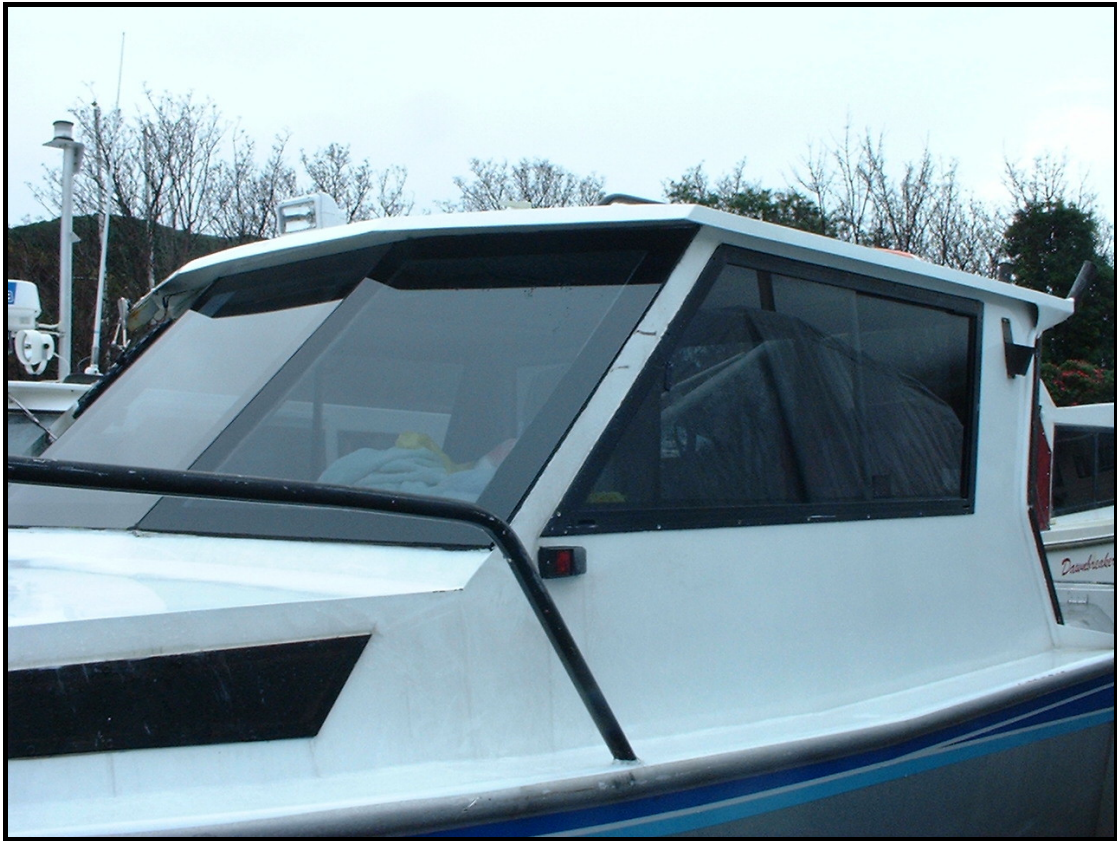
Appendix 2

**1.1.12** *Senator* sustained some minor damage in the collision (See Appendix II – Photograph of recreational vessel).
