Class A Accident Report

Louisa & Emma J

Collision

At Golden Bay on 7 November 2004

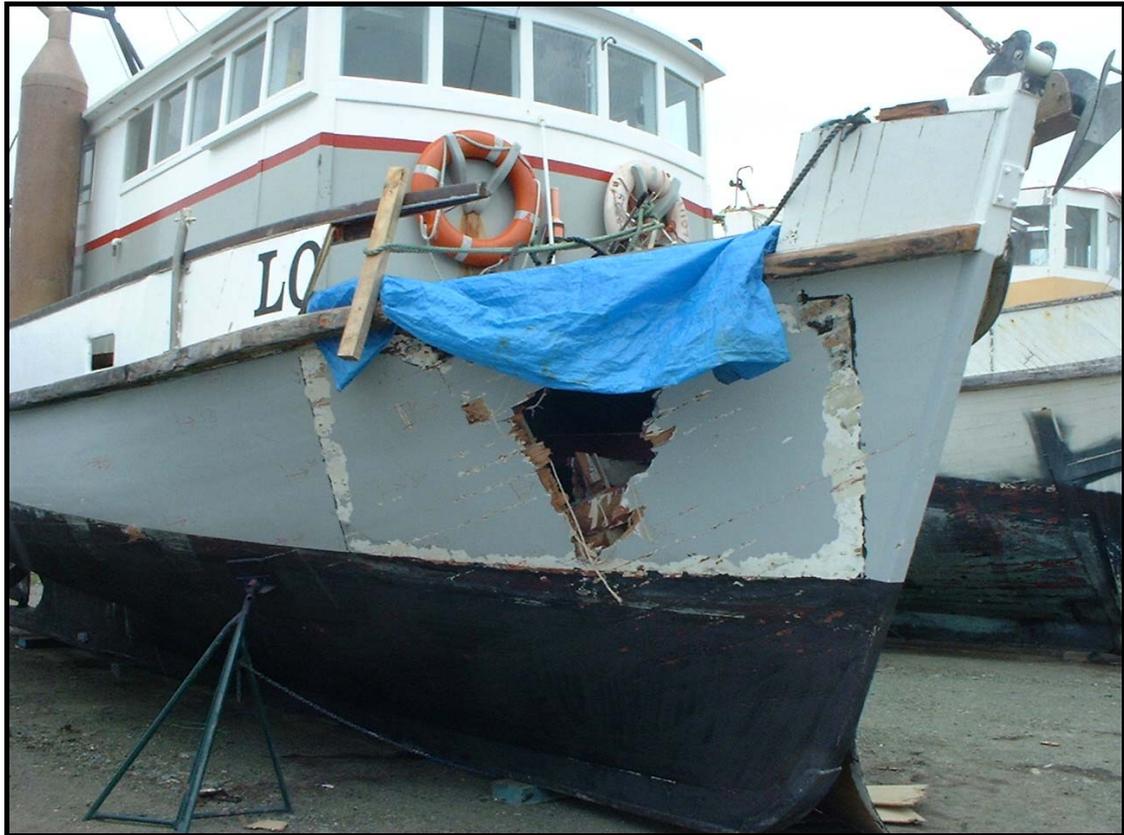
LOUISA

Louisa sustained extensive damage to the starboard side planking, ribs, beam shelf, deck beams, deck crash bulkhead, stringer, bull-works and capping rail.

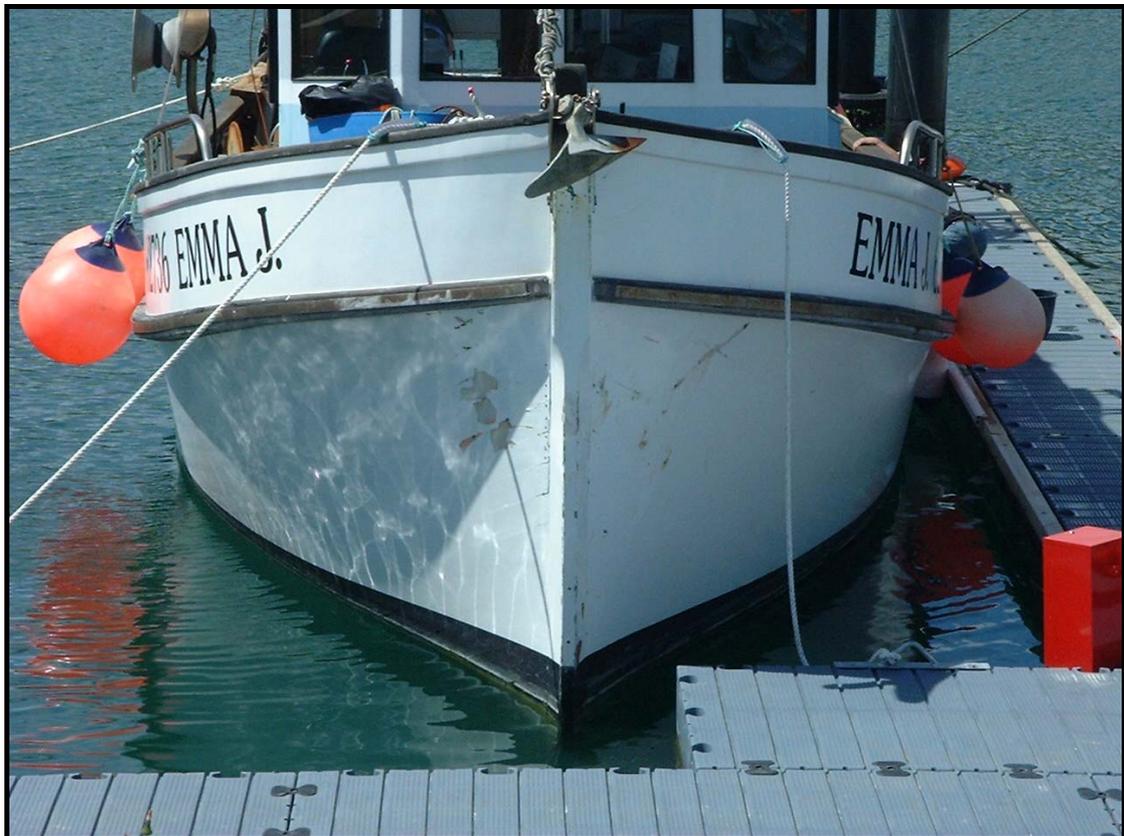
EMMA J

Emma J sustained very minor damage to the paint work around the stem post.

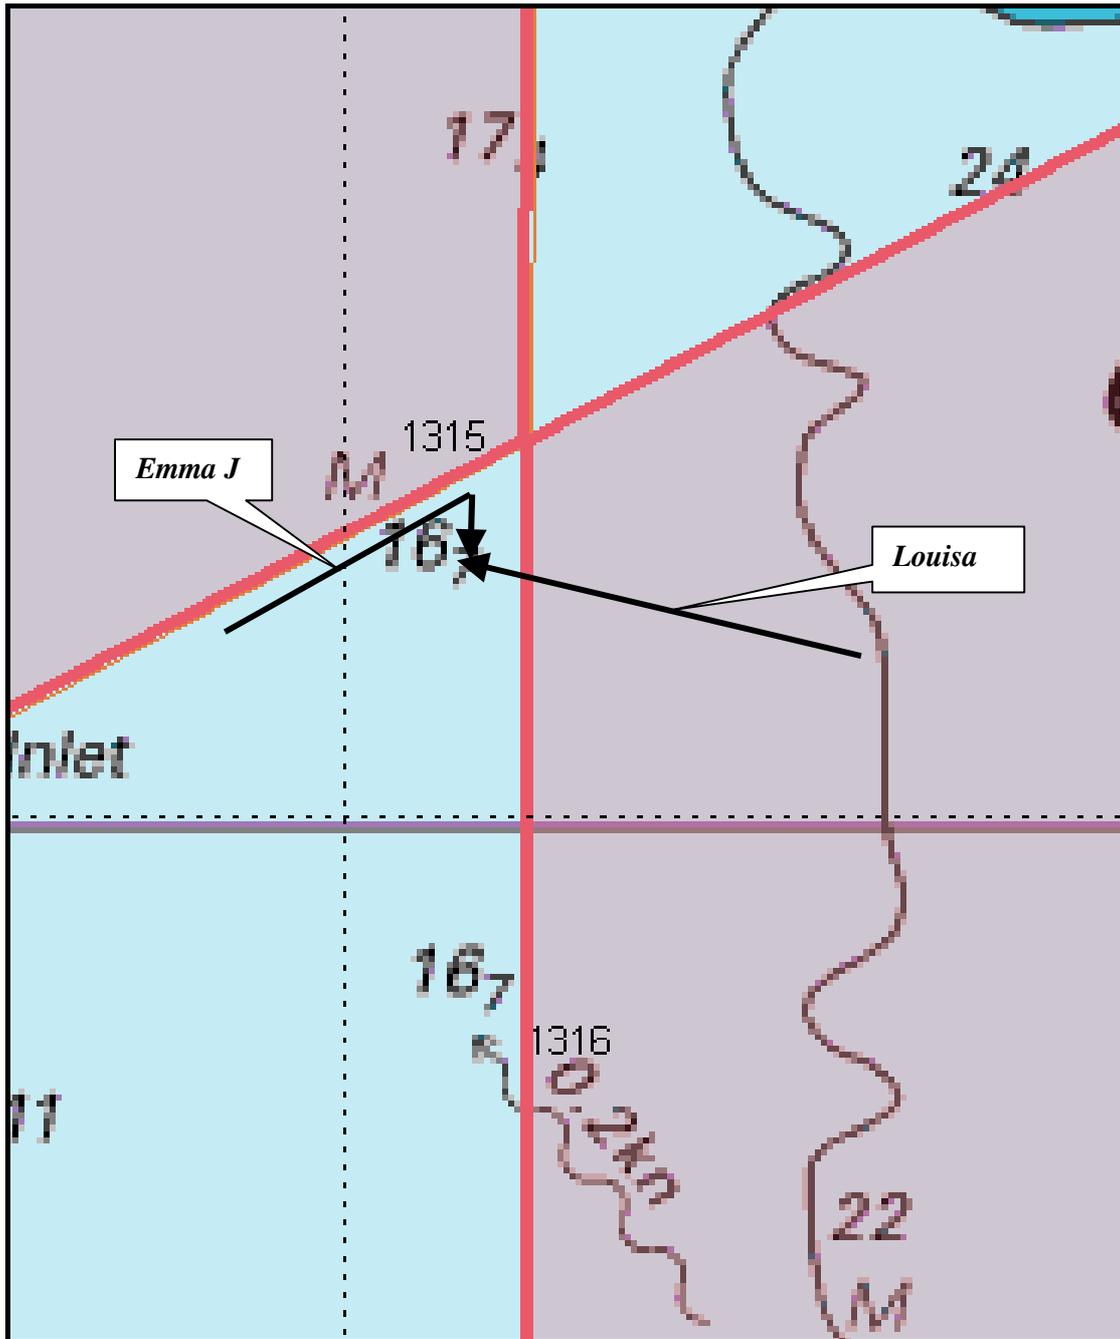
Chart NZ 61

Emma J had been towing in a northeasterly direction along the northern boundary of the fishing prohibited area. The Skipper wanted to turn the vessel onto a reciprocal course when he neared the northeastern corner. At the same time *Louisa* was on a nearly reciprocal course but slightly to the south of track of *Emma J*. The Skipper of *Emma J* went into the wheelhouse and applied 40° of starboard helm then went back to the tray. This alteration closed the distance between the vessels; the angle of impact was almost 90°, with the stem post of *Emma J* striking the starboard shoulder of *Louisa*.
