Accident Report

# Glen Rosa Flooding

Auckland Harbour on 20 March 2004

**REPORT NO: 04 3438**

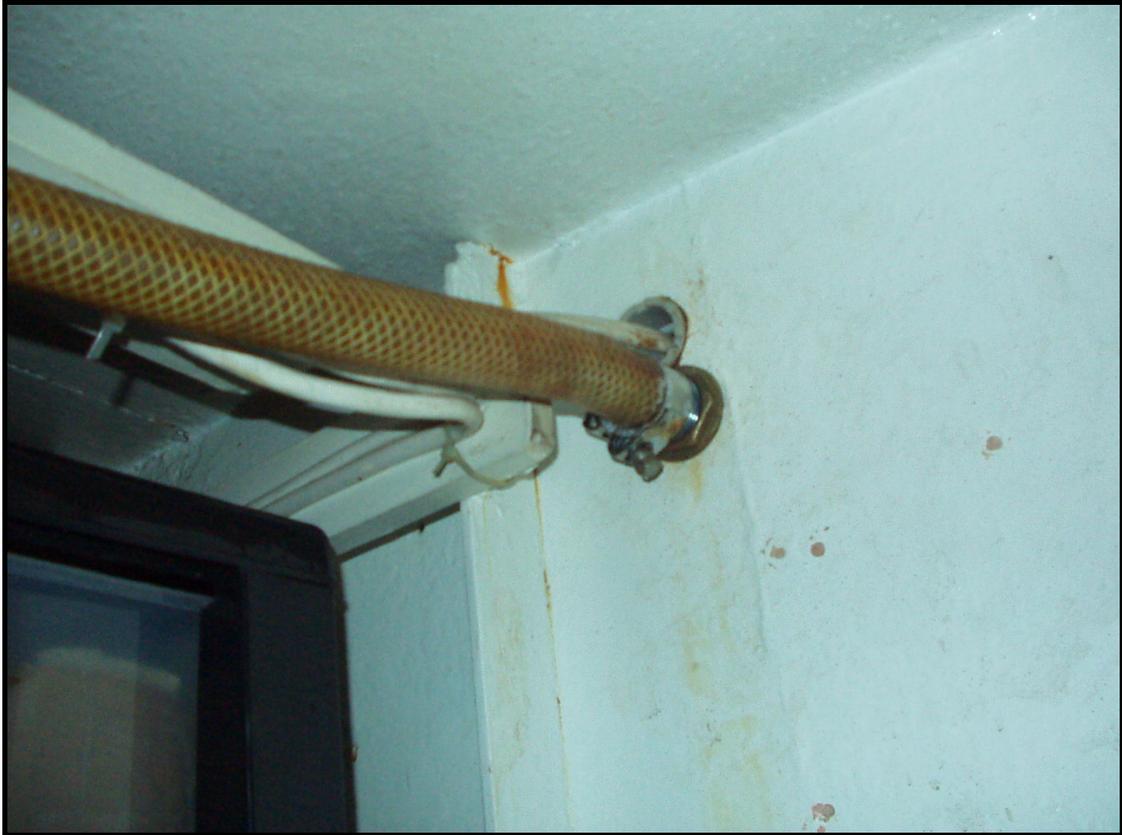
- 1.9 On inspection of the engine room, it was found that a reinforced plastic pipe, fitted to the discharge pump for the salt water engine cooling, had become disconnected at the point where it passed through the after engine room bulkhead.

- 2.4.1 The flooding started when a reinforced plastic pipe, connected by a jubilee clip, to the salt water-cooling system, came away from an after bulkhead fitting after the jubilee clip loosened (*See Appendix 3 - Photograph of fitting*). The fitting consisted of a one-inch diameter tail pipe that passed through an aperture in the bulkhead. The reinforced plastic pipe was attached to the tail pipe with a jubilee clip, which was found, on inspection, to be free of rust.
- 2.4.2 It was the opinion of the Owner that the jubilee clip had loosened due to the vibration of the centrifugal cooling pump.
- 2.4.3 After the flooding, the tail pipe was changed to a six-inch stainless steel tailpipe, extending three inches on either side of the bulkhead. The pipe was then re-attached with two jubilee clips on either side.

*Glen Rosa’s* overboard discharge pipe carried seawater and was constructed of reinforced plastic. The vessel was constructed of steel and accordingly was in breach of **Rule 40A.35(6)** for failing to have marine quality metal piping.

- 4.1** The failure of the jubilee clip holding the salt water-cooling pipe to the aft bulkhead fitting.

- 2.6.1** The overboard discharge line has been diverted from passing through the aft bulkhead to a through hull fitting in the main engine room.
- 2.6.2** The vessel has been fitted with bilge alarms and automatic float switches.
- 2.6.3** The Owner has written instructions on the use of the 240 volt submersible pump in the SSM manual and has given his Masters instructions on operation.

- 5.8 It is recommended that the following matters be attended to by the owner of *Glen Rosa* within 2 months of the report being finalised namely:
  - That all saltwater overboard discharge piping be constructed of metal in accordance with **Maritime Rule 40A.35(6)**.
