Accident Report

Crane Failure

Global Wind

16-November-2006

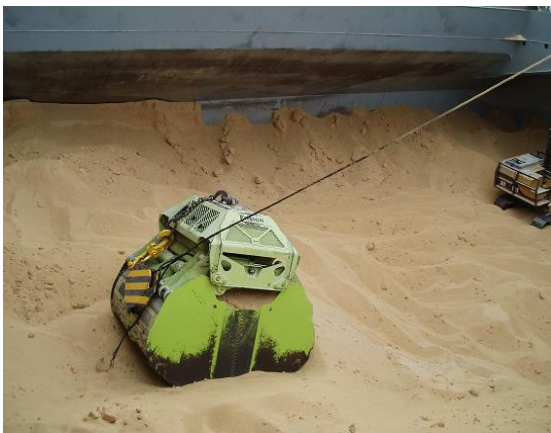
At 1630 hours, No. 4 crane had just started to lift a grab full of cargo from No. 5 hold when its hoisting wire parted, allowing the grab to fall back into the cargo (see Photograph 2). There were no injuries or damage.

Photograph 2 - cargo in No. 5 hold

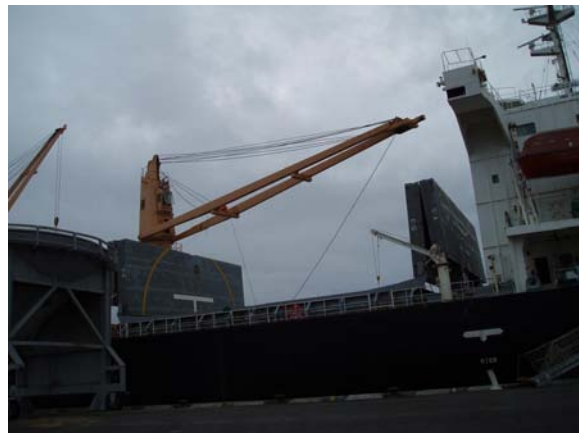
Photograph 3 – No. 4 crane after the wire parted

After checking the ship's lifting appliances and documentation, a Notice of Imposition of Conditions was issued, prohibiting the use of the cranes to work any further cargo until they had been assessed as safe to use by a competent person.

The ship's crew replaced the hoisting and luffing wire ropes on No. 2 crane with certificated new wires.

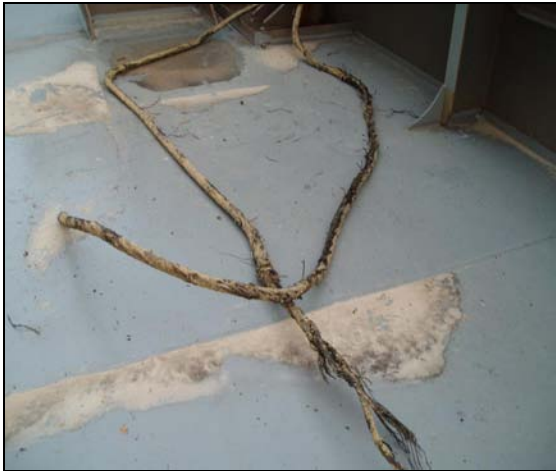
The hoist wire ropes on board **Global Wind** were well greased. The vessel was discharging soya bean meal at the time and the ropes were coated with cargo. Point inspections along the wire rope away from the part that was damaged by the breakage indicated that it was in satisfactory condition. From this it may be concluded that a visual examination of the rope may not have been sufficient to detect that it was about to fail.

Photographs 5 - the broken hoisting wire rope

The hoisting wire rope of a 30 tonne crane on board **Global Wind** parted while it was lifting about 25.4 tonnes. The wire rope had been in use for three and a half years.

The four cranes on board **Global Wind** were rigged with a total length of 1456 metres of wire rope. The reliability of an inspection on that length of rope, coated in lubricants, while it is in place on ship's cranes is questionable.

1. It is recommended that the ship's operators use other means, in addition to visual inspections by crew, to ensure the reliability of wire ropes used in ships' cranes. This may include a policy to replace wire ropes used for lifting after a reasonable interval determined by the use to which it has been put and any conditions such as the carriage of abrasive or corrosive bulk cargoes which may affect their integrity.

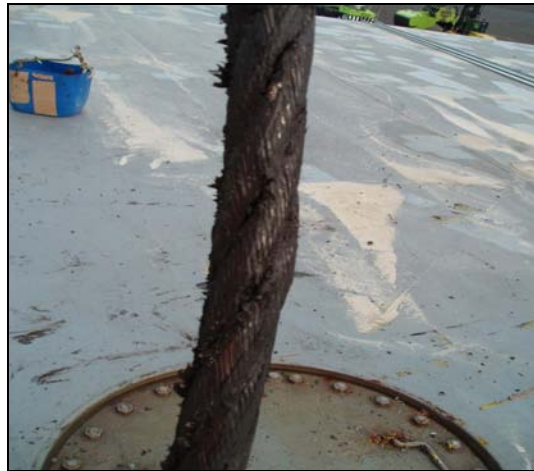
Photograph 6 – section of No. 4 hoisting wire
