Accident Report

Sinking (1 fatality)

Hard Out

23 February 2008

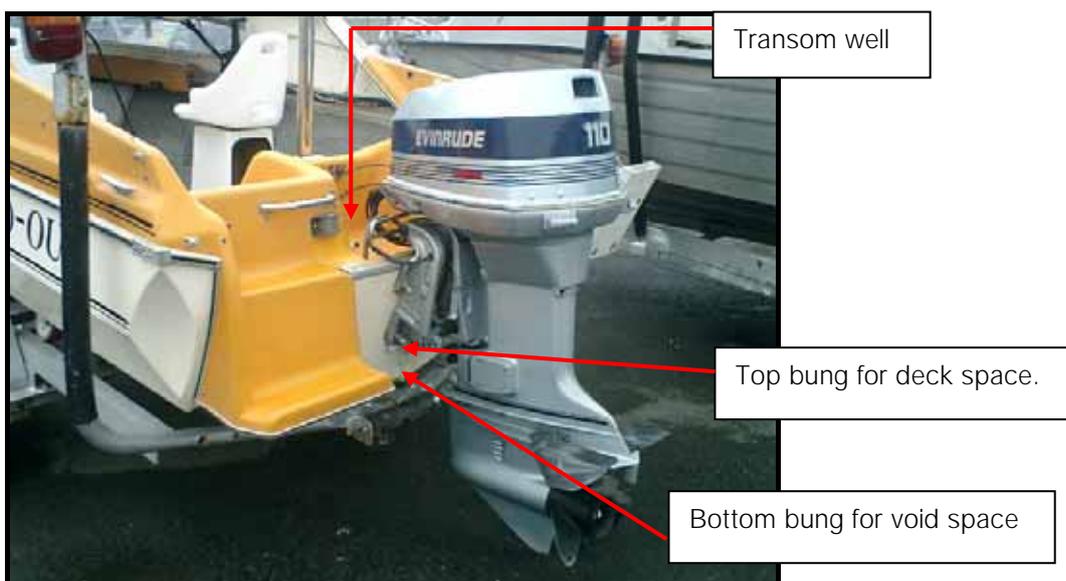
Photograph 2
Hard Out - transom position of bungs indicated above.

- 3.22 The void space between the hull and deck was fitted with a bung in the transom to drain the void if required.
- 3.23 There was also a bung in the transom fitted just above the level of the interior deck level to drain the interior of the boat when hauled out of the water. In addition, there was a drain hole in the transom well to drain any water that may slop in (*See Photograph 2 - showing the transom and bungs*).

- 3.24 The owner reported that he had replaced both bungs when he purchased the vessel, because the top bung had started to perish and he believed that it was not sealing too well. He also indicated that he had put silicone around the new bung *"to make sure it was all ok"*.
- 3.25 The owner pressure tested the bungs to check the water tight integrity of the vessel. He stated:

- 3.27 This method of testing may have stressed the hull and transom causing possible fractures. The fractures may have been latent and become active when the boat was flexing in a seaway causing the void space to flood. This view is supported by the manufacturer.

- 3.28 To determine with some accuracy the possibility of fractures occurring from this method of pressure testing, it is necessary to establish the exact amount of water used during the pressure test and which space was filled during the described test methods. Unfortunately this could not be confirmed.

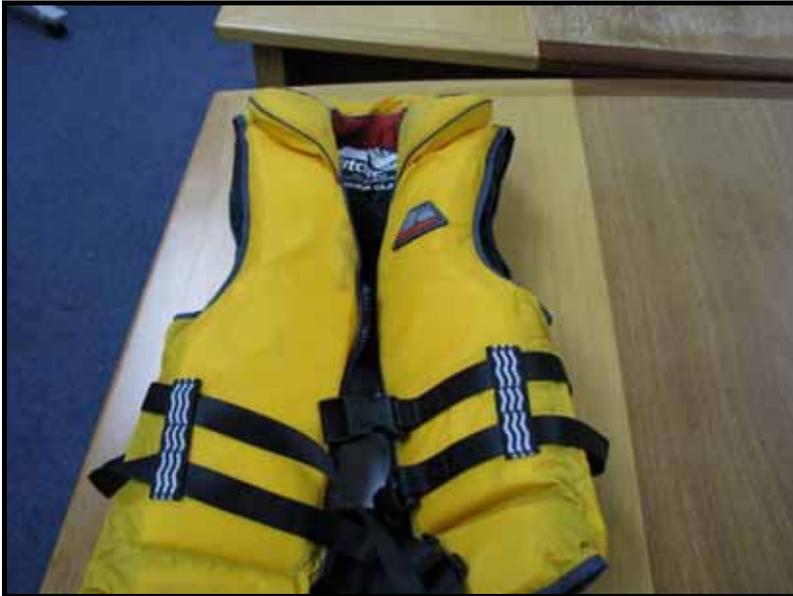
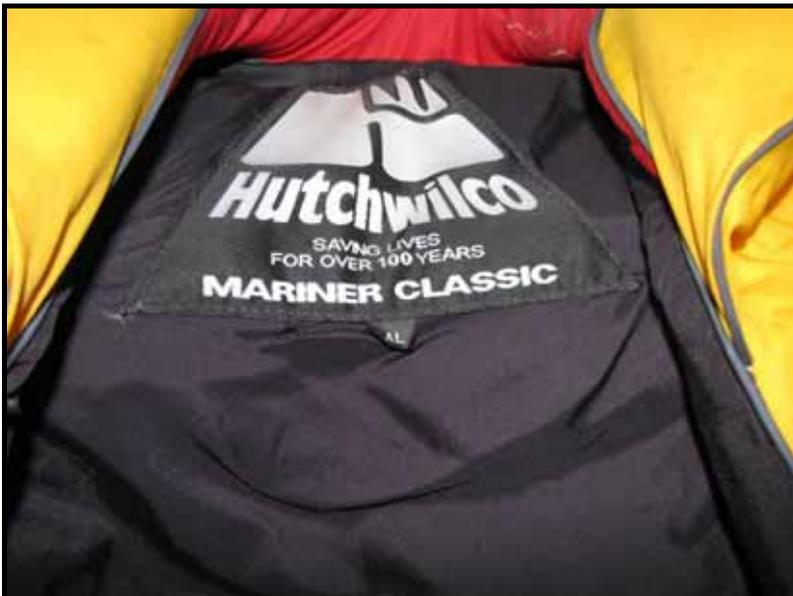
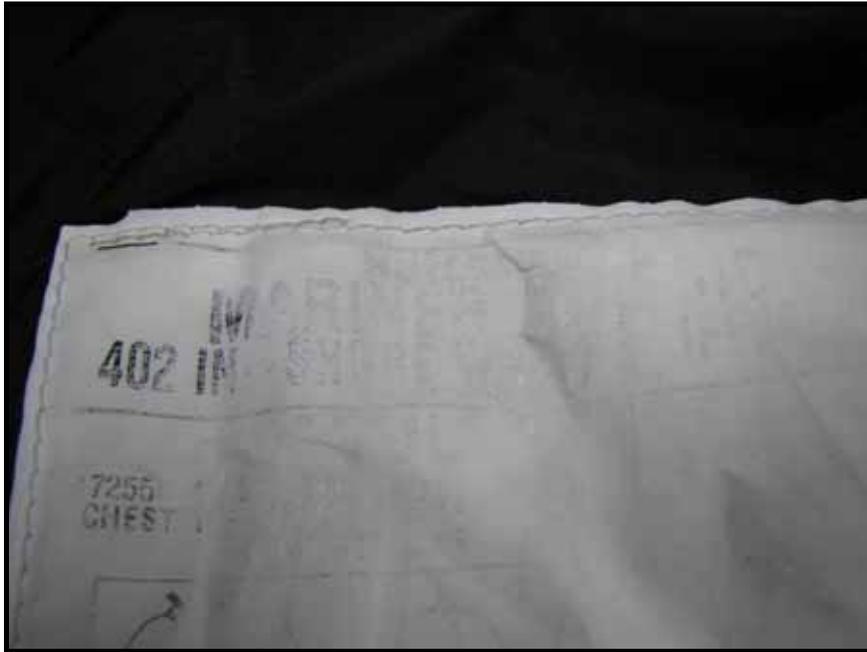
3.62 The passenger wore a Hutchwilco Mariner Classic, adult large, of New Zealand Category 402 (See Photographs 3, 4 & 5 – Passenger's PFD).

- Hutchwilco Mariner Classic, adult large of New Zealand category 402.

- Showing brand and size label on inside

- Label on the inside of the lifejacket. The lifejacket is marked '402 In-Shore waters'

3.63 These photographs of the passenger's PFD, confirm that it is Category 402 designed for inshore waters, defined by NZSM 5823:2005 as a location *'Where an early rescue may be anticipated'* and was previously referred to as *'Sheltered Waters'*. This PFD is not the correct jacket for use in open sea.

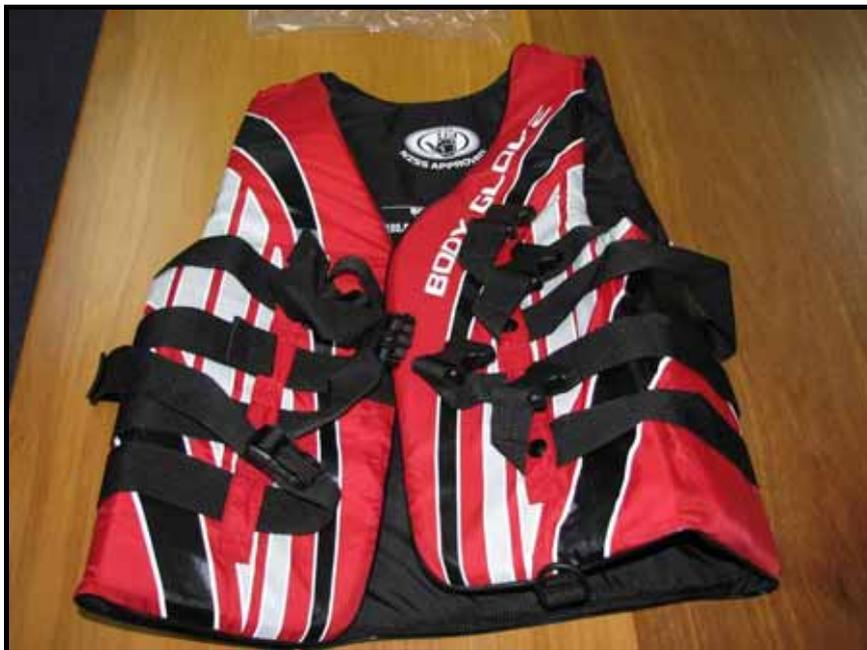
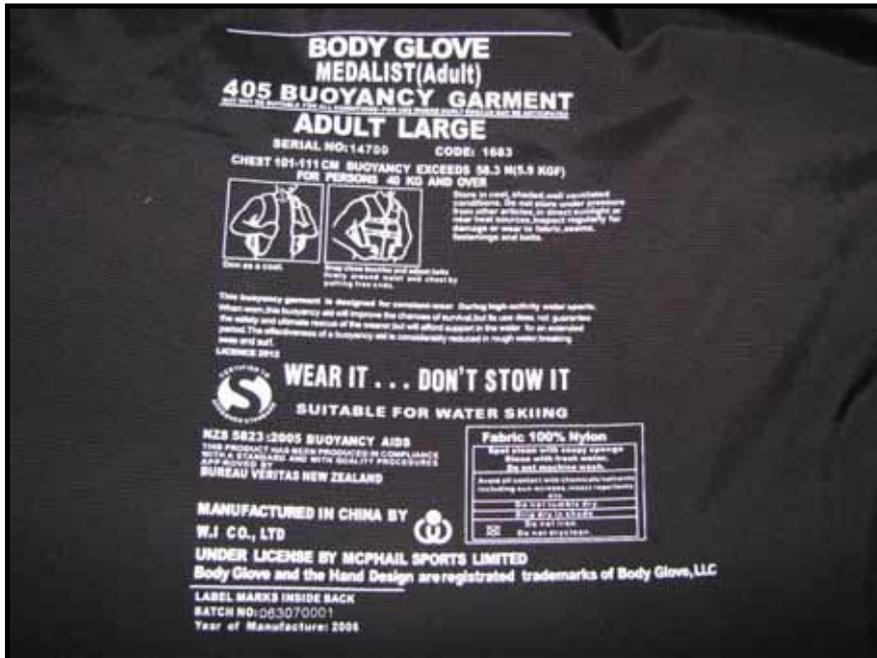
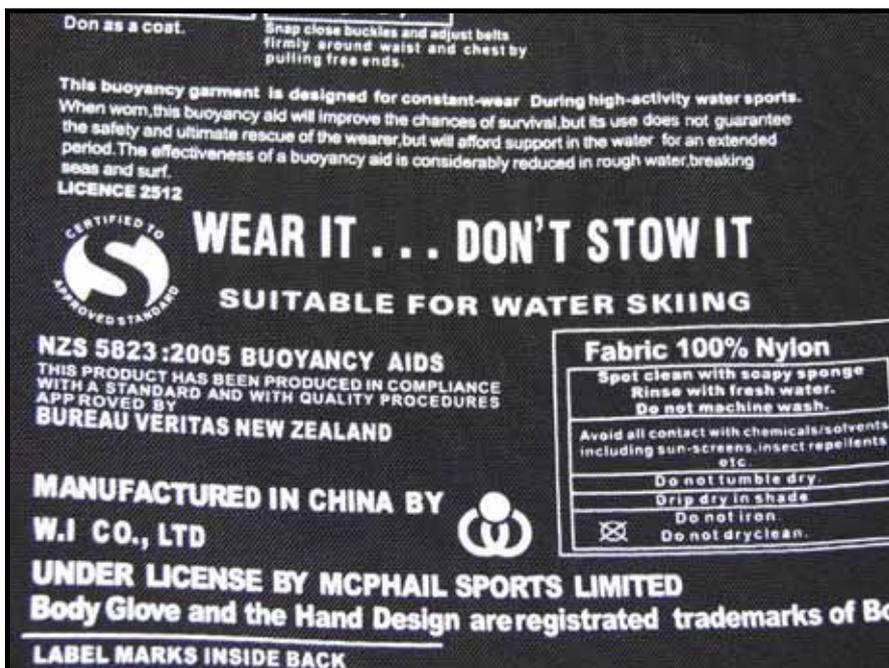
3.64 The owner was wearing a Body Glove Personal Flotation Device Category 405 (See Photographs 6, 7 & 8 – Owner's PFD).

3.65 The PFD worn by the owner was designed to be worn on the body when the wearer is at risk of short term immersion in water.

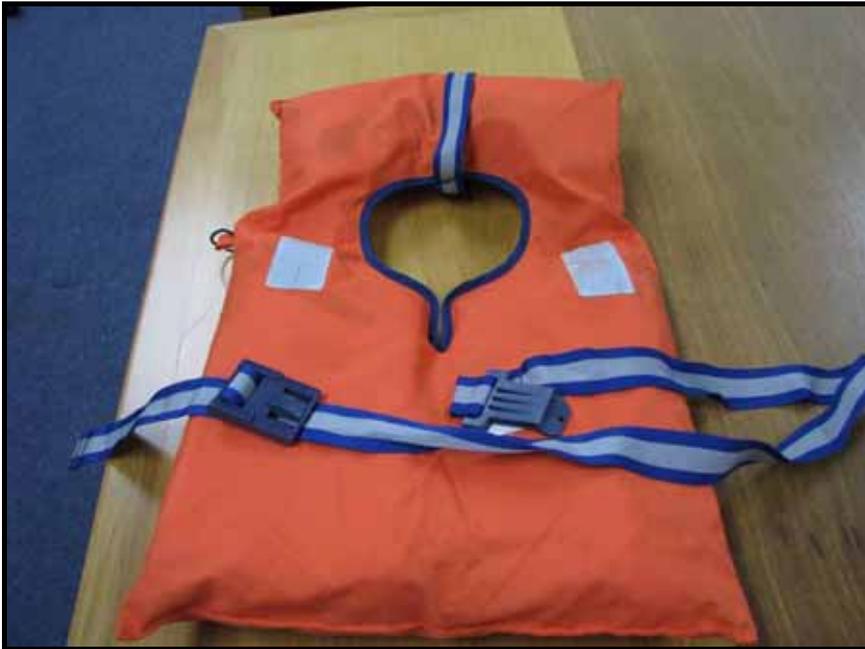
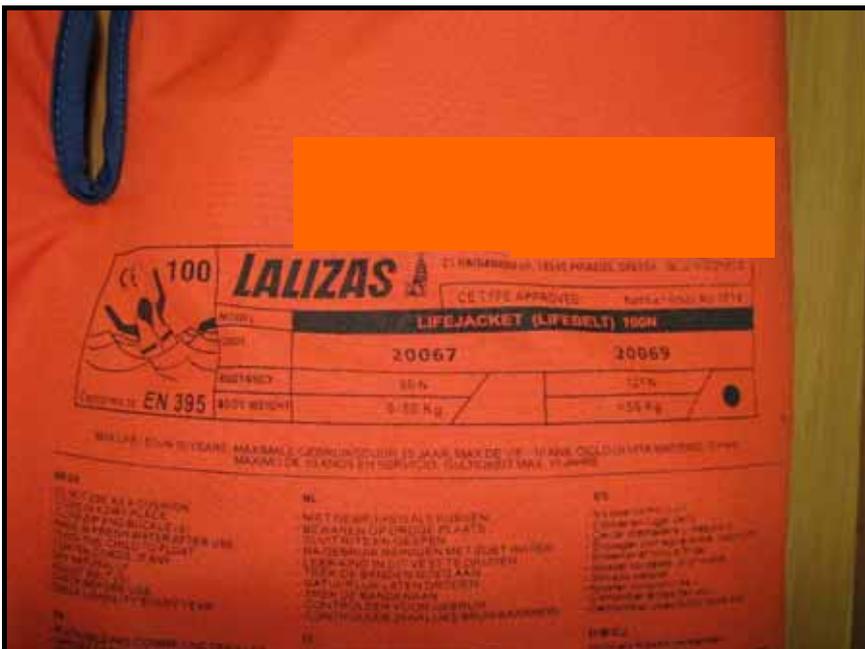
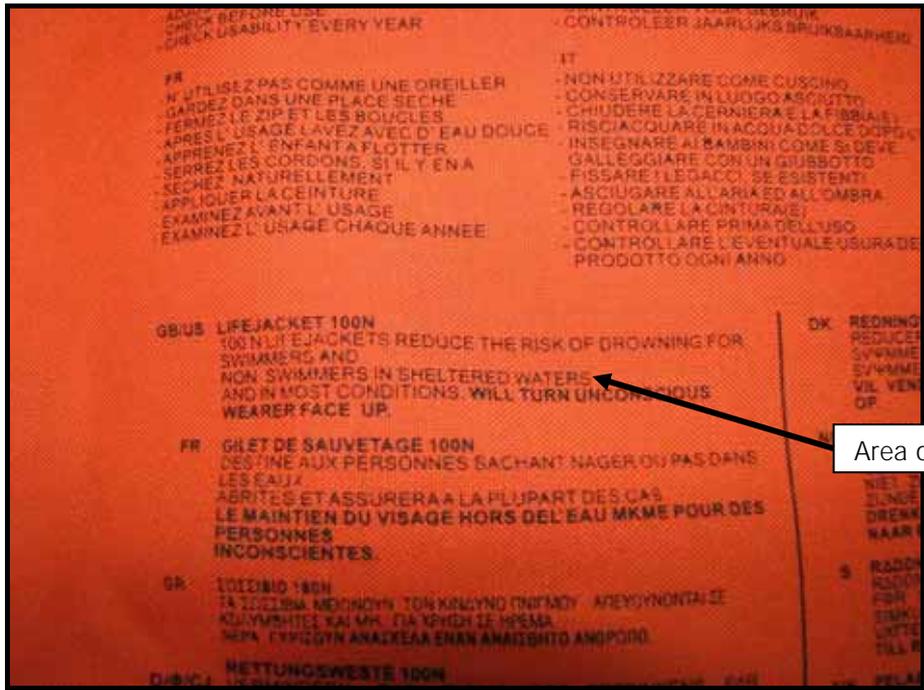
3.67 The PFD worn by passenger 2 was a LALIZAS 100 N (*See Photograph’s 9 & 10 – showing Passenger 2’s PFD*).

- 3.68 New Zealand Standards and European Standards differ in their definition of the attributes of a lifejacket.
- 3.69 The European Standard EN395 (the PFD worn by passenger 2) calls a buoyancy aid with 100 N a lifejacket.
- 3.70 The comparative New Zealand standard for a lifejacket refers to the device as having to exceed 100 N plus 10%. The term lifejacket is commonly used to describe all forms of buoyancy aids. It should be noted that although the common term may be lifejacket, it may be a buoyancy aid which does not reach the specified standards for a lifejacket.

- Area of use

- 3.71 The PFD worn by passenger 2 was designed for the average adult and is intended for use in sheltered waters. Using either the European Standard or the New Zealand Standard, this PFD is not designed for use in open seas (*See Photograph 11 - area of use.*)
- 3.72 On **Hard Out** there was an additional PFD which was retained by the occupants when they were in the water. This PFD was used as additional support for passenger 2.
- 3.73 The additional PFD was an older AK1 model kapok filled lifejacket, manufactured in the 1970s (*See Photographs 12 & 13 – additional PFD.*)

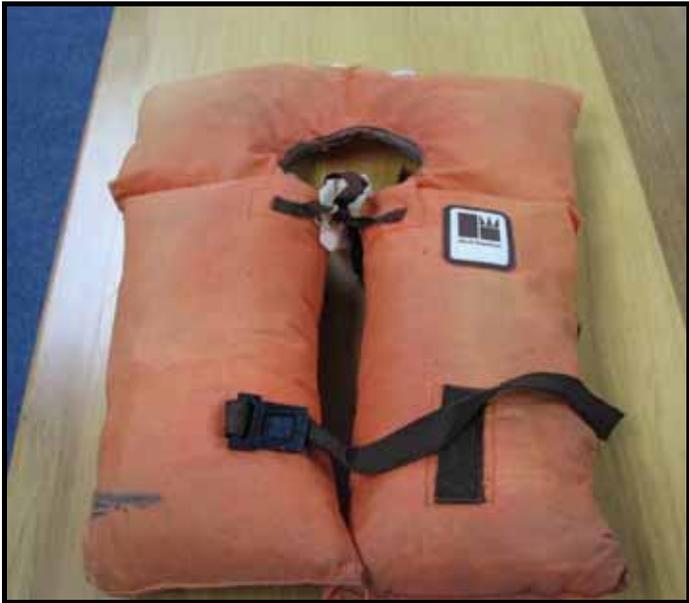
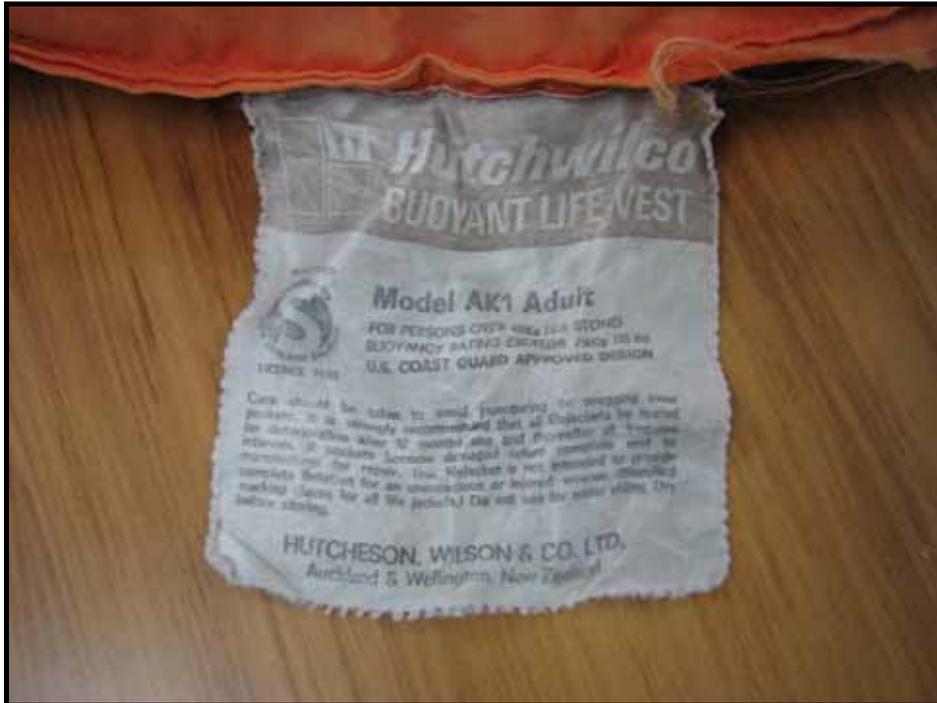
- 3.74 The manufacturer recommends that this PFD is periodically checked to ensure fabric and fittings are in good condition. This is to ensure that water ingress is not present which would result in the saturation of the kapok and reduce its buoyancy.
