Accident Report

Hirere

Injury – Pandora Banks area on
11 May 2005

REPORT NO.: 96 406

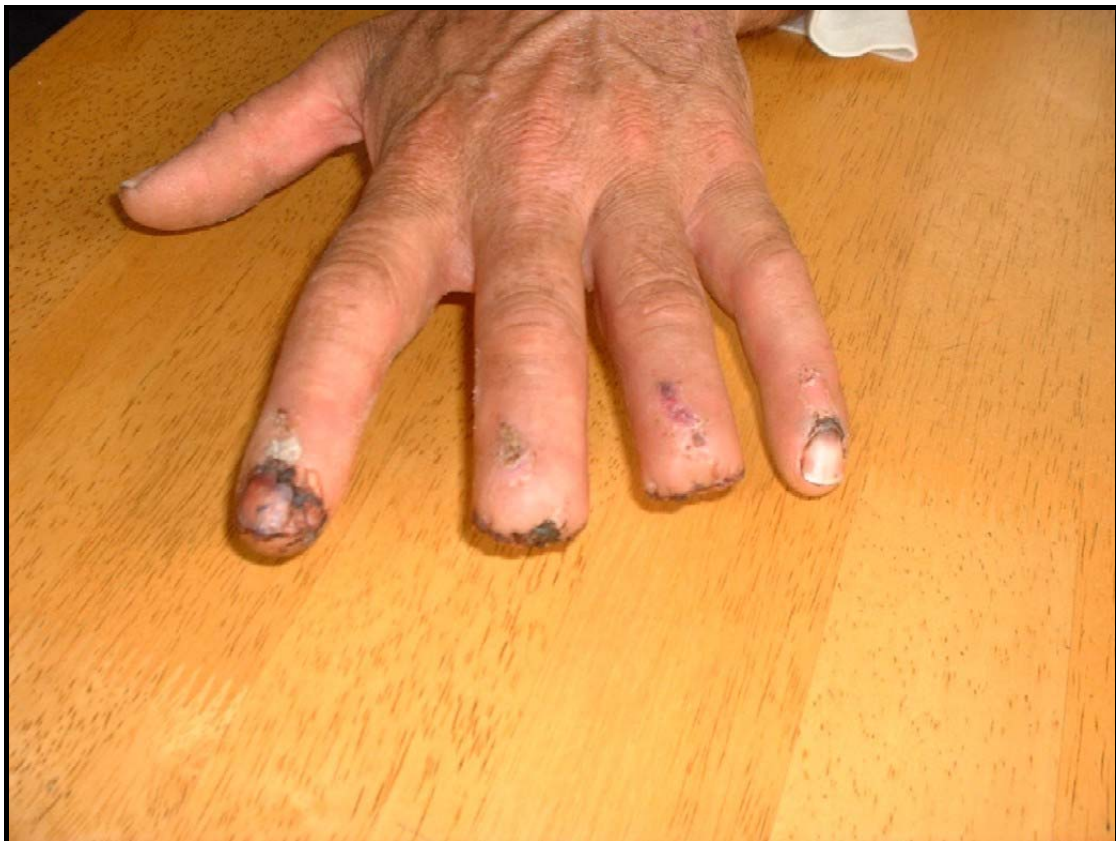
Photograph 1 – Injured Left Hand

He sustained a complete loss of pulp and nail bed to the first knuckle of the left middle and ring fingers. The little finger and first finger were both crushed causing severe bruising.

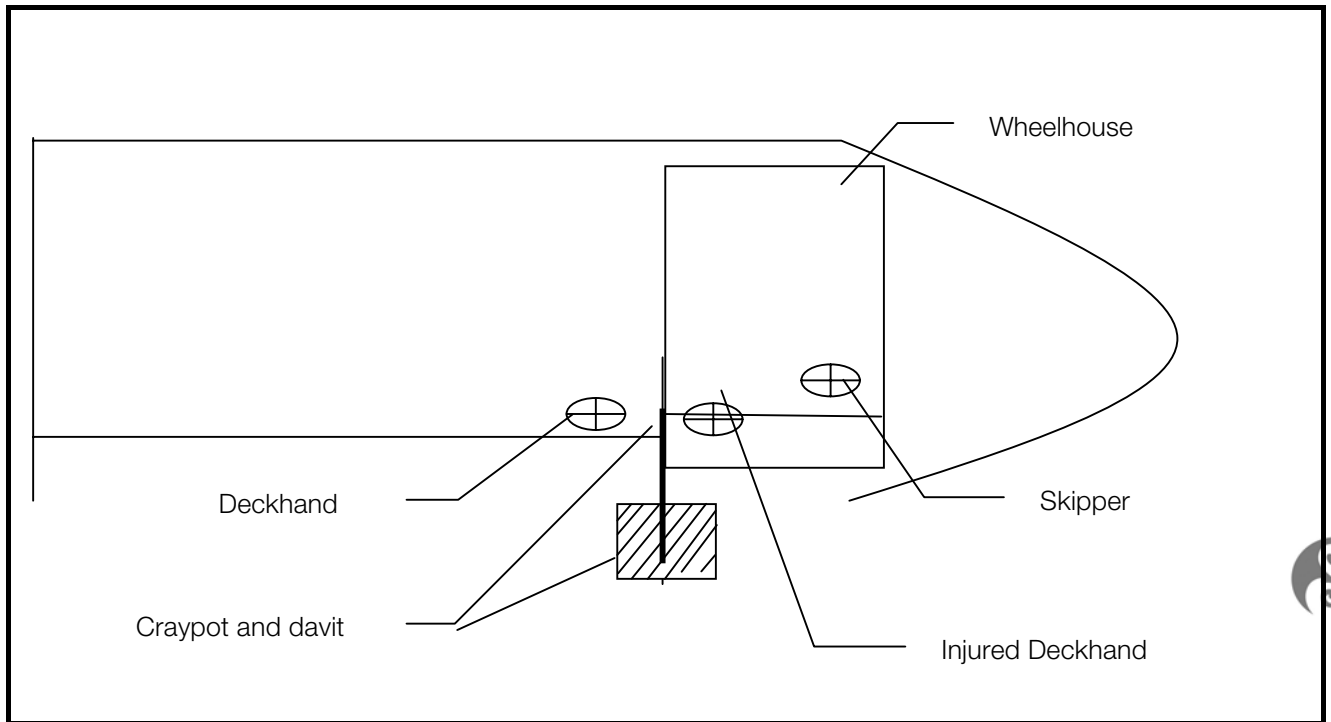
Diagram 1 – Layout of Hauling Operations

On the afternoon of Wednesday 11 May, the Skipper completed setting some cray pots and was steaming to a deeper area. In the early evening, the Skipper hauled two pots of a three-pot patch. They had almost completed hauling the last pot of this group. The winch was stopped with the pot clear of the surface. The two crew, one forward and one astern of the pot started to swing the pot inboard, at this point. The rope momentarily jumped out of the cheek hauler. This allowed the rope to run free. The first crew had his hand on the rope and was helping to tail out the slack rope. His hand was trapped between the rope and the block as the weight came back on the rope. He severed his two middle fingers and crushed the other two fingers of his left hand.

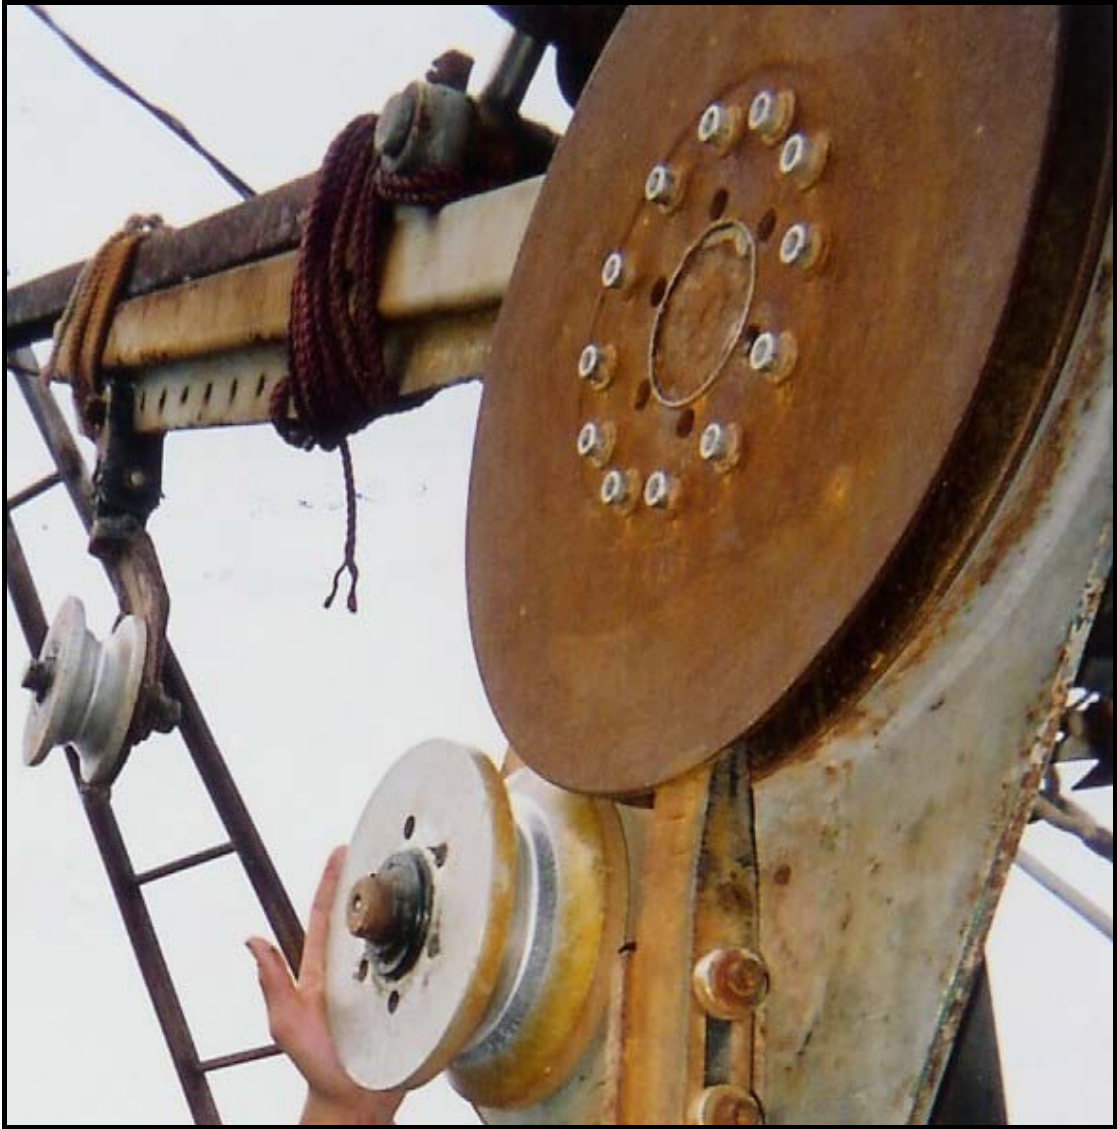
Photograph 2 – Winch and Approximate Hand Position

The winch was not fitted with a two-way rope peeler. This would allow the winch to be reversed without the need to tail off the rope manually.

1. Since the accident, the cheek hauler has been fitted with a two-way rope peeler. This allows the hauler to operate successfully in both directions, and negate the need for a crew to manually tail out the rope when operating in reverse mode.
