Investigation Report
Jay Penelope
Severe weather incident
13 August 2010

Maritime New Zealand

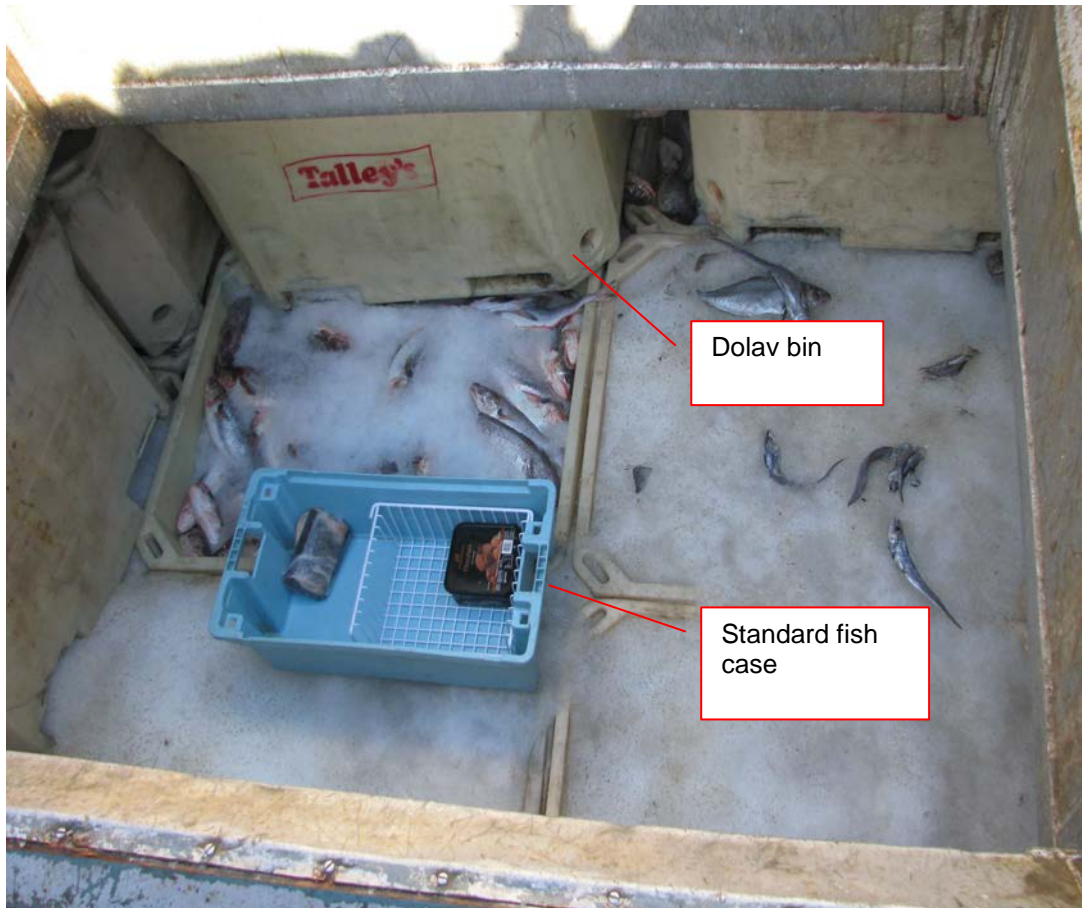
Figure 2 Dolav bins stacked in the hold

14. The skipper stated that the vessel had listed to about 70 degrees. This allowed the upper bins to disconnect from the lower Dolav bins and the fish to flow freely out of the bins towards the starboard side of the hold. The skipper estimated that about 4 tonnes of fish had moved to the starboard side of the hold.
15. Sea water was also able to enter the starboard fuel tank vent, situated about 1.8 metres above the deck, further adding to the list.

20. Several vessels sustained damage and all decided to exit the bay at about 0200 hours on 13 August.
21. **Jay Penelope** was struck by a number of large waves, which caused some of the fish to move as part of a free surface effect in the hold, creating a list. This list was perpetuated by water entering the starboard fuel tank and accommodation area.

22. Had the Dolav bins been partitioned and secured, then the fish and bins would not have moved. However, the system in use was suitable for normal operating conditions and roll of the vessel during normal weather patterns.

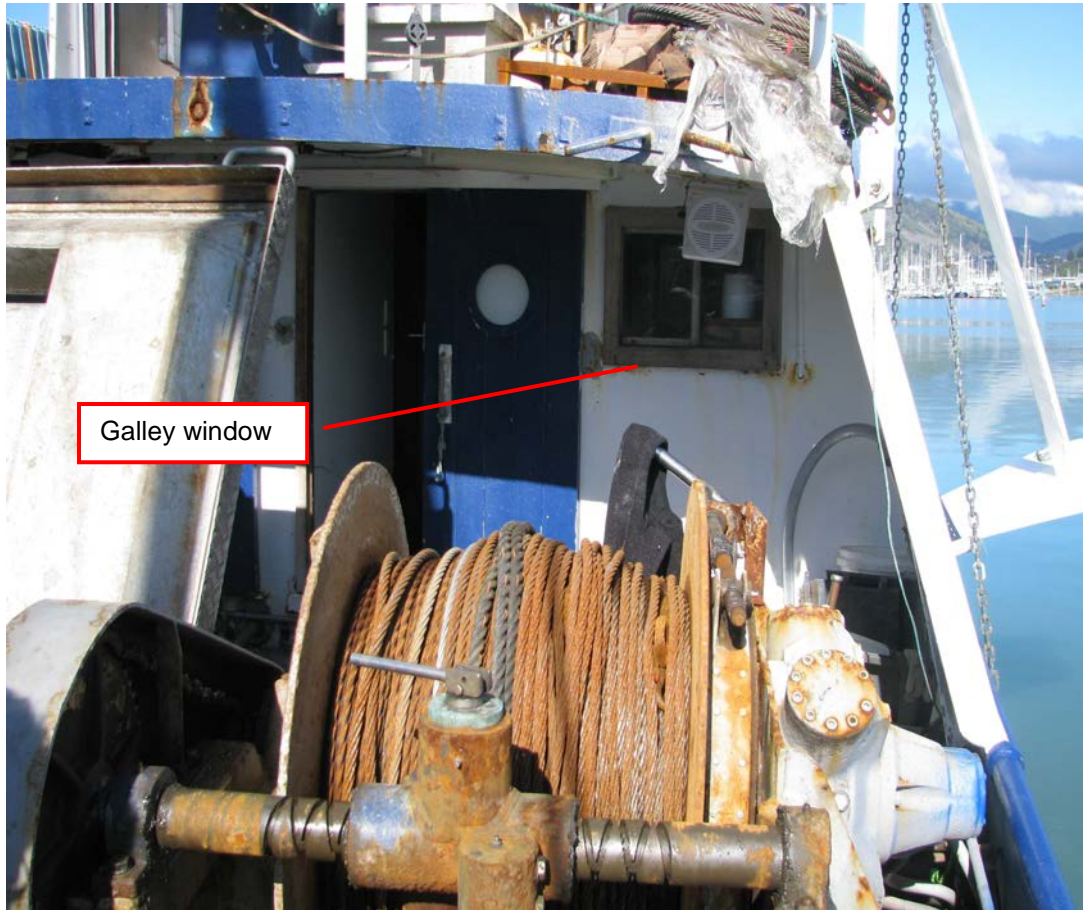
Figure 4 Galley window

16. Due to the list, sea water was able to enter the vessel galley and mess area through a window, which was also situated about 1.8 metres above deck. Significant water damage occurred in the accommodation area.
