# Accident Report

*Kathleen G*

Grounding, North side of Double  
Bay on 30 May 2004

REPORT NO.: 04 3484

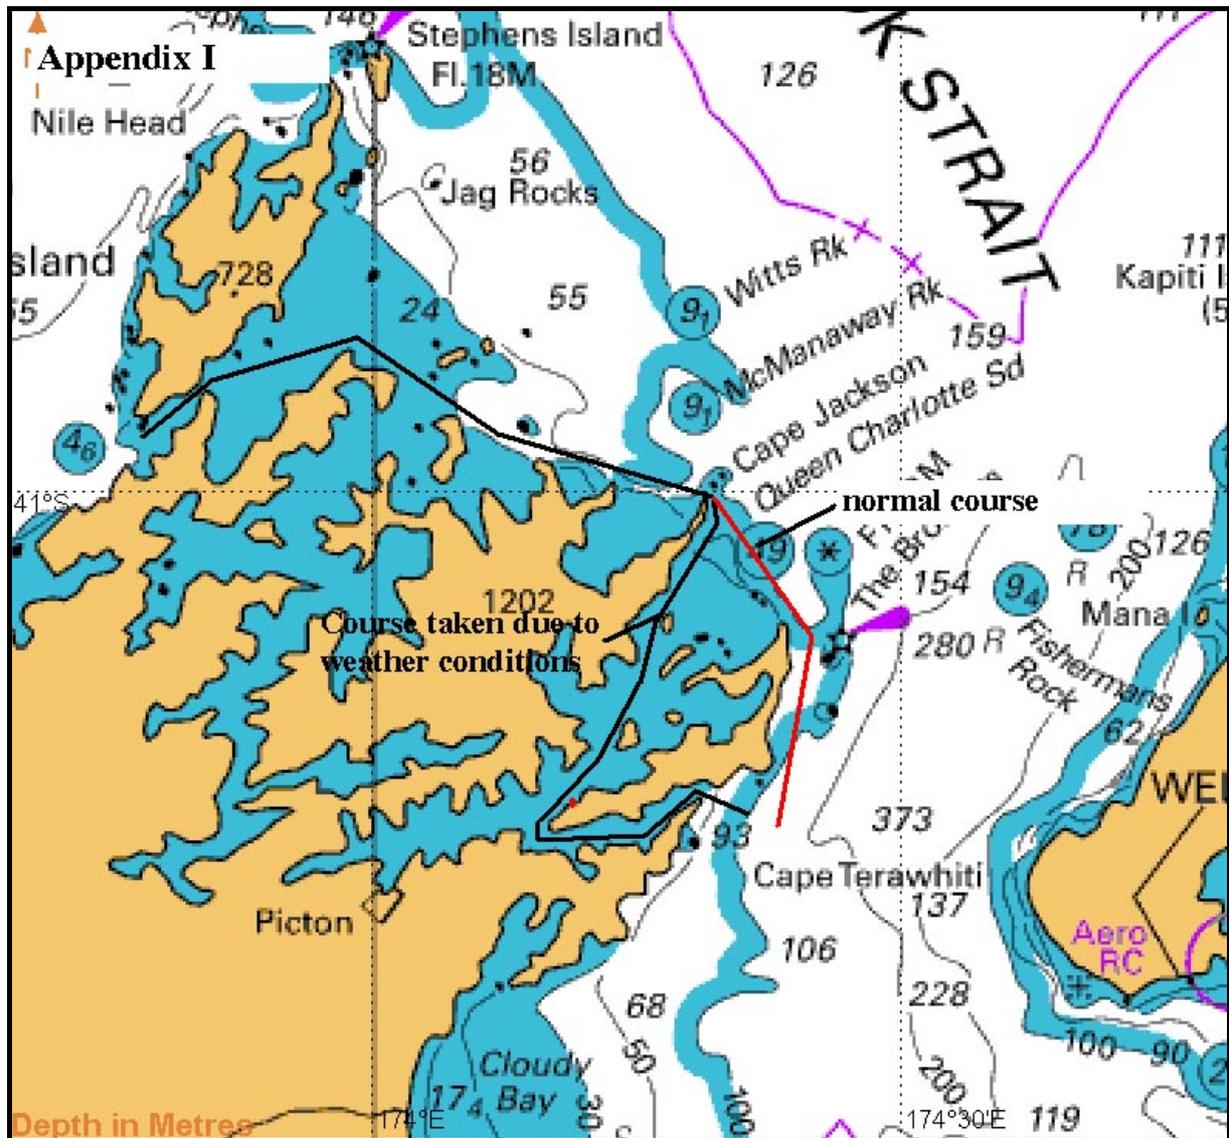
# Appendix I

- 1.5 After clearing French Pass the Skipper headed around the top of the Marlborough Sounds.
- 1.6 At about 2230 hours, when the light at Cape Jackson was abeam, the Skipper decided to head into Queen Charlotte Sound, steam around Arapawa Island and then head out of Tory Channel and back into Cook Strait (*See Appendix I*).

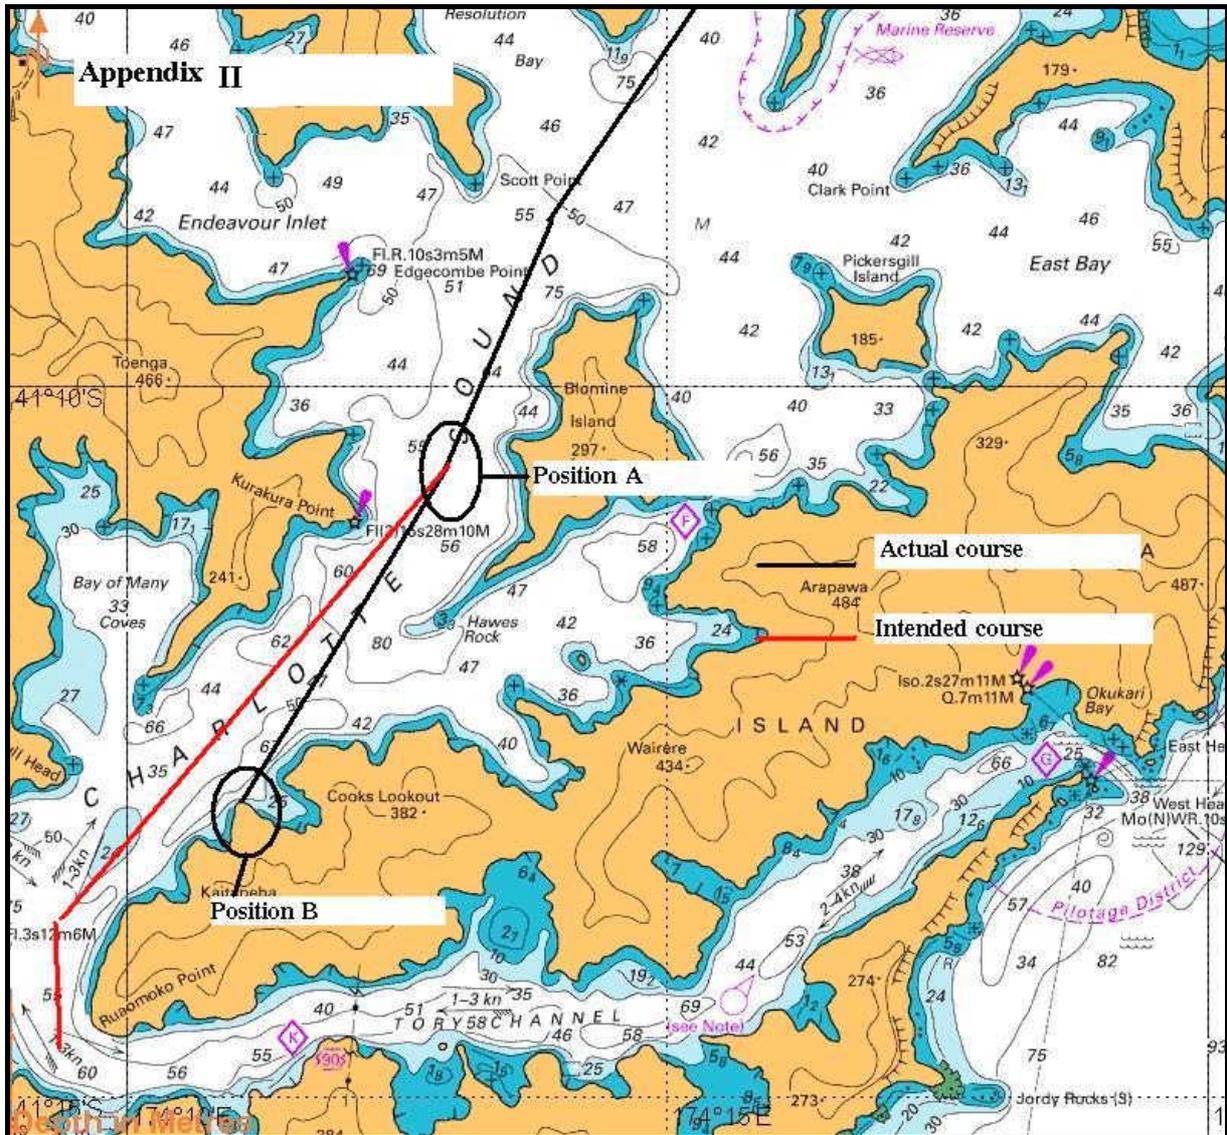
# Appendix II

- 1.7 At about 2400 hours, when the vessel was in a position with Blumine Island abeam to port, the Skipper fell asleep (*See Appendix II - Position A*).

- 1.8 At 0030 hours, on 30 May 2004, the vessel grounded on the southwestern extremity of Double Bay on Arapawa Island (*See Appendix II- Approximate course: Position B*).

2.6.3 The Skipper had set a course using his GPS plotter cursor. When he fell asleep the vessel maintained it's heading, but the vessel was affected by the northwest wind causing leeway to port.
