Accident Report

Kawau Kat III

16 September 2005

REPORT NO.: 96 458

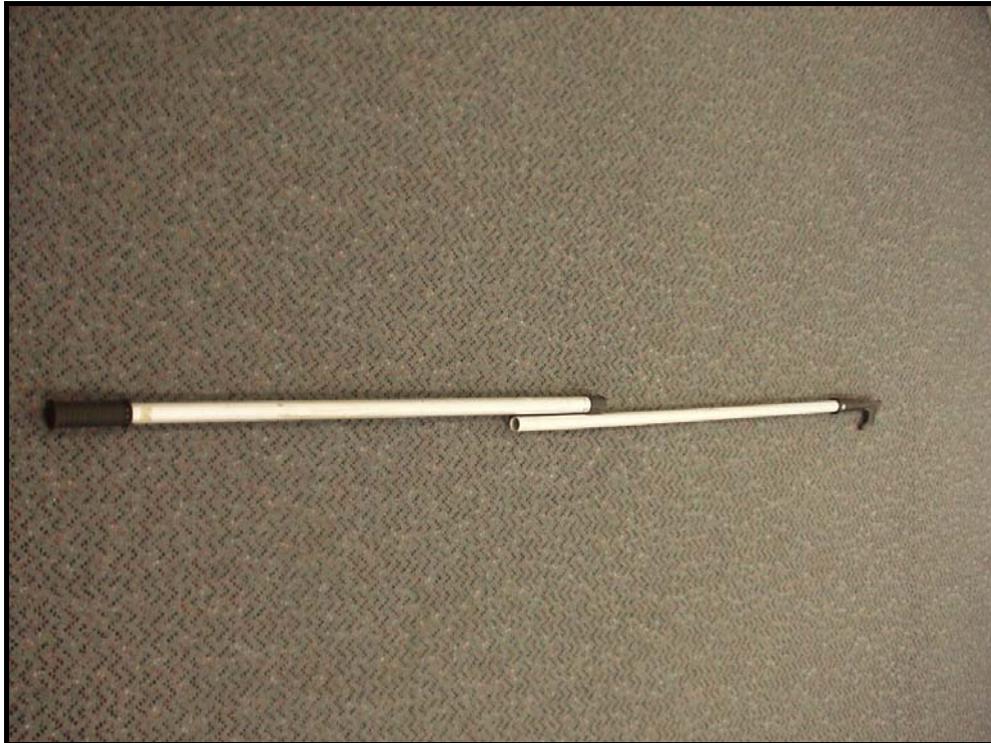
Figure 2
Photograph of Boat Hook

Kawau Kat III was equipped with a 212 cm long boathook pole. This was removed from the vessel during the investigation and on examination found to be defective. The hook comprises two sections of aluminium pole one of which extends from inside the other. The hook section is 116 cm in length. A twist lock mechanism is intended to prevent the two sections from extending or telescoping whilst in use. It was found the locking mechanism was defective and there was nothing to prevent the hook end of the pole from detaching from the other section. The last SSM company inspection form, dated 25

Before being injured she made several attempts to use the boat hook whilst telescoped but found it extended further as she attempted to pull the line in. As she feared she would lose the hook end of the boathook she had to release the line. It was necessary for her to lie on her stomach to reach the line with the unextended boathook. Before the final attempt she partly extended the boat hook and bound the joining section with tape to prevent the hook end from sliding out. This was unsuccessful and she disconnected the two sections and used only the hook end section. She then succeeded in recovering the line from the water. As she was attempting to place the loop of the line over the cleat she heard the Master shout at her to get her fingers out. She stated she reacted “pretty much immediately” and attempted to pull her hand clear. When her fingers were caught she pulled hard. She stated that had she not reacted as soon as she did her injuries would have been more serious. She considered she would have been able to secure the line on the first attempt had the boat hook been working properly.

The Company failed in its obligations under the Health & Safety in Employment Act to ensure that plant commonly used in berthing operations, namely the boathook, was fully operational.

It is likely that had the boat hook been working properly the accident would not have happened.

The defective boathook, whilst it may have compromised the ability of the Crewmember to secure the berthing line, was not the immediate or primary cause of the accident.

1. The company is severely censured for failing to ensure the boat hook was operational.
2. New crewmembers are carefully monitored even after completing training to ensure they are competent to safely operate line whilst berthing.
3. The danger of injury whilst berthing be listed in the hazard identification checklist
4. A requirement be incorporated in the crew training sign off sheet requiring all crew to read and understand the safety information in the SSM manual.
5. The company put in place procedures that provide for the utilization of wharf personnel to assist in handling lines in adverse conditions.
6. Maritime New Zealand publishes a safety bulletin on the hazards associated with crew handling berthing lines.

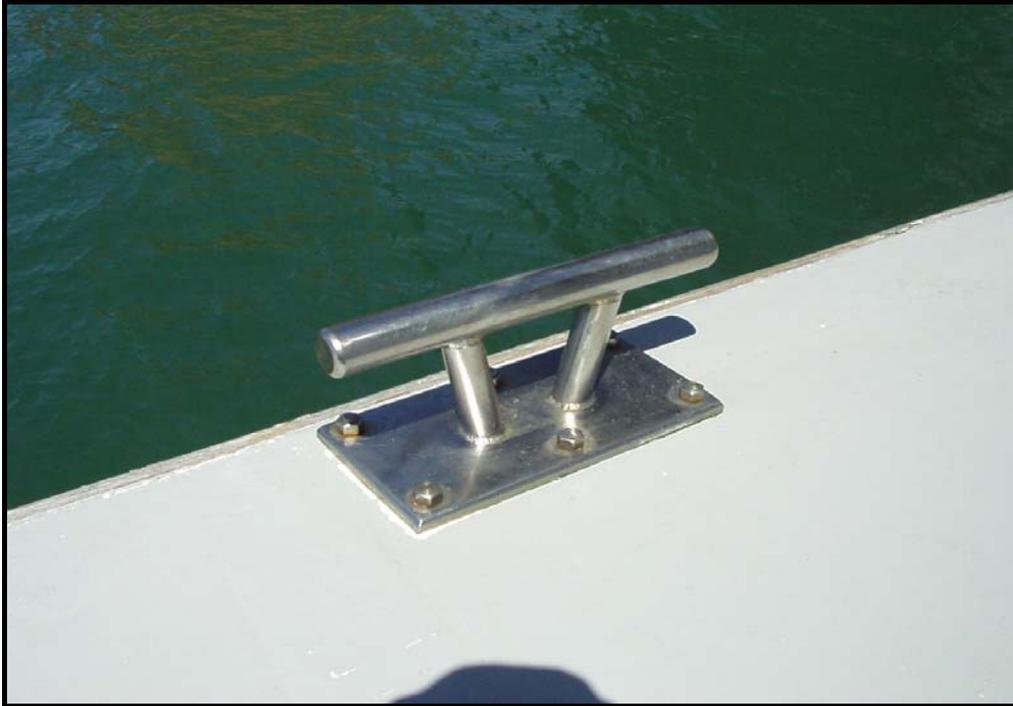
Figure 4
Photograph of Cleat

After a series of approaches, the Crewmember managed to secure the loop end of the line over the forward horn of the cleat. Whilst she was doing this vessel was blown off the face of the wharf and tension started coming on to the line. She attempted to secure the loop over the aft horn of the cleat. The Master shouted at her to remove her hand. The line tightened and her fingers were caught between the line and the cleat causing serious injuries.

January 2005, indicated the boat hook was in good order. A senior crewmember stated he recalled using the boathook one week prior to the accident and found it to be in good order (See Figures 2 & 3 - Photographs of boathook). The cleat was constructed of stainless steel (See Figure 4 - Photograph of cleat).
