Class B Non Serious Harm Accident Report

Lady Marie

At Havelock on 4 November 2004

REPORT NO: 96 323

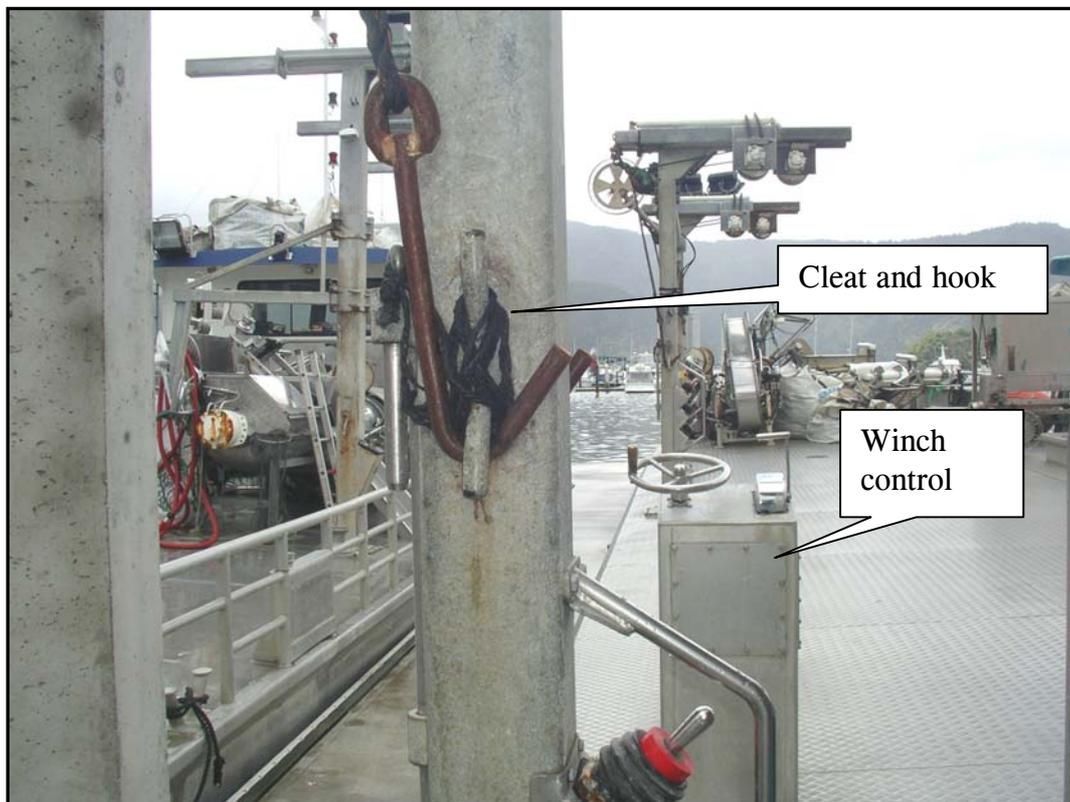
Deckhand One placed the hook from the aft gantry over the rail on the wharf, put the rope around the gantry cleat using his left hand and reached out with his right hand to take the slack up using the winch. This would secure the vessel against the wharf.

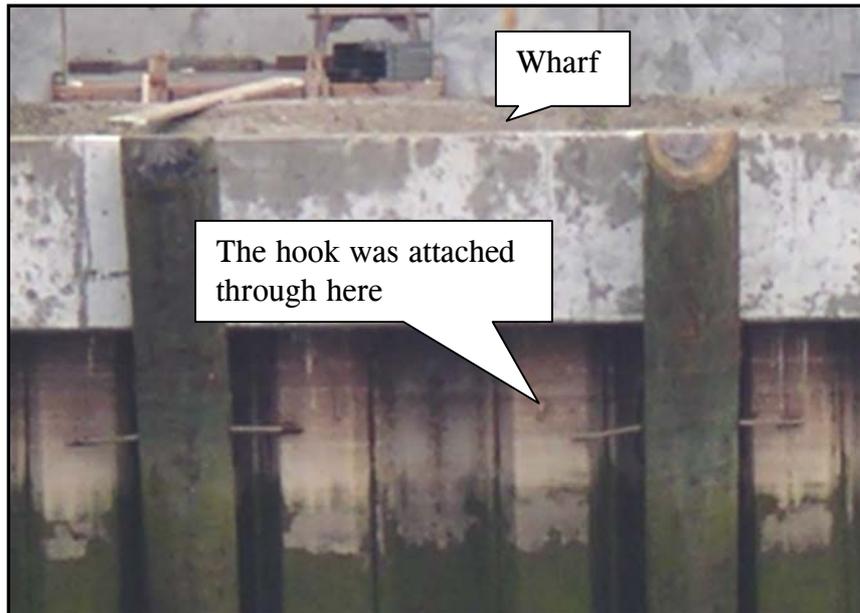
At the same time as he activated the winch to take up the slack, a gust of wind hit the vessel and moved it away from the wharf. Deckhand One had not removed his fingers from the vicinity of the cleat and they got caught between the line and the cleat as the wind pushed the vessel away from the wharf and the winch took up the slack. He cried out and then pulled his fingers clear of the cleat.

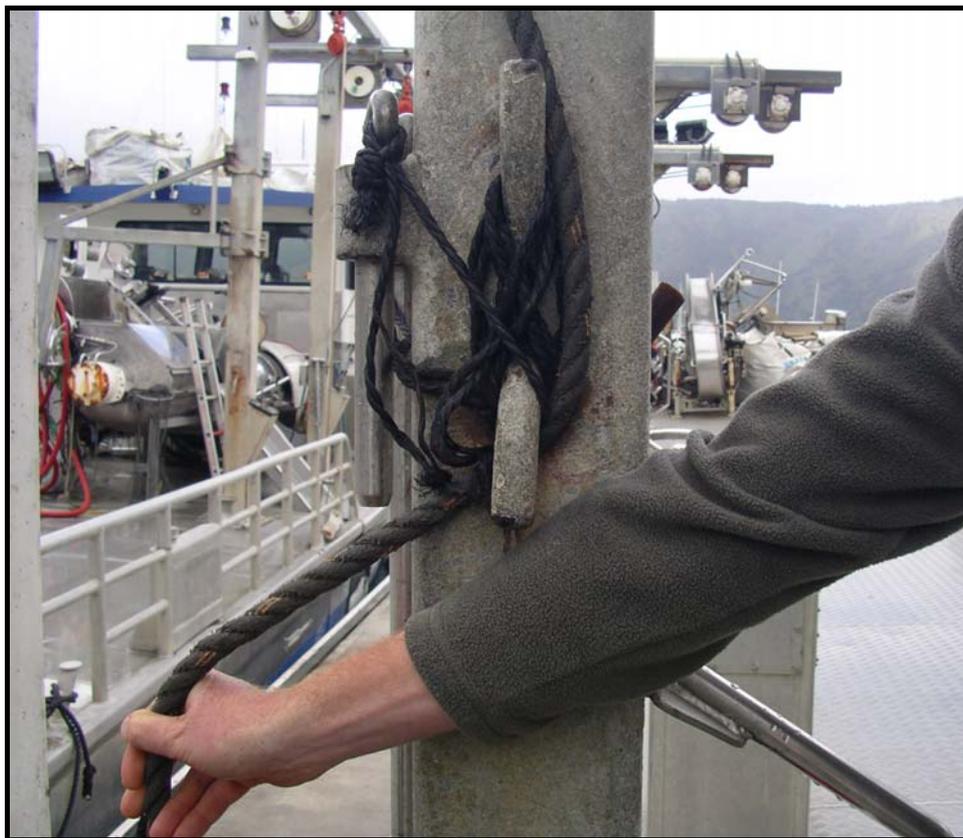
*Photo showing where Deckhand One was holding the line before the accident
(note: at the time Deckhand One was holding the line with his left hand)*
