Class B Accident Report

Legacy Grounding

At Fiordland on 3 December 2004

REPORT No: 04 3614

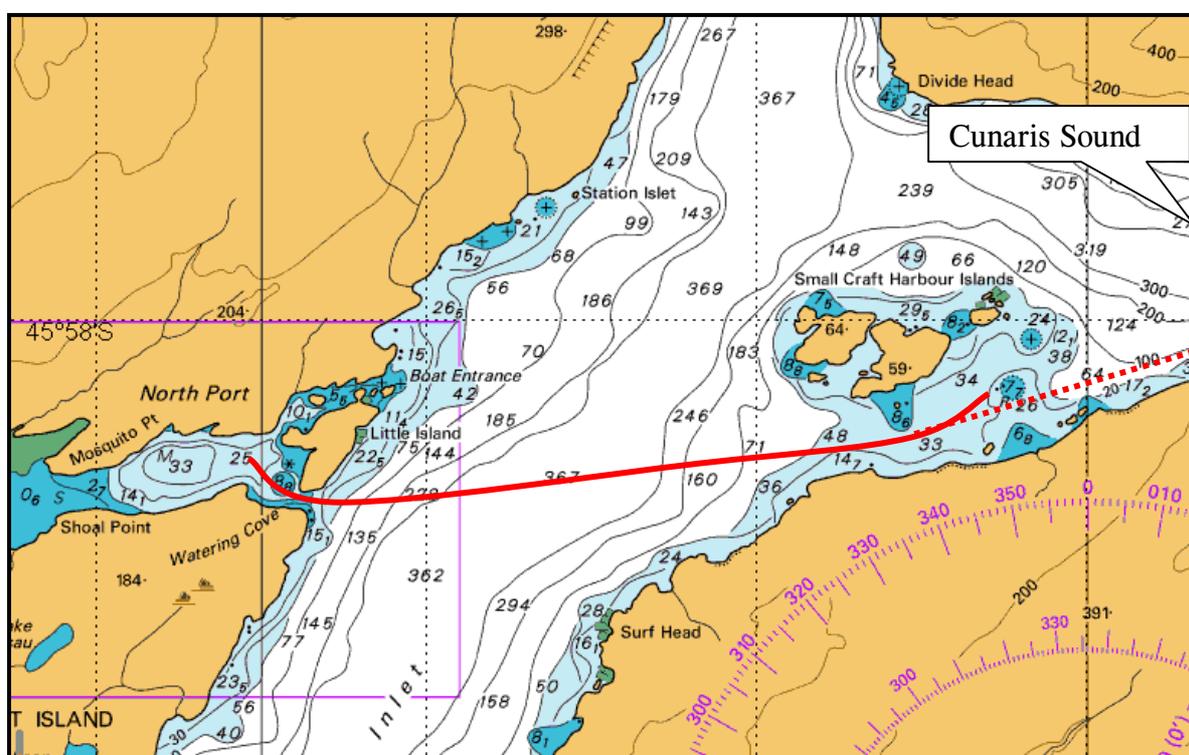
DIAGRAM 1 - CHART EXTRACT FROM LINZ CHART NZ7654
(NOTE - C = CABLES)

As *Legacy* crossed Chalky Inlet her course took her south of the Small Craft Harbour Islands (See Diagram 1 – Showing track of vessel). The Skipper was at the helm. The crew were resting below. The vessel was travelling at about 7½ knots on autopilot. The Skipper had set the autopilot on a course that would keep the vessel clear of all hazards. He left the bridge and went into the engine room to pump the live wells. He thought it would take about 30 seconds. After pumping the live wells he decided to grease a bearing in the engine room. The approximate time spent away from the helm position was a minute and a half.

From the chart, it would appear that the two “dots” either side of the 7 soundings are rocks that are partially “dry” i.e., they are above MHWS (Mean High Water Springs) at all times.

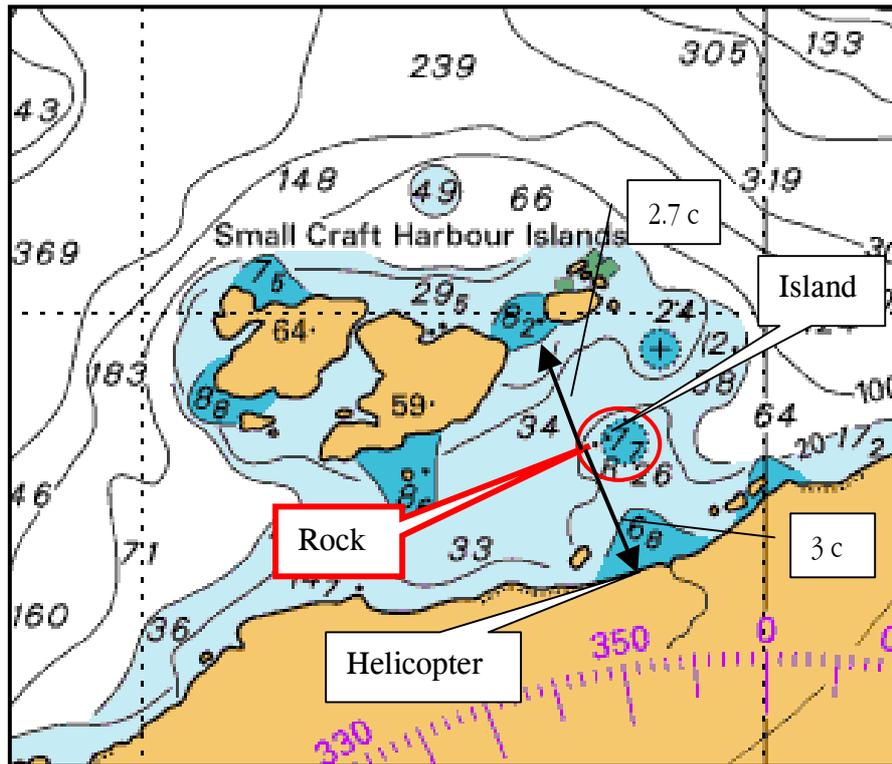
DIAGRAM 2 - CHART EXTRACT FROM LINZ CHART NZ7654

At about 1230 hours, the Skipper returned to the helm and saw a rock ahead of the vessel. He pulled the engine out of gear but did not have time to slow the vessel. *Legacy* grounded on a partially submerged rock south east of the Small Craft Harbour Islands (See Diagram 2).

The course line ran south of rocks on the southeast side of Small Craft Harbour Islands.

The Skipper lined up the course by eye, midway between the island, marked on *Diagram 2*, and the coast to the south.

It is believed that after the Skipper left the bridge, the vessel was subjected to significant leeway from the prevailing wind conditions, which the Skipper had not allowed for when setting the course to steer. The resultant course made good, caused the grounding to occur.

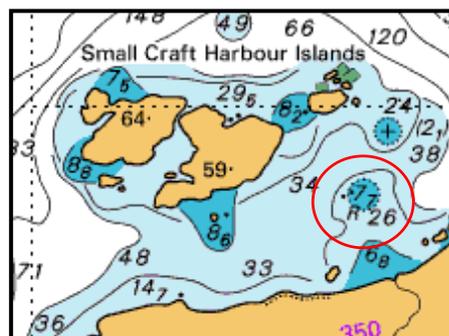
The chart shows the two rocks as small dots on the chart as below.

Care must be taken when studying charts before transit. On this occasion the Skipper did not consult the chart beforehand. The Skipper had transited this area before and was aware of the rock and its location.
