Accident Report  
*Marina*  
Grounding, Port Taranaki on  
17 May 2004

REPORT NO.: 04 3466

VESSEL NAME: *MARINA*

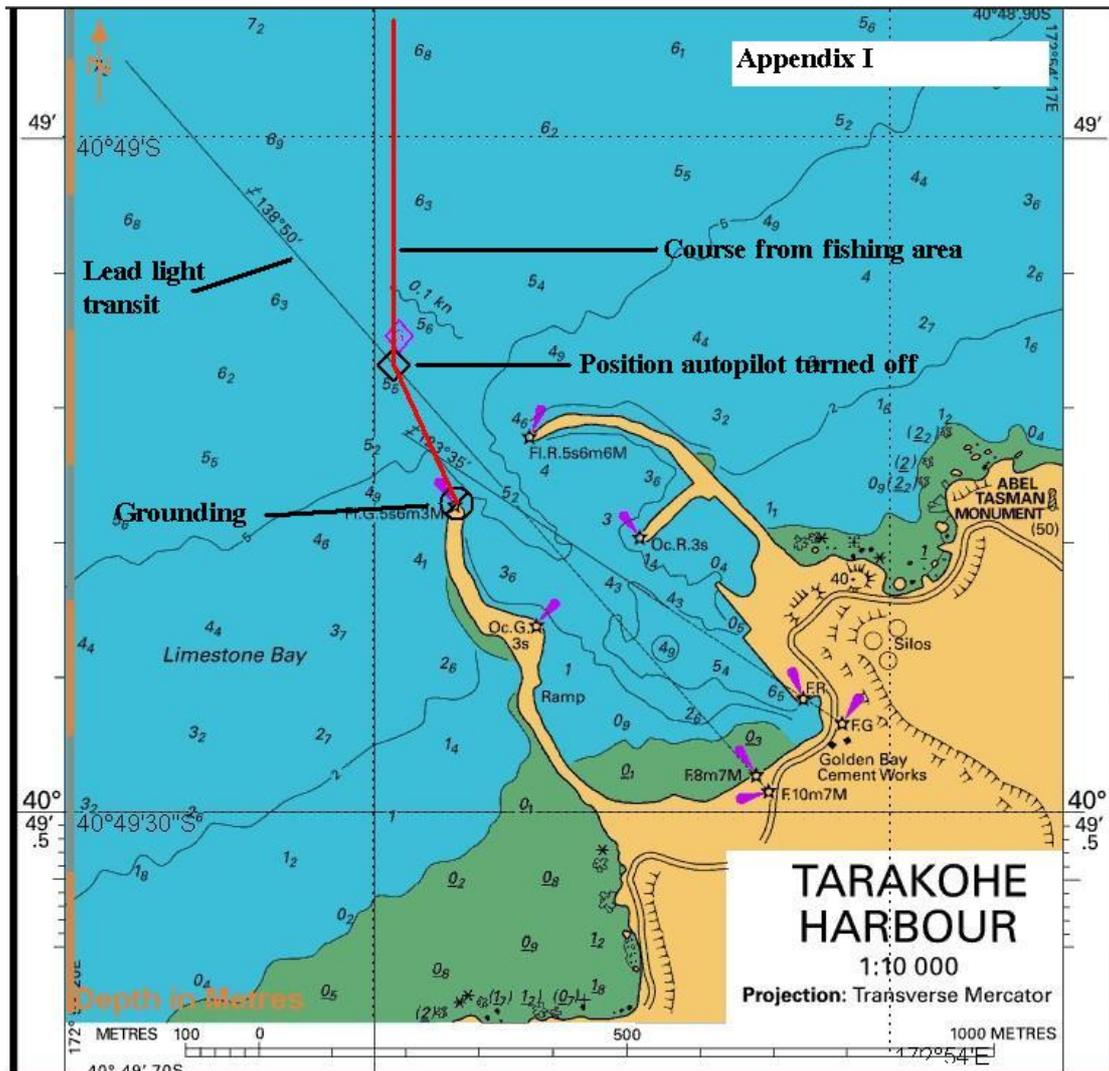
# Appendix 1

- 1.7 The vessel was still closing with the entrance to the Port, and the Skipper realised that he was very close to the rocks forming the breakwater. He put the engine full astern, but it was too late and with the helm to starboard the vessel struck the western breakwater of Port Tarakohe (See Appendix I- Approximate course).
