Summary Report  
Serious Harm Injury/Mooring  
Rope Failure  
*Osprey*  
11 August 2006

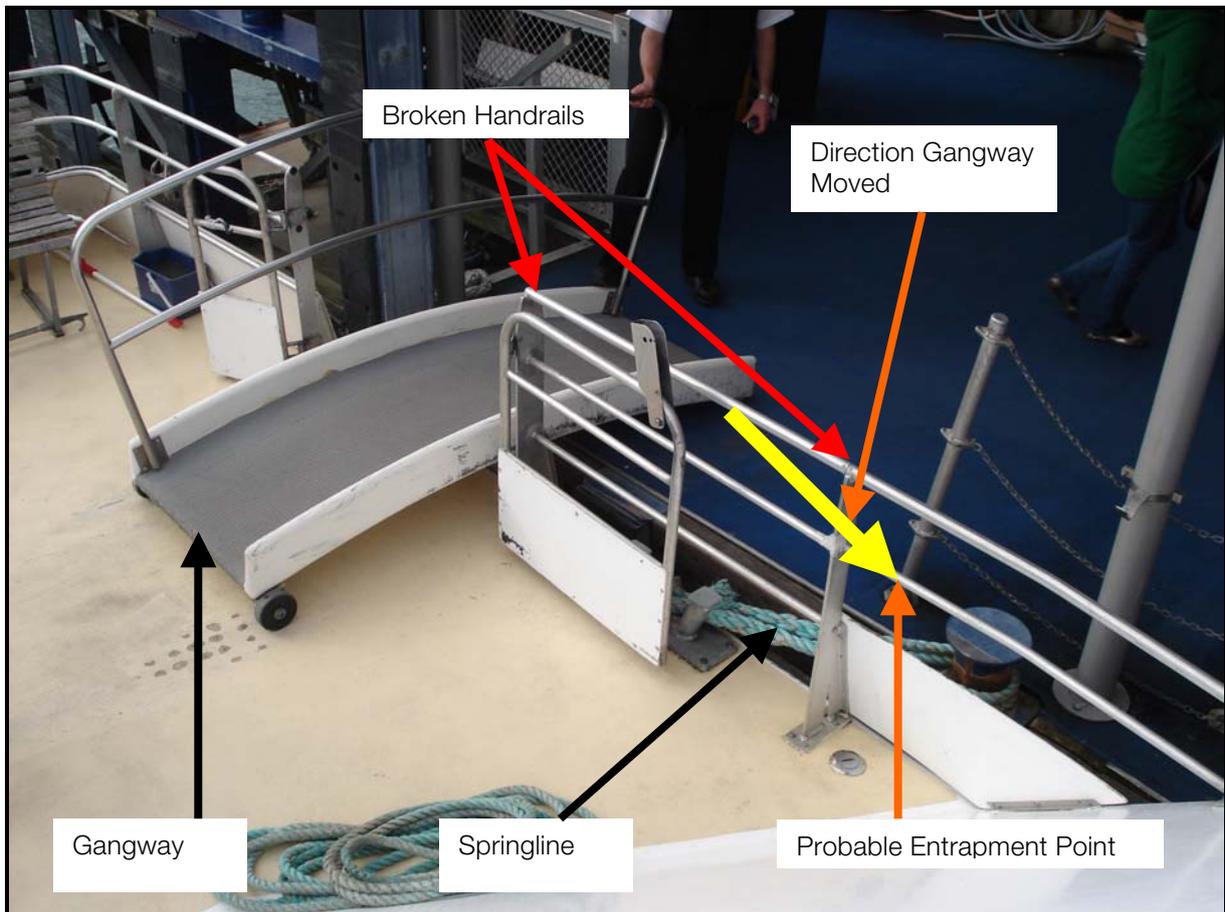
**Photograph 2**  
Gangway & Cleat

As a result **Osprey** moved forward on the berth. This in turn caused the gangway to catch on the wharf and break a section of the vessel's handrail. The shore side section of the gangway then skewed towards the deckhand who was on the wharf. His foot was caught between the gangway and an upright on the wharf. He suffered two hairline fractures in his foot (See *Photographs 2 & 3 - Gangway & Cleat*).

The cleat was made of heavy galvanised steel. Examination of the section that broke disclosed internal corrosion. This was not visible externally.

- The weakened condition of the cleat due to corrosion
- The turbulence in the basin causing the vessel to pitch with associated increased pressure on the cleat.
- The increased pressure placed on the cleat due to the additional revs on both engines.
- The large number of passengers moving on to the foredeck for disembarkation caused the starboard bow to drop. As result the cleat was below the level of the wharf creating a 45° angle up to the wharf. This caused the spring line to ride on to and exert pressure at the top of the cleat horn. The leverage angle exerted greater pressure than normal on the base of the horn contributing to its failure.

- The owner has replaced the broken cleat and will check and relace all other cleats if corroded.
- A Safety Alert was issued to all crew advising as follows:
