**Safety Investigation**  
Paihia High-Speed Passenger  
Boats  
**27 June 2009**

## **Maritime New Zealand**

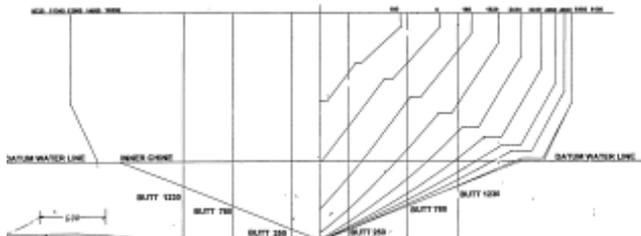
**Figure 1** Bow section of **Excitor**

11. This vessel is a moderate to deep V mono hull with a single chine. This type of hull is designed for high-speed. In moderate or larger sea conditions this could result in the vessel appearing to handle the larger waves easily, but as a result the vertical motion of the bow would be pronounced which can lead to rapid deceleration when passengers are seated in the most forward areas.

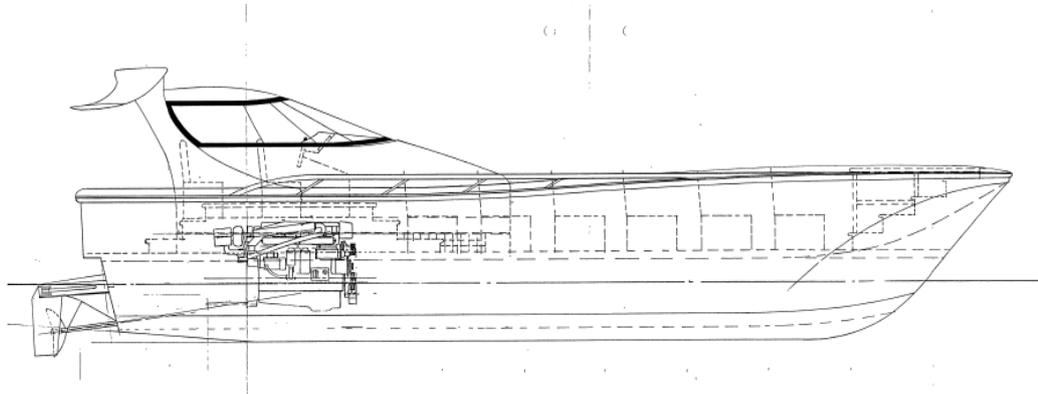
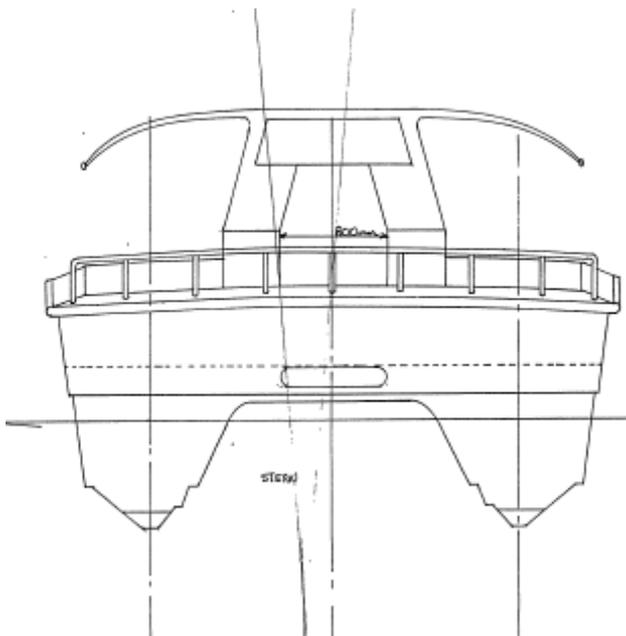
13. This vessel is a catamaran design. Vessels of this type of design are likely to operate in similar conditions as the mono-hull up to a point. The maximum point is reached earlier and a reduction in speed and/or course is likely to be needed earlier for comfort and safety of those on board the catamaran.

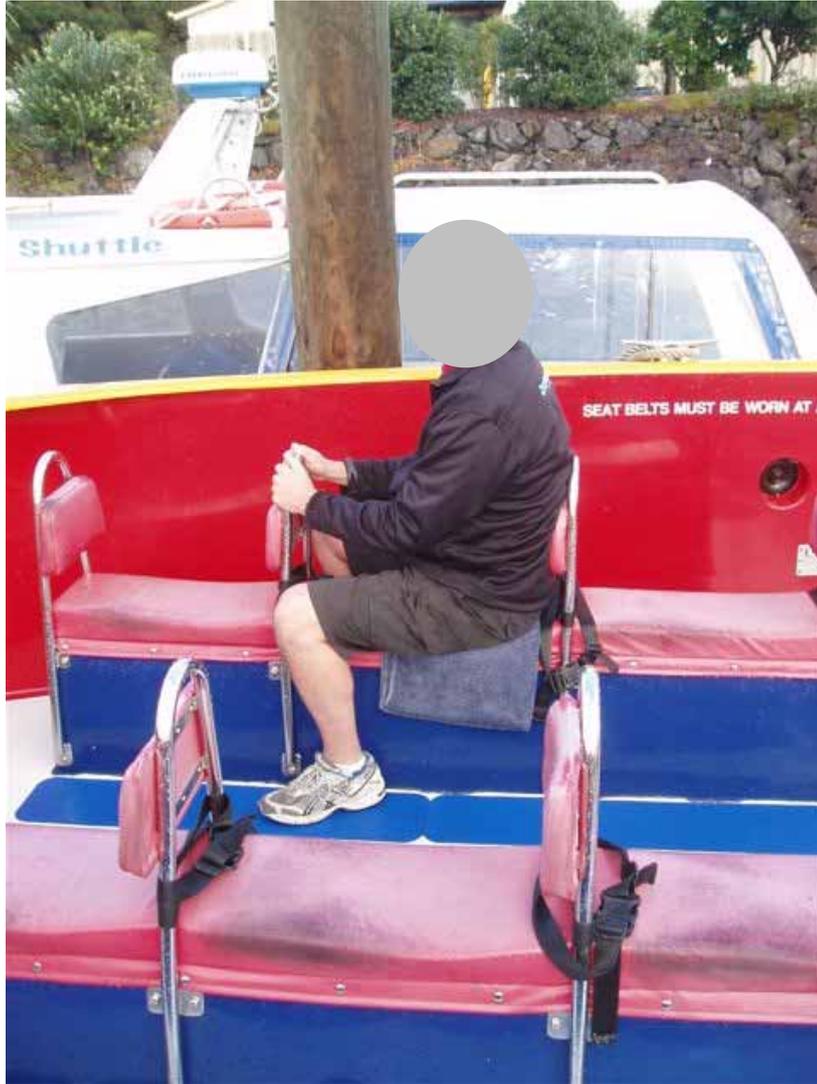
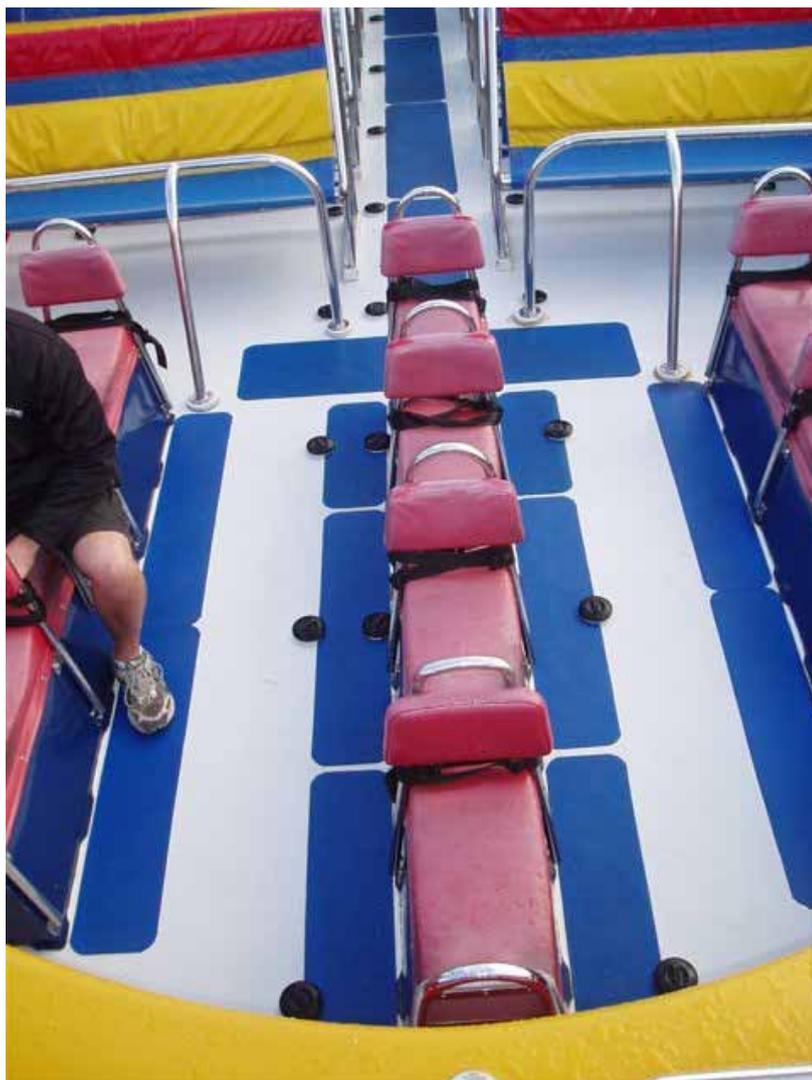
48. ***Excitor*** has a number of different seating designs. The vessel has a number of 'extreme' seats that are situated at the most forward part of the passenger area. These are a 'jockey' style where passengers need to sit astride the seat and grip the seat pod between their legs and use their knees to absorb the shocks, in a similar manner to a jockey riding a horse.

50. The seat cushion padding of this type of seat is 70mm thick with the lumbar padding being 40mm thick. Note the narrow hand rail available to passengers seated here; this could contribute to a lack of lateral support where a wide hand grip is seen as best practise.
51. Other designs on board **Excitor** are a bench seat type. There are slight variations in design and padding but all are essentially very similar. They do, however allow for wide hand placement.

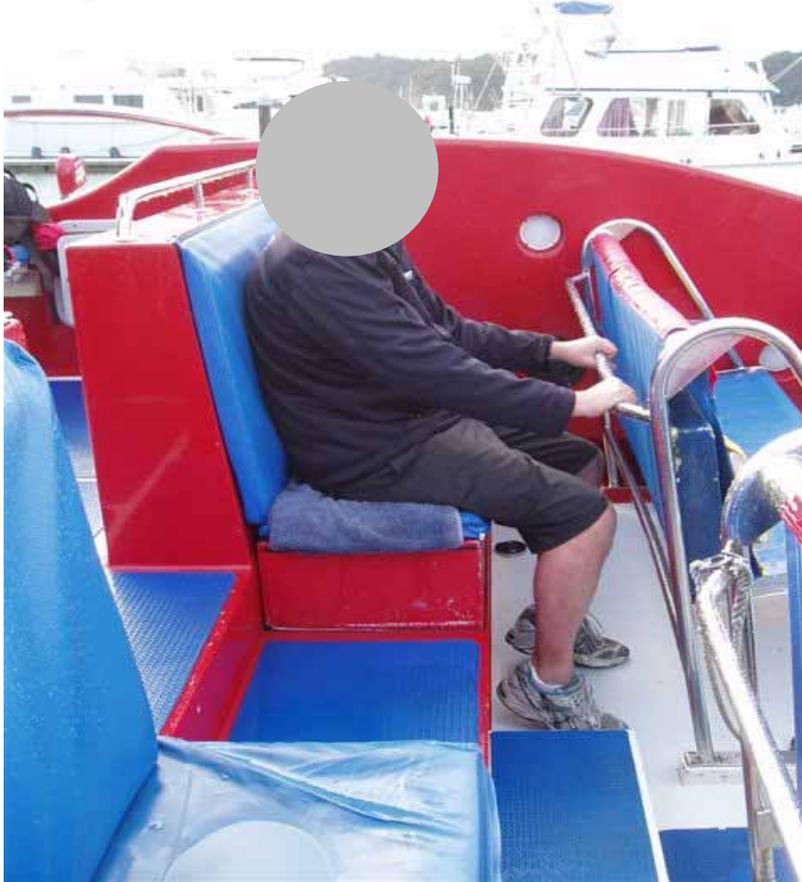
**Figure 22** Alternative bench seat on *Excitor* showing that low forearm angle which allows for greater lumbar instability compared to a higher forearm angle

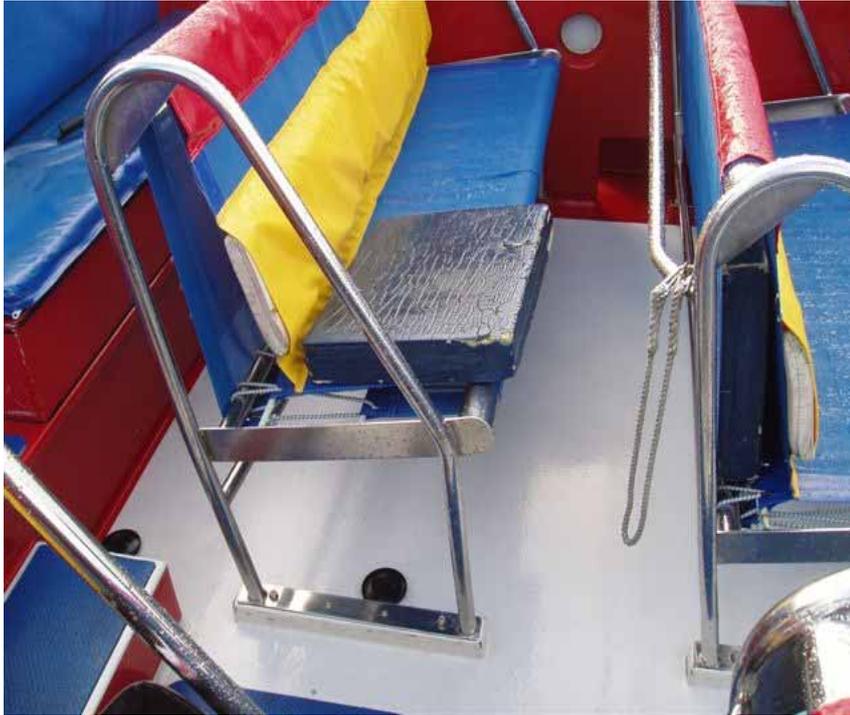
**Figure 23** Bench seat on *Excitor*

52. Figures 23 and 24 show the different styles of bench seats currently used on board *Excitor*. Figure 24 shows the moveable seat cushion used for short people and children.
53. Bench seats offer little opportunity for passengers to use their legs to absorb shocks while underway. They are, however, simple to use and are generally better suited for high-speed vessel trips on smoother water.

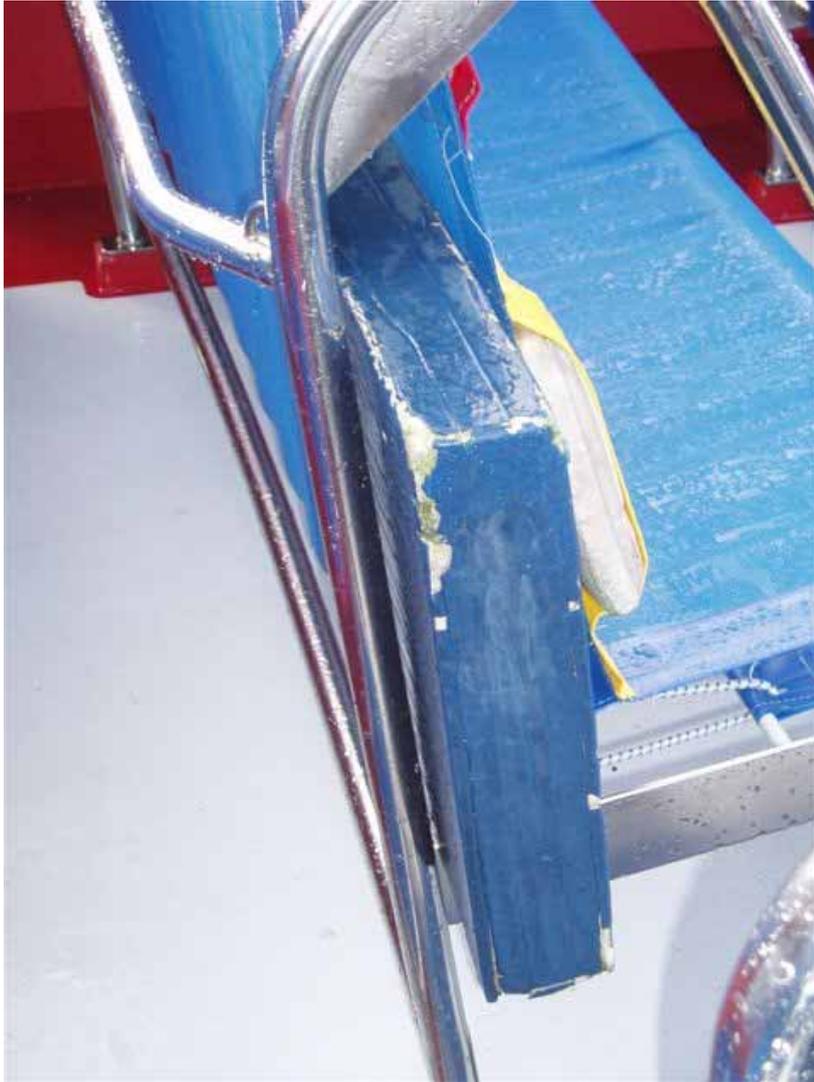
**Figure 24** Showing wear on padding in its stored position.

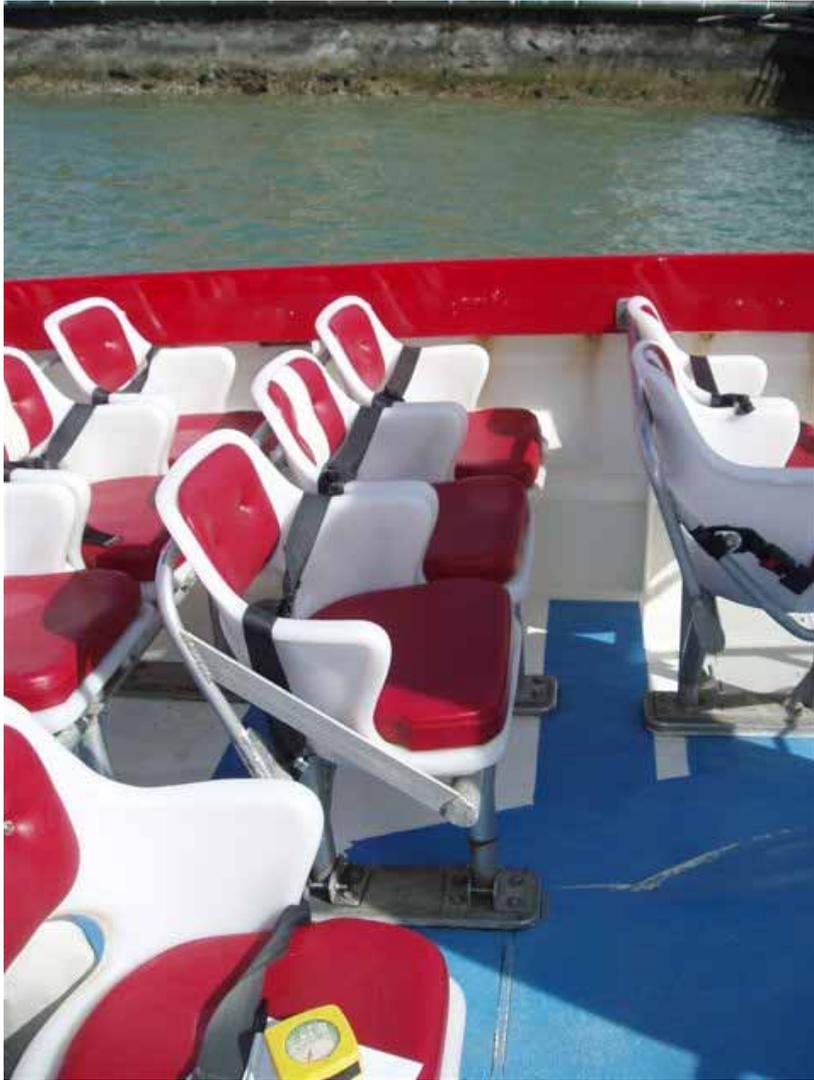
54. The condition of the seat cushions is an important part of the overall operation of the seat. Figure 25 shows that the cushion cover has been allowed to degrade. This will allow water ingress to the cushion, as well as allowing the foam material to protrude which can further accelerate degradation.

**Figure 25** Bucket style seating of *Mack Attack*. The seat padding is 60mm thick and the lumbar padding is 20mm thick

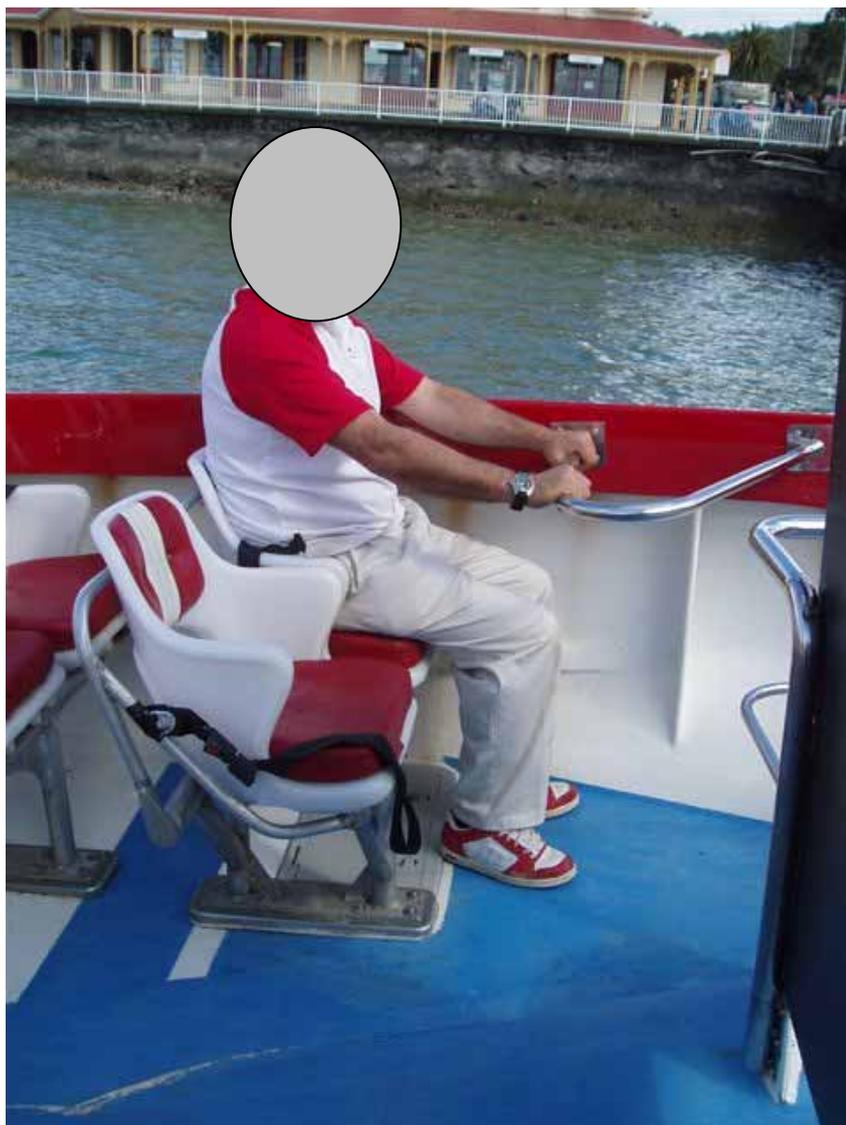
**Figure 26** Front seats of *Mack Attack*

57. This vessel has four seats at the extreme forward end of the passenger deck. These are shown in Figure 27 above. Note that the inside passenger has no readily available hand rail for their use. This reduces the ability of the passenger to support themselves during periods of vertical movement.

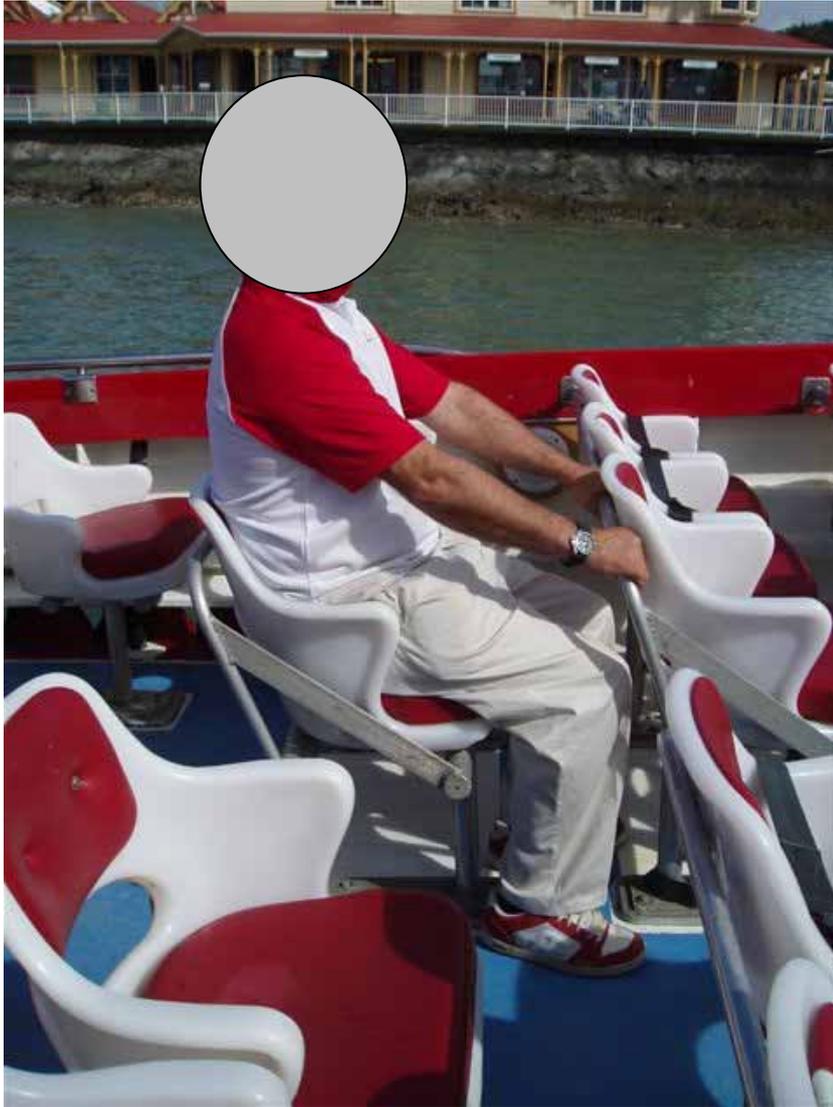
**Figure 27** Hand position on *Mack Attack*

58. Figure 28 shows poor positioning of passenger hands with regard to the forearm angle. This low angle does not allow the passenger to set a solid stance when riding over waves. The angle is further reduced when the passenger lifts off their seat when the vessel drops away. It does, however, appear to provide support for the hands to be wide enough for better posture.
59. In summary, both vessels have a one size fits all seating arrangement. Seating styles do differ and with passenger placement the risk of injury could be reduced when body type, strength and experience are taken into account.
