Class B Accident Report

Paihia Duck

Collision

REPORT NO: 04 3632

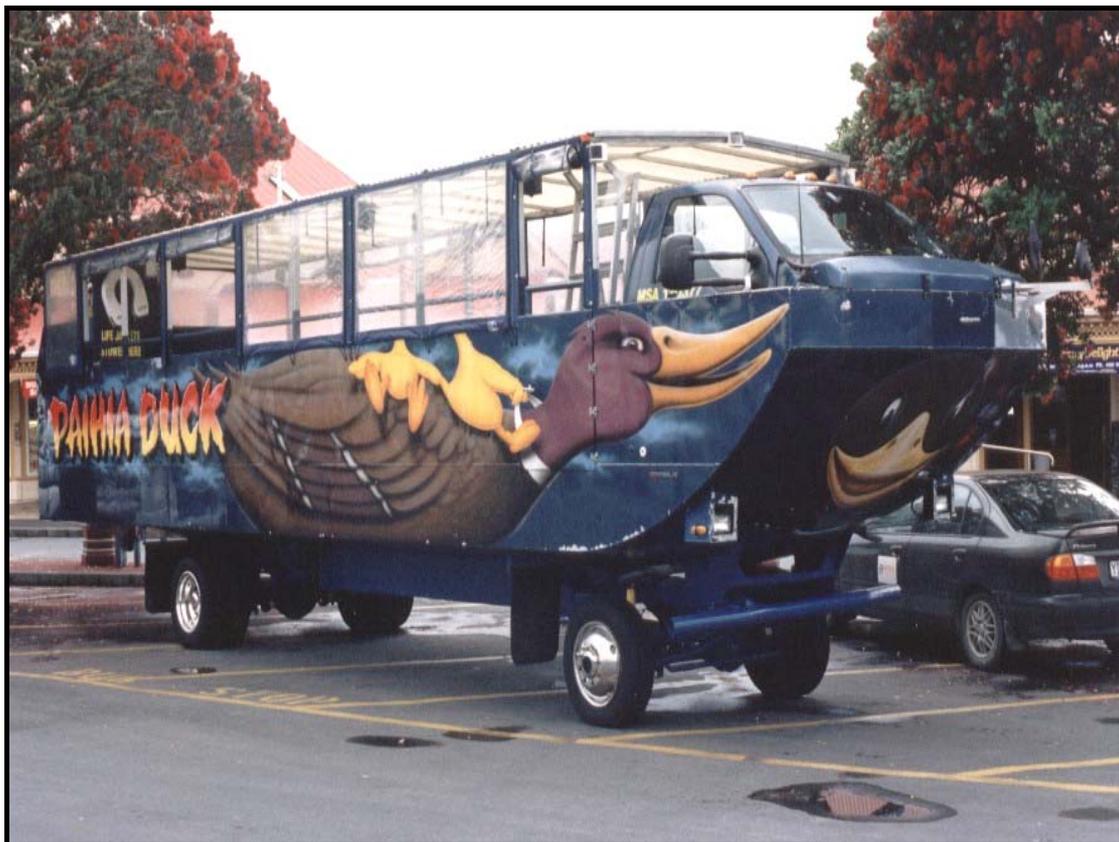
When entering the water via a boat ramp at Okiato in the Bay of Islands, the amphibious craft *Paihia Duck* sustained damage to its left front wheel and rim and broke the ‘centre bolts’ which moved the rear axle out of its alignment.
