Accident Report
Para 1 & Lightning One
Collision on Lake Wakatipu
on 14 July 2004

REPORT NO.: 04 3511

VESSEL NAME: *PARA 1 & LIGHTNING ONE*

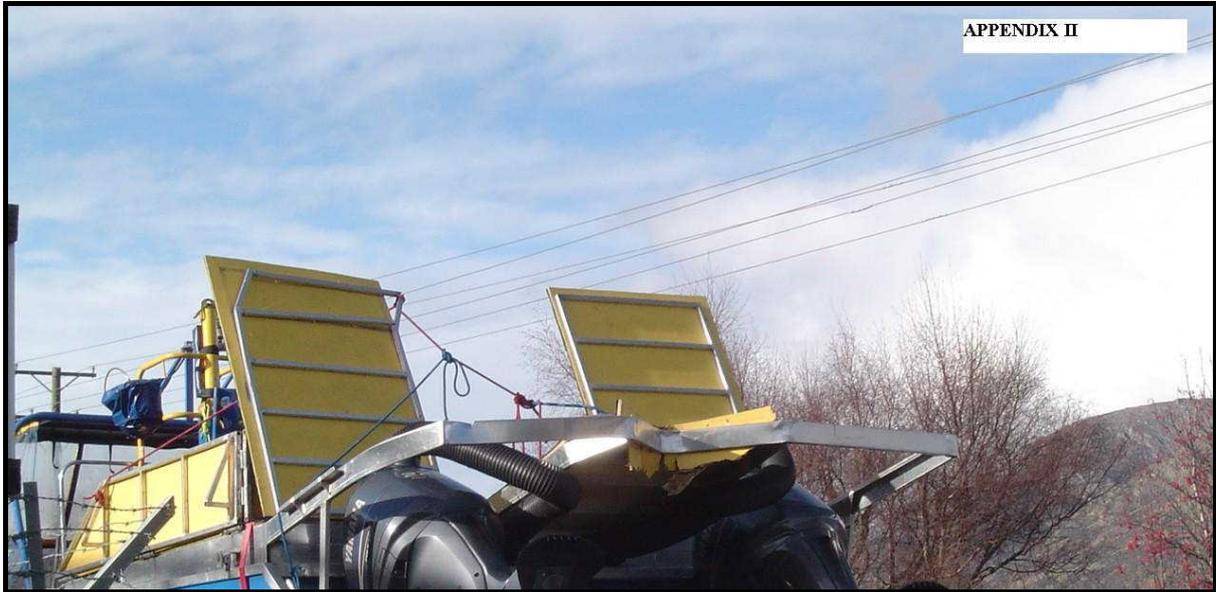
Appendix II & II(a)

- 1.7 At 1720 hours, the bow of **Lightning One** struck the stern of **Para 1** damaging both vessels. Passengers on both vessels were checked for injuries with none found.

- 1.9 Both vessels were assessed for damage. **Lightning One** was removed from the water for engine repairs as was **Para 1** for repairs to the aluminium launch platform at the stern of the vessel (See Appendix II – Damage to **Para 1** and IIA - Damage to **Lightning One**).

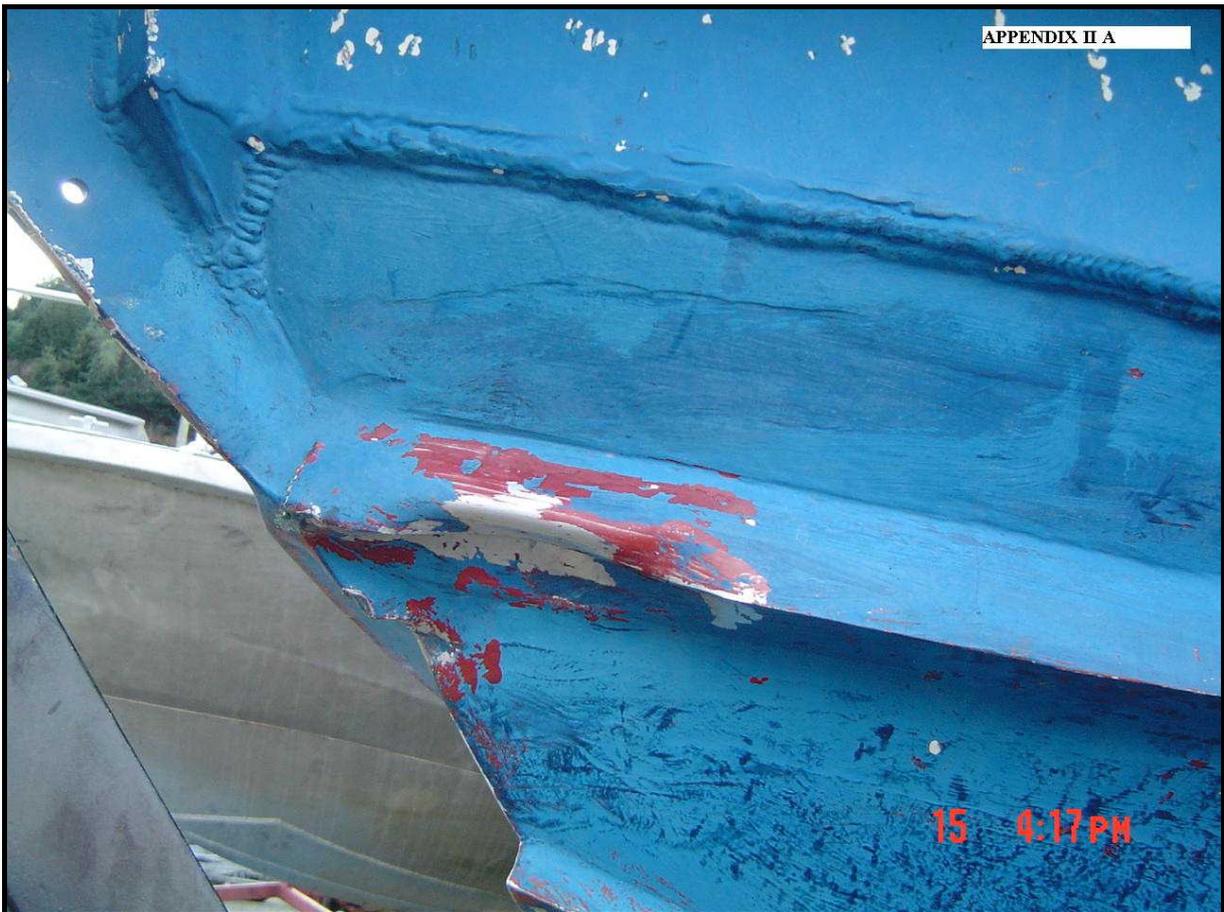
- 2.3.1 When the Skipper of **Lightning 1** put both engines full astern the vessel was still travelling ahead at about 15 knots. The throttles were in the process of being returned to the idle position but were still at about ¼ revolutions.
- 2.3.2 Both engines stalled when they were put full astern. One engine could be restarted after the collision and the other could not due to a bent conrod.
