Accident Report

Predator

Capsize & Fatality

REPORT NO.: 05 1166

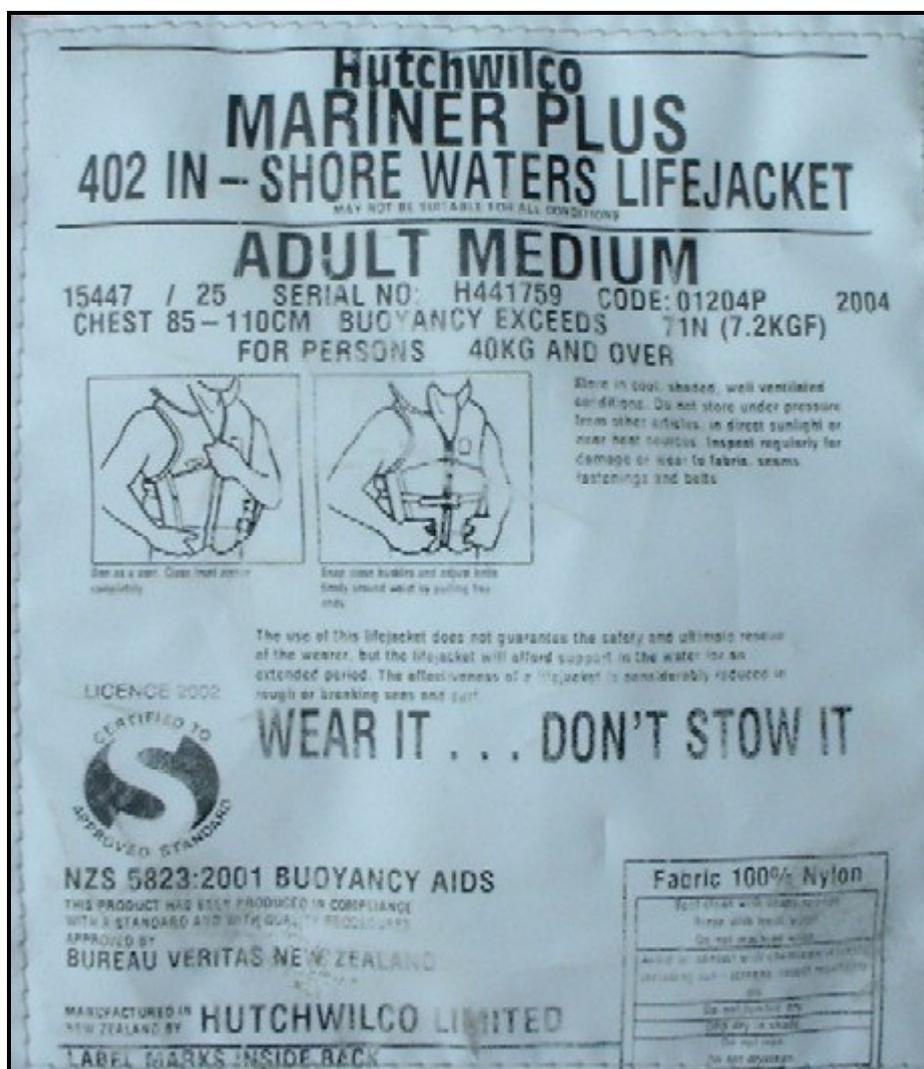
The Owner asked if all the boys had done up their lifejacket but did not check this for himself. Steven was seen to have zipped his lifejacket up but had not secured the two securing clips. This jacket was seen shortly after the capsizing floating away. Without the two clips secured and pulled tight, the lifejacket would have floated clear of the wearer.

Photograph 2
Label of the Lifejacket that Steven was wearing before capsizing

3. That the Business Development & Communications Division of Maritime New Zealand continue to promote by all possible means, the wearing and proper securing of lifejackets for recreational boat users.

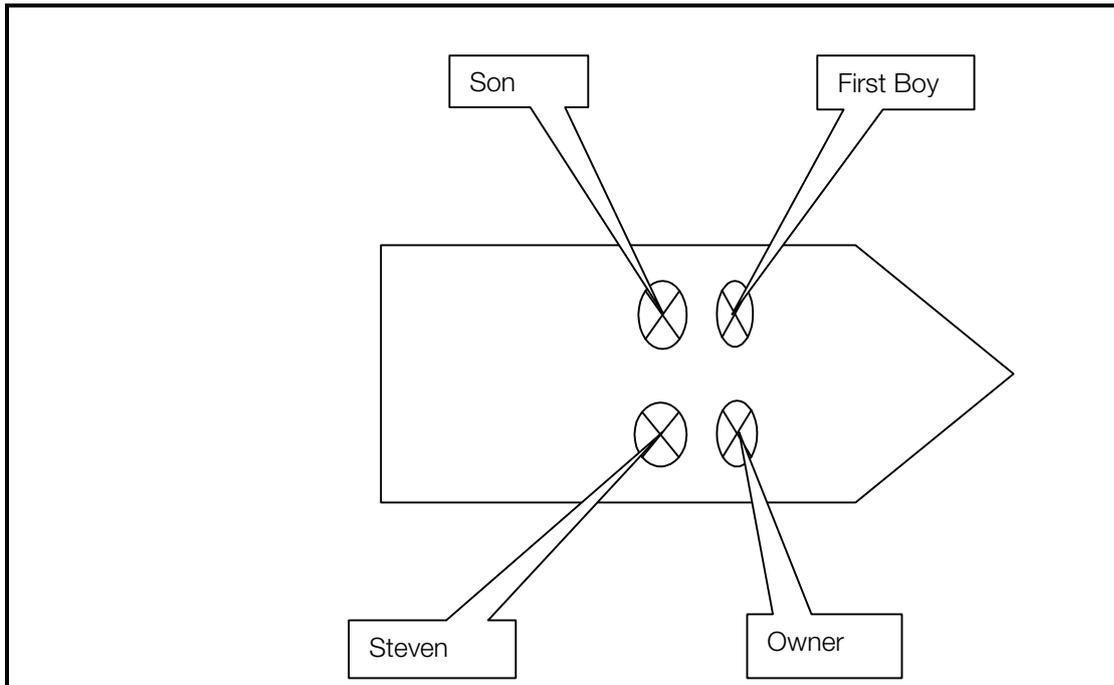
The Owner was standing on a pedestal at the helm station on the starboard side of the vessel. The first boy was seated on the port side, and Steven was standing behind the helm station seat on the starboard side. The Owner’s son was standing behind the port side seat.

Figure 2
Plan of vessel before capsizing

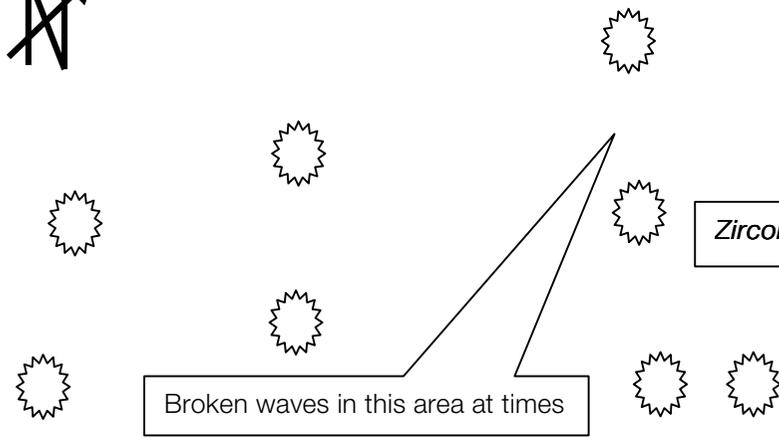
Figure 3
Sketch of Maraetai Bay

Approximate *Predator* track and capsize position

Swell direction

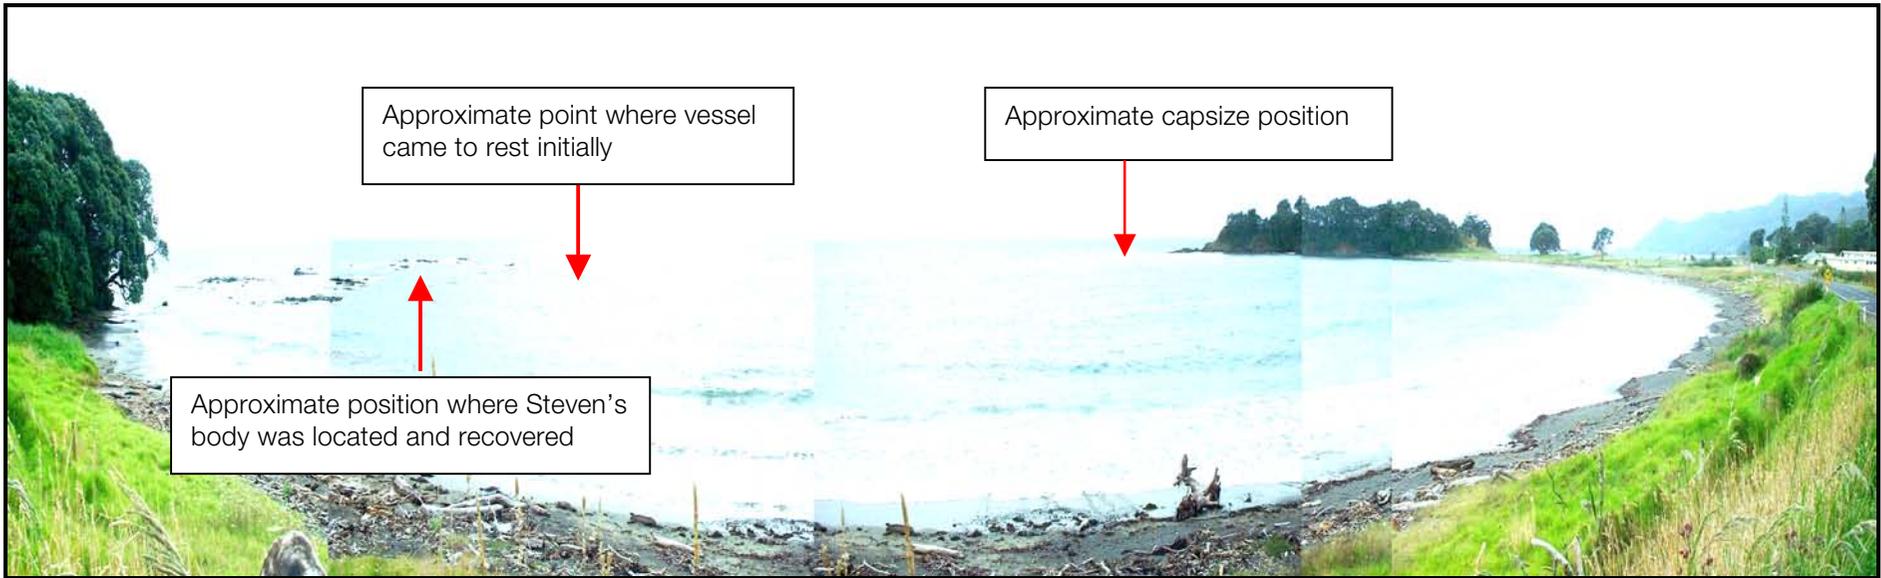
Photograph 3
Te Kaha (Maraetai Bay)

Maraetai Bay (See *Photograph 3*) has transit marks which are used as a guide to indicate the entrance of the main navigable channel. A second unmarked channel is situated to the west of the main channel.

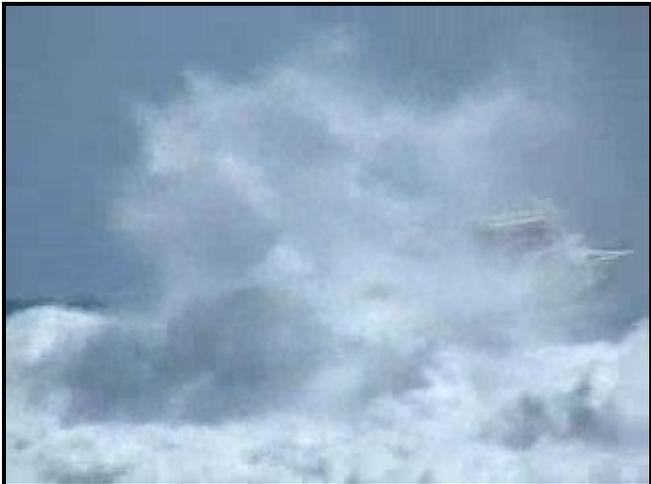
Photograph 4a
Predator emerging from wave

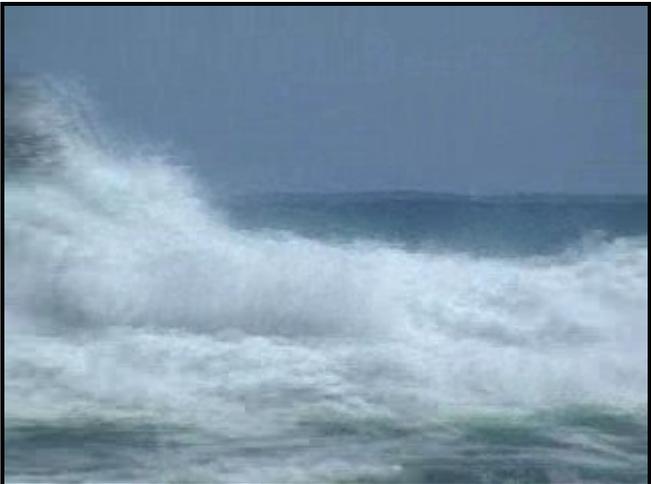
Photograph 4b
Predator is partially rolled over backwards

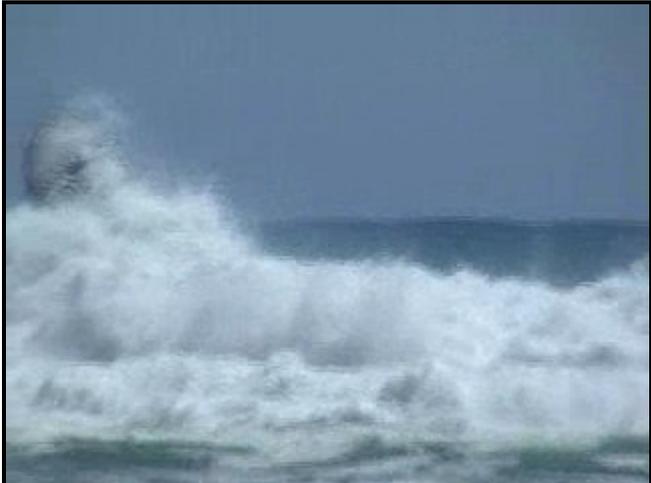
Photograph 4c
Predator falling over to upturned position

- **Predator** was designed with its reserve buoyancy situated in the floors below the water line, with the result that, in conjunction with a heavy outboard motor at the stern, it adopted a "bow up" attitude following the capsize.

2. That Maritime New Zealand, in conjunction with the Marine Industries Association and the boat building industry continue to explore the feasibility of the ways in which level floatation can be achieved for vessels up to 8 metres in length.

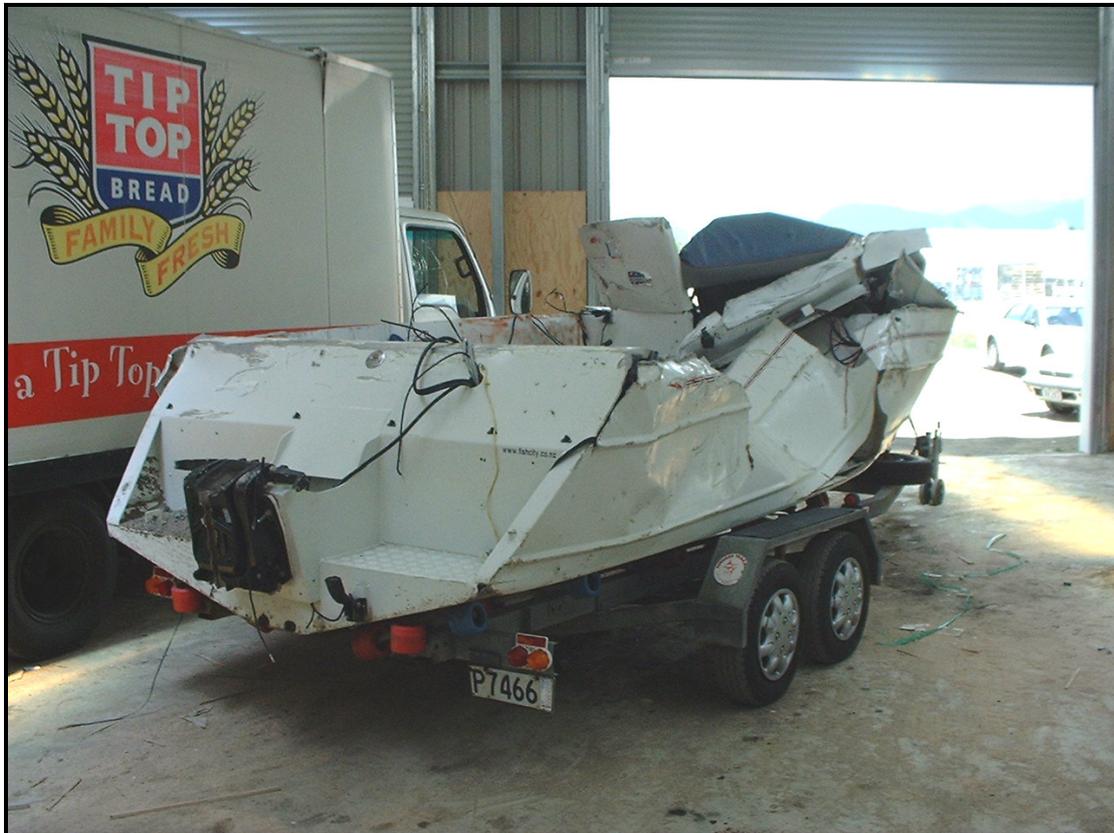
Predator sustained severe damage due to the fact that after it capsized, it drifted over a number of rocks and reefs before reaching the shore. It is difficult to determine what damage the vessel sustained as a result of capsizing. However, the hull of the vessel was apparently intact when the survivors exited the upturned vessel.

Photograph 5
Predator after recovery
