Accident Report

Serious Harm

Receiver

27 January 2007

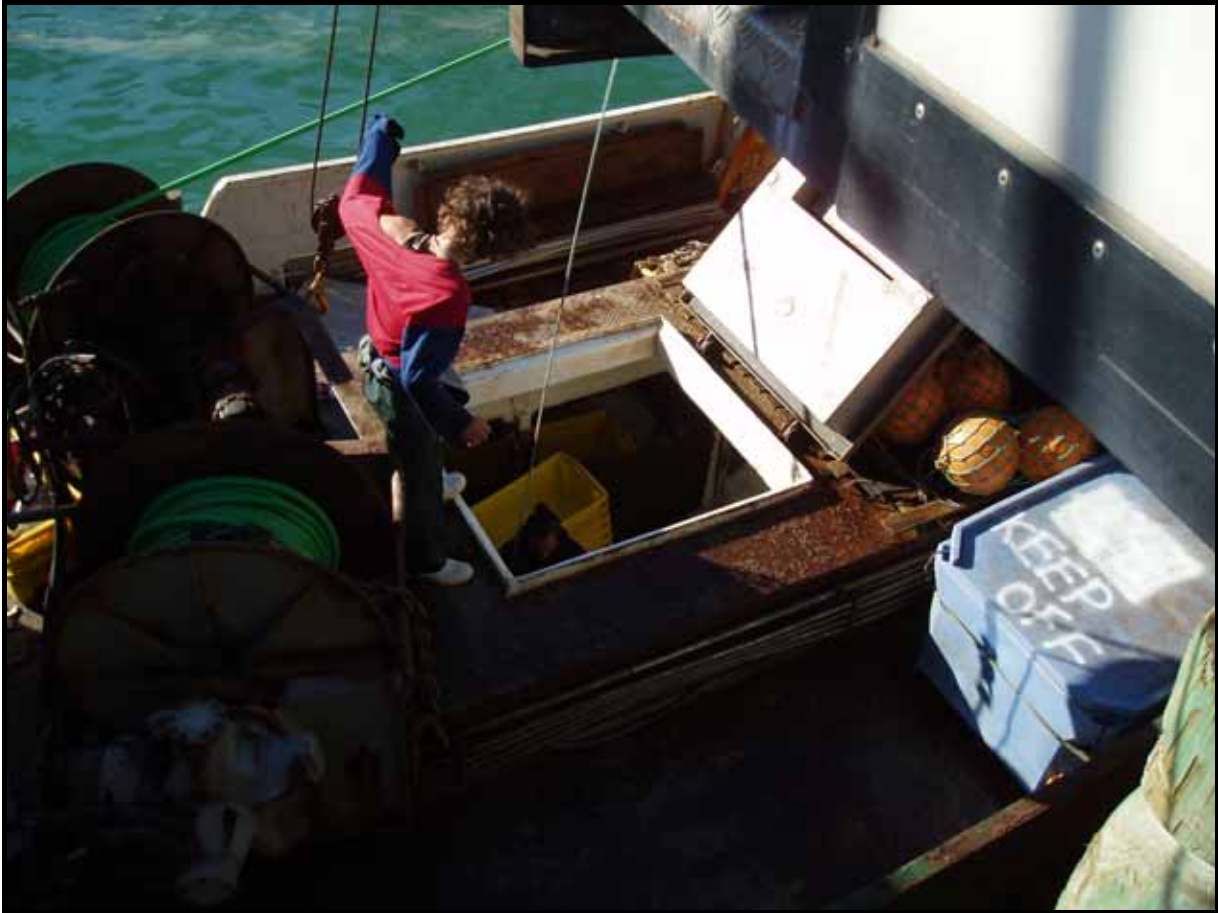
Photograph 1

A stack of four fish bins were positioned under the hatch for lifting out.

The Deckhand who did not turn around as he dropped back down into the fish hold, landed heavily on the fish bins.

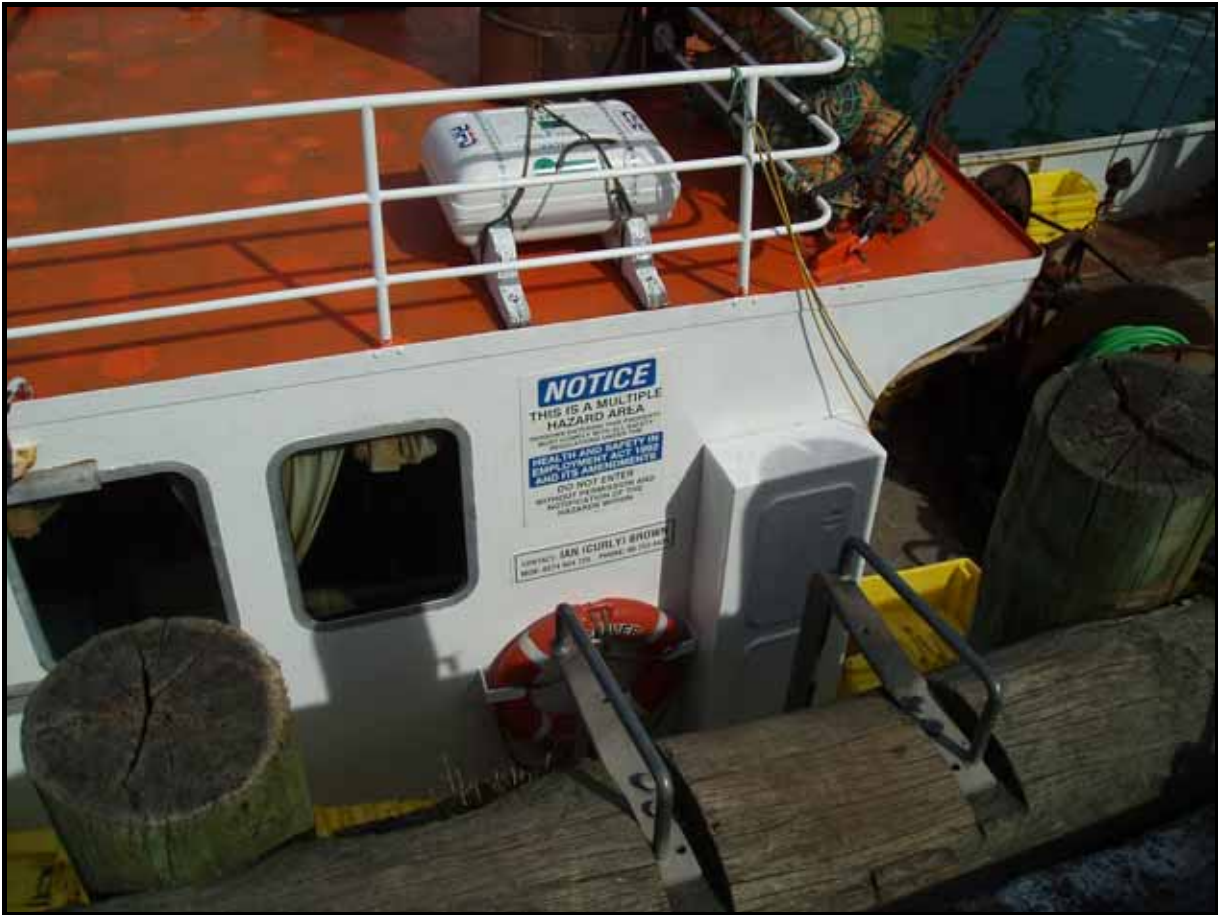
Photograph 2

Included in the list of hazards is the following remark:

'Take care when moving or working around open deck hatches'.

The Skipper will include in the list of hazards that 'when unloading any person entering or exiting the hold must do so on the starboard side'.

1. This hazard could be further minimised by the use of a suitable ladder to access the hold so that access is controlled. This should be investigated by the Skipper.
2. The Skipper should instruct the crew and un-loaders taking part in the unloading to keep clear of the area on the port side of the fish hold.
