Accident Report
Recovery II
Grounding, approximately 5
miles south of Karamea
on 17 May 2004

REPORT NO.: 04 3465

VESSEL NAME: *RECOVERY II*

Casualty Type: Grounding

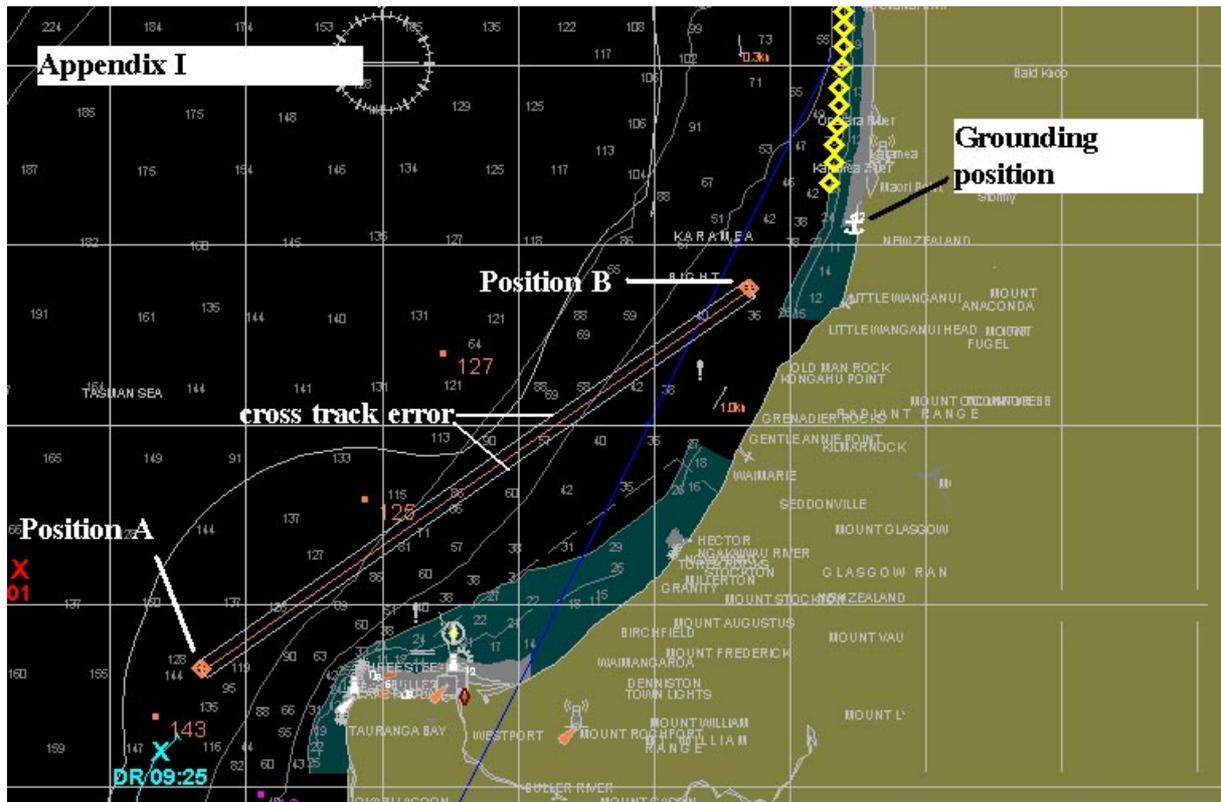
- 1.5 Deckhand 1 and Deckhand 2 came into the wheelhouse at 0145 hours on 17 May, when the vessel was approximately 5 nautical miles (nm) west of Cape Foulwind. The Skipper told them that he wanted them to follow the course line on the GPS plotter and, if they got to the waypoint earlier than 0600 hours, then they were to stop the vessel (*See Appendix I - Vessel Seaplot chart: Position A start and position B stop*).

- 1.8 Shortly after sitting down again he fell asleep.
- 1.9 The vessel grounded at about 0530 hours. Deckhand 1 and the Skipper woke shortly after the grounding (*See Appendix I - Position C: Grounding*) The Skipper came to the wheelhouse and realised that they were aground. All crew had assembled by now in the wheelhouse, so the Skipper sent them to check the vessel for damage and ingress of water.

- 2.3.2 All the above equipment was working satisfactorily. The Skipper had activated the autopilot and had put a waypoint on the Seaplot screen and its associated route. The Skipper had also set a cross track error alarm each side of the course to steer (*See Appendix I - Cross track error*).
