# Summary Report

Grounding

*Rere*

14 August 2006

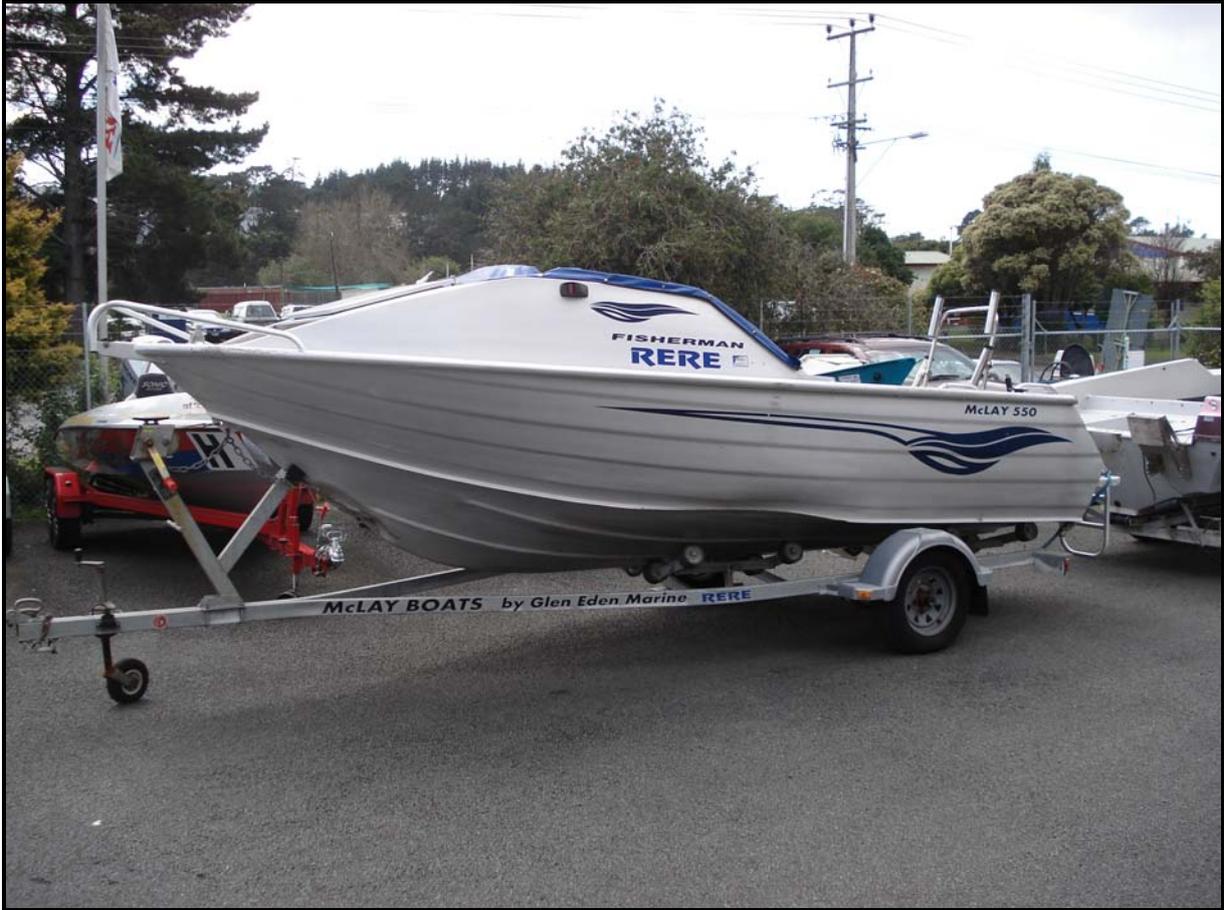
Photograph 1  
*Rere*

- 5.5 m McLay fisherman cabin boat (*See Photograph 1*)
- Power – 67 kW Honda outboard
- Hull 5 mm alloy with 4 mm topsides
- GPS/Depth sounder
- Flare Pack
- VHF
- Six Lifejackets

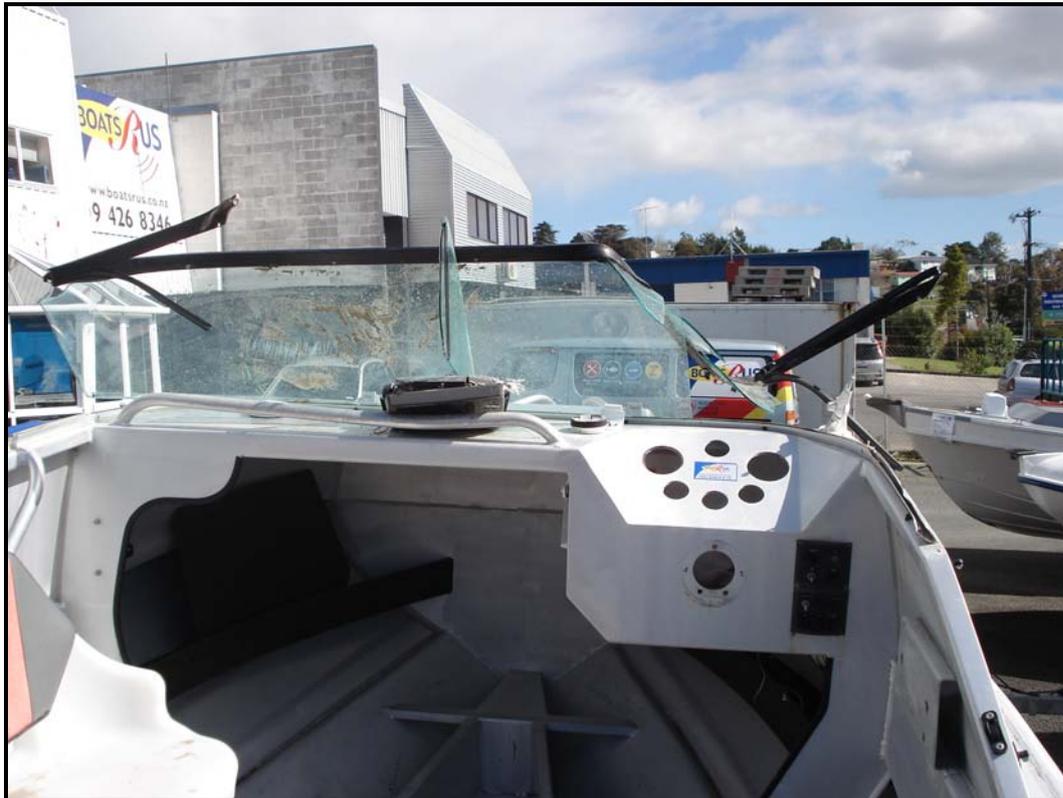
Photograph 2

**Rere** sustained substantial damage. The Perspex windscreen was smashed by impact with the vessel's crew, two of whom sustained severe cuts to their faces (*See Photograph 2*). The section directly in front of the steering station appears to have being subject to high impact, probably from the Skipper's body.

The collapsible canopy that was fixed to the top of the windscreen and supported by alloy poles also showed signs of a high force impact with many of the poles being bent.

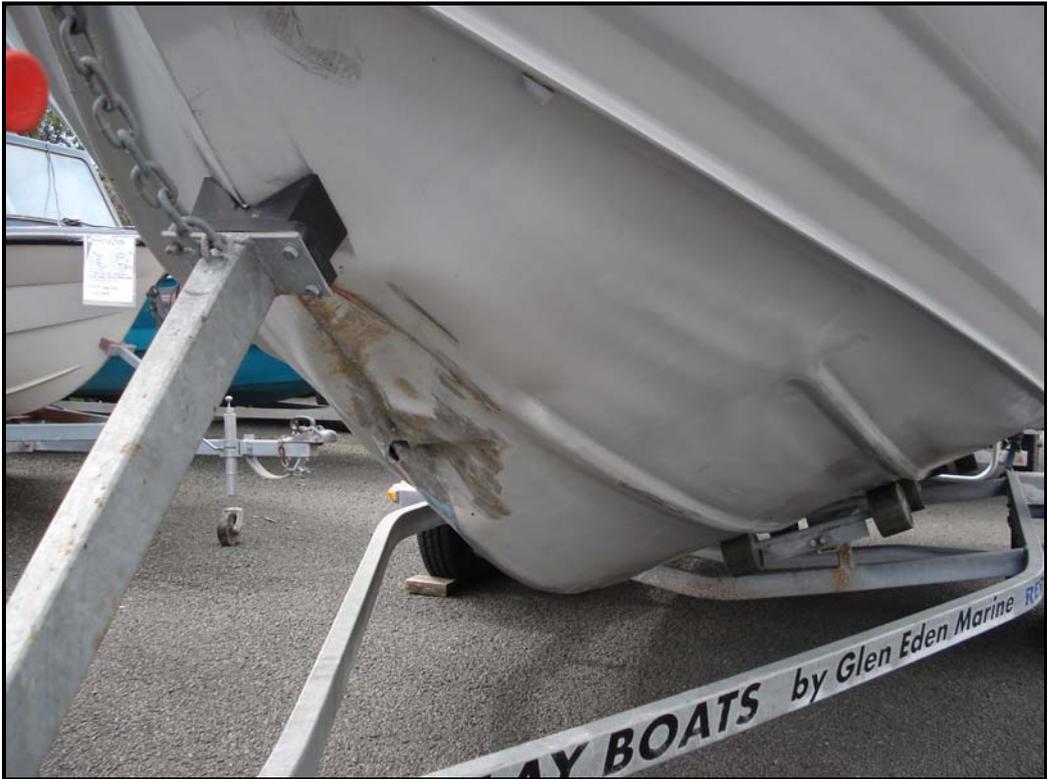
Photograph 3

A 500 mm section of bow was stove in with a 45mm hole (See *Photograph 3*). An indentation of 1.13 metres was observed on the port planning strake. On the starboard side an indentation 350 cm x 200 cm was observed just above the planning strake forward of amidships.

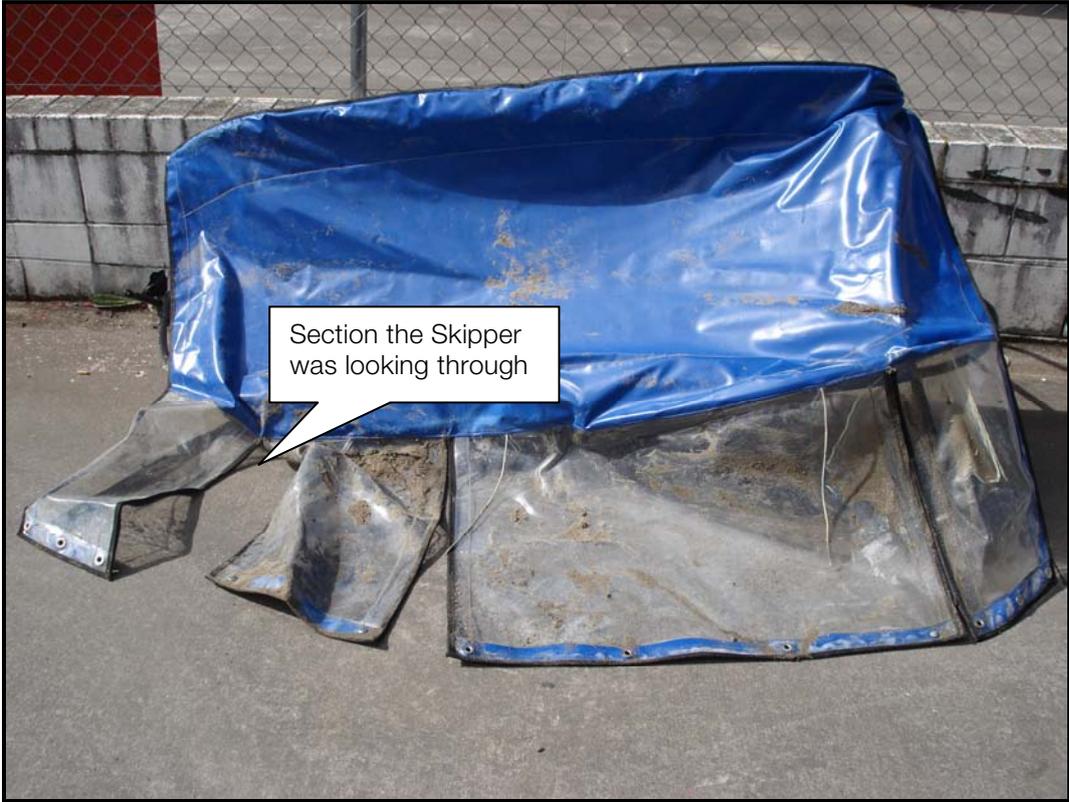
Photograph 4  
Canopy

The canopy had a section above the top of the windscreen that could be rolled up to allow the helmsman to poke his head through for the purpose of providing better vision (See *Photograph 4*).

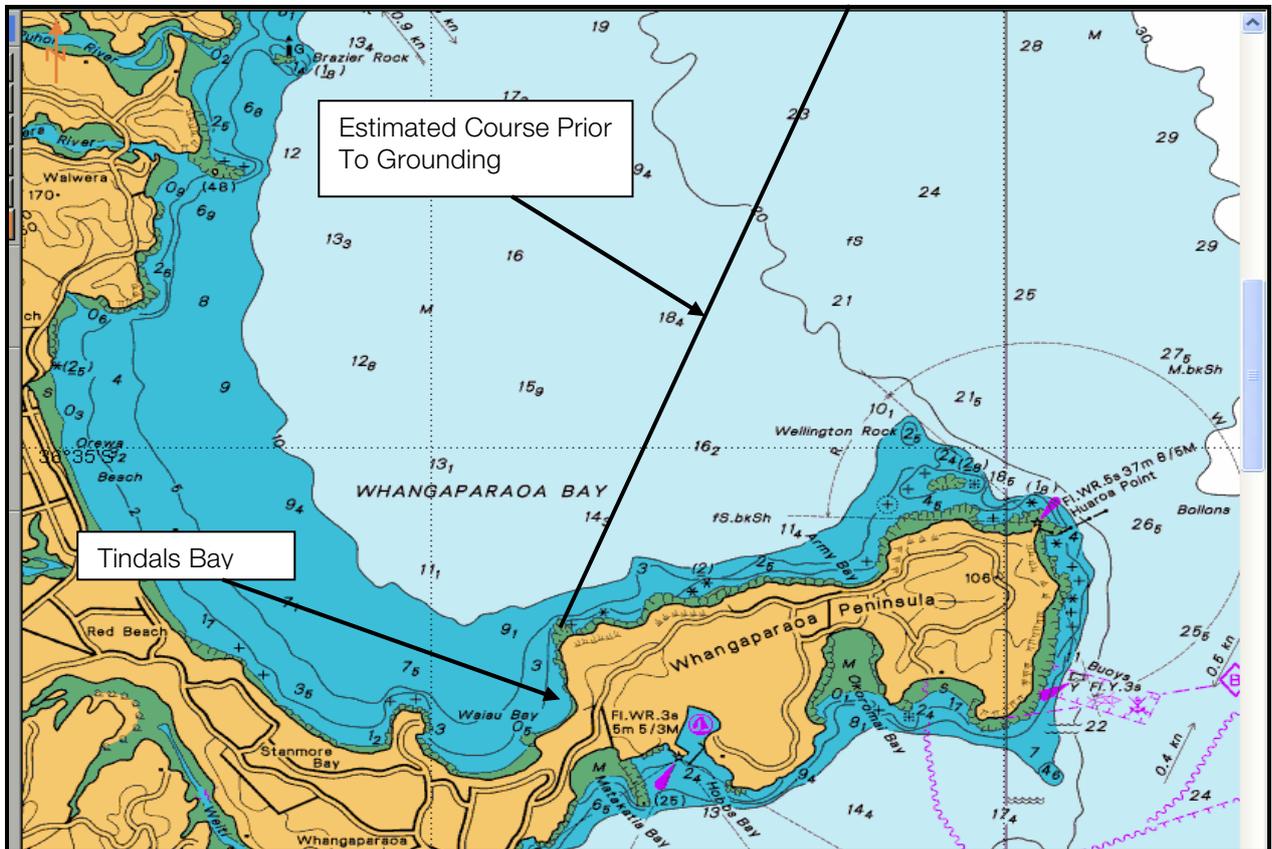
Figure 1

The north coast of the Whangaparaoa Peninsula is a jagged coastline characterised by rocks and reefs extending well out from the shoreline. There are no lights or marks identifying outlying dangers where the accident occurred (See Figure 1).
