Accident Report
Collision
Rescue Alpha v PWC 911
13 June 2009

Maritime New Zealand

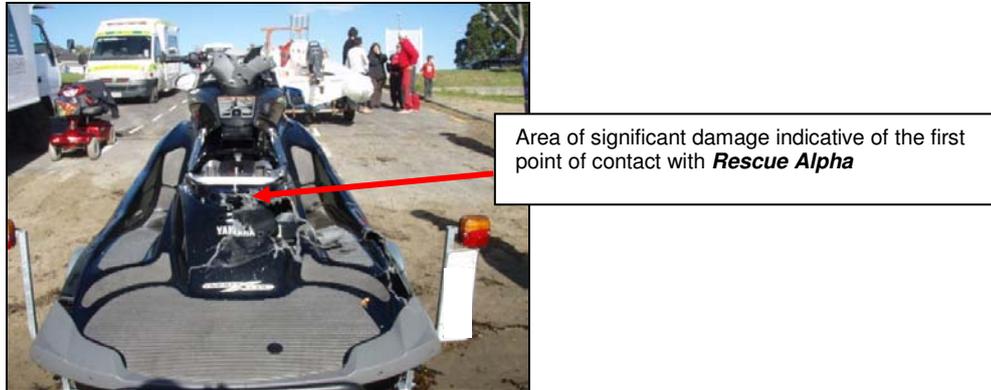
21. **Rescue Alpha's** port pontoon struck the rider from the starboard quarter of **PWC 911**; riding up over **PWC 911** and striking the rider in the right side of her helmet.
22. The evidence indicates that the impact threw the rider from **PWC 911** and clear of **Rescue Alpha**. The propellers of **Rescue Alpha's** two outboard engines caused extensive damage to **PWC 911** as it passed underneath the boat. The **PWC 911** rider suffered a fractured ankle and several fractured ribs as a result of the collision.

Figure 2 Photograph showing damage sustained by **PWC 911**

23. The photograph above was taken shortly after **PWC 911** was recovered from the water.⁶ The damage is situated predominately on the starboard side, and after quarter of **PWC 911**, which indicates **Rescue Alpha's** impact with **PWC 911**, and is consistent with eyewitness accounts.

35. The **PWC 911** rider's description of being struck on her starboard after quarter is consistent with the damage to both vessels and the accounts given by other witnesses. It is unknown whether or not **Rescue Alpha** was within the rider's field of view at any stage prior to the collision, it is possible that it was not given the witness accounts and indicated direction of travel of the vessels.

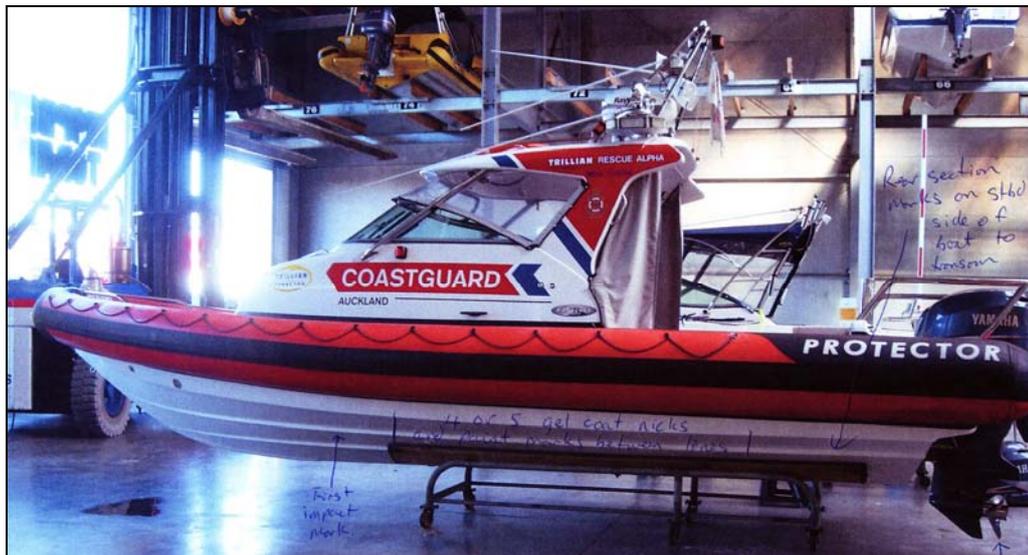
Figure 3 Photograph showing damage sustained by **Rescue Alpha**. Handwritten notes explaining areas of damage.

24. **Rescue Alpha** was taken from the water and repaired before a MNZ investigator could examine the damage. The photograph above was taken shortly after the accident and contains hand-written notes describing the damage, which were made by the repairer. There was damage to the port side and the starboard skeep of **Rescue Alpha**. The damage is consistent with witness accounts of **Rescue Alpha** riding up and over **PWC 911**. The damage to the port side of **Rescue Alpha** corresponds to the area of significant damage on the starboard after quarter of **PWC 911**.

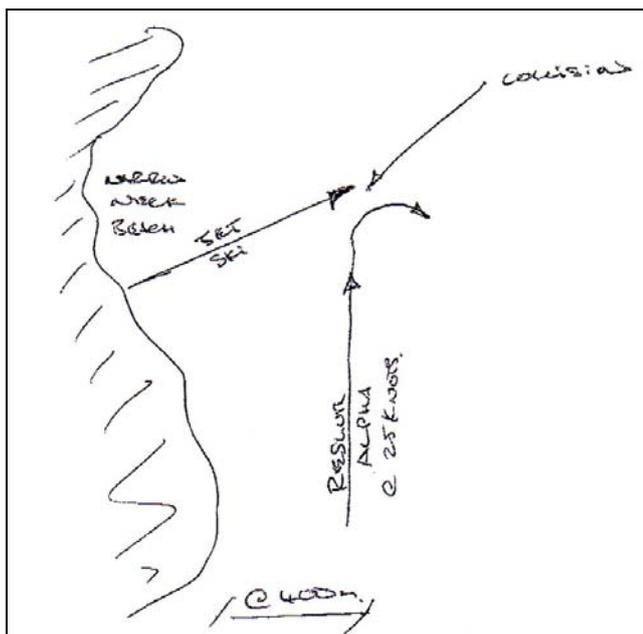
38. When reporting the matter, the master of **Rescue Alpha** provided the following sketch showing the course of each vessel to the point of collision. From this sketch it is possible that **Rescue Alpha** may have been within the **PWC 911** rider's field of view when the crew of **Rescue Alpha** first sighted **PWC 911**. However, given the courses indicated it is possible that **Rescue Alpha** was outside the rider's restricted field of vision as the vessels converged.

Figure 4 Sketch diagram provided by skipper of **Rescue Alpha**

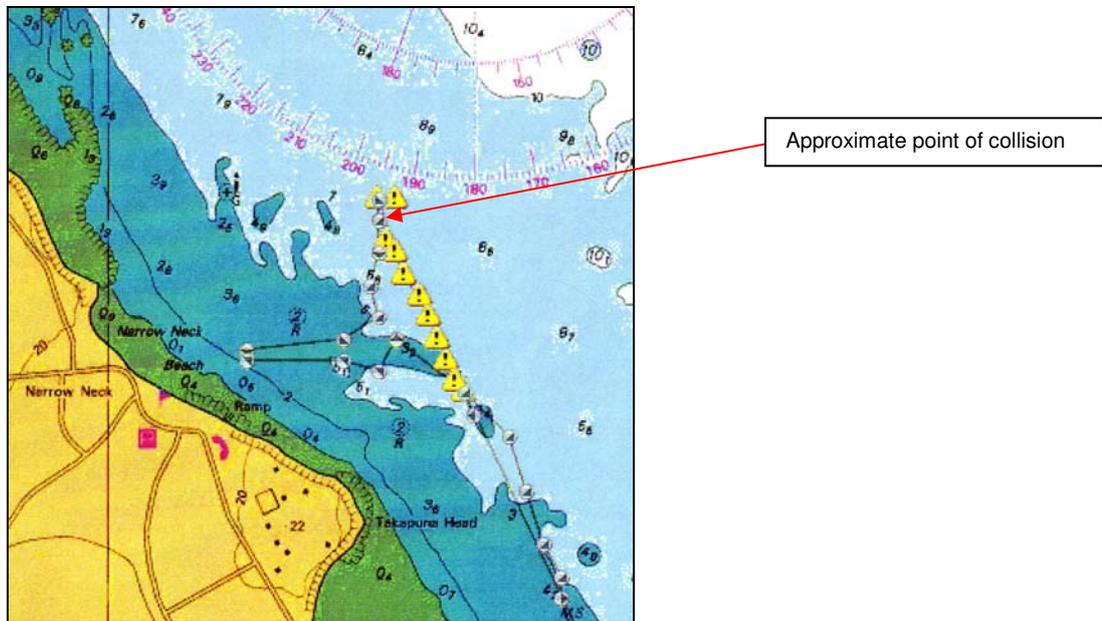
39. This sketch is corroborated by the screen-shot below, taken from the Coastguard Northern Region's Global Positioning System (GPS) plotter that monitors Coastguard vessels. The GPS screen-shot provided an accurate account of *Rescue Alpha's* course. The path of the collision course is highlighted by the exclamation marks shown in yellow.

Figure 5 Course taken by *Rescue Alpha*⁸
