Incident Report  
Close Quarters Situation  
*Washington & Rose Croix*  
1 September 2005  
Class C

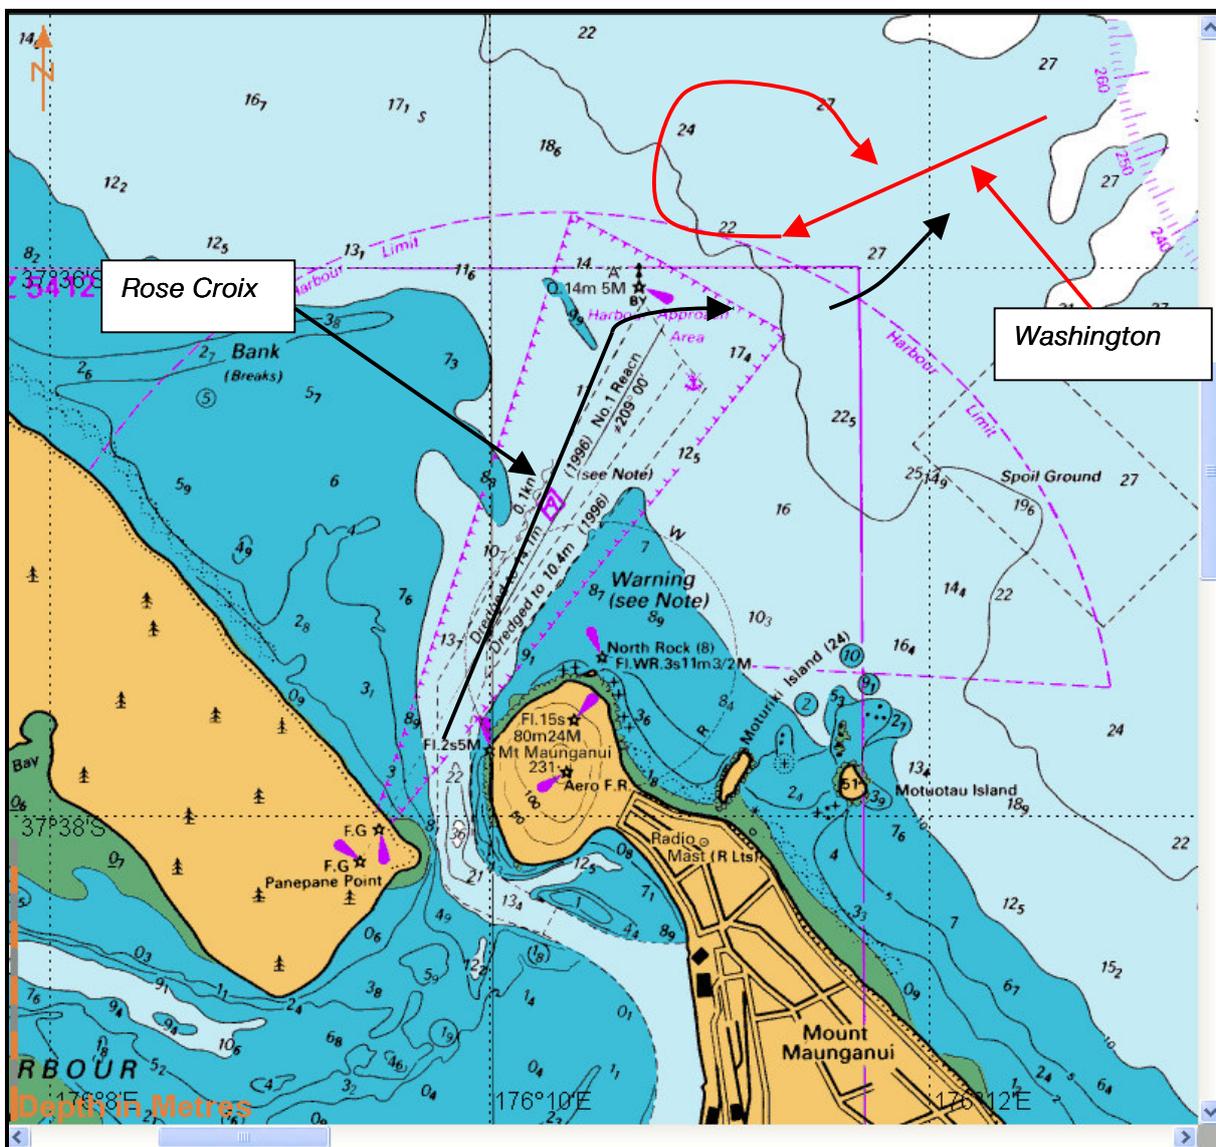
Figure 1  
Chart NZ5413 – Approaches to Tauranga

On 1 September 2005, at 0900 hours New Zealand Standard Time (NZST), fishing vessel **Rose Croix** was outbound from Tauranga Harbour. At the same time, refrigerated cargo ship, **Washington** was inbound, heading about 240°(T) towards 'A' Beacon.

At 0905 hours, **Rose Croix** was seen crossing from **Washington's** port side on a steady bearing.

**Washington** was about to enter the Port Approach Area when **Rose Croix** was seen in the main channel, heading approximately 029°(T). Since **Washington** was required to keep its course and speed, and therefore unable to turn to port to enter the channel, **Rose Croix** was impeding its way, which was contrary to the requirement of **Maritime Rule 22.9(b)**.

About half a mile from the beacon, the Skipper of *Rose Croix* saw *Washington* about 40° on the starboard bow, approaching the channel from the north-east. The Skipper expected *Washington* to turn to port to enter the channel and thought that if he maintained course, the two vessels would pass clear of each other. By that time *Rose Croix* would have been well to the port side of the channel.
