Incident Report

Switchboard Fire

San Enterprise

18 September 2006

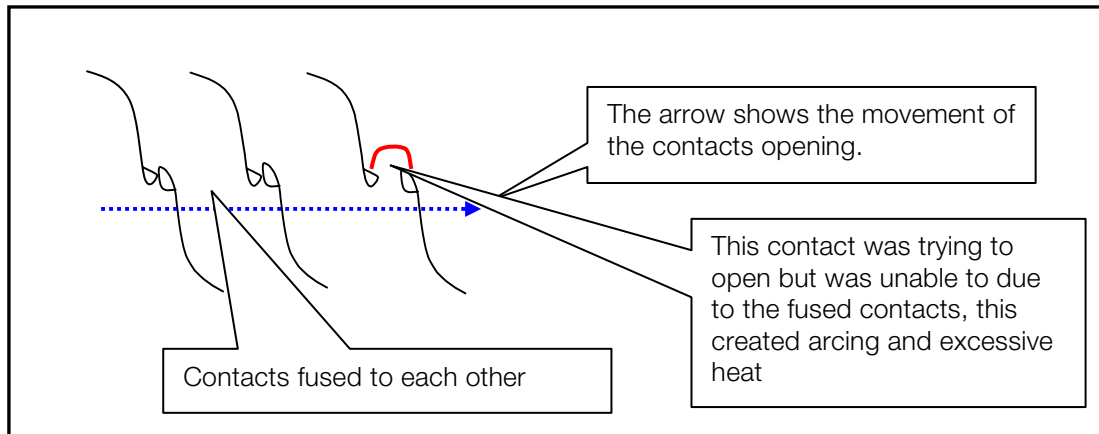
Figure 2

Diagrammatic representation of affected breaker

The reasons for contacts to arc include: poor adjustment, worn surfaces due to prolonged use, contamination of surfaces, dirt, corrosion, oxides and loose components due to vibration.

The loud chattering sound heard by the Engineer prior to the fire is a common sound heard when a contactor is opening and closing rapidly, usually due to at least one contact remaining closed and re-energising the hold on coil time and time again.

The fire was caused by intense heat as a result of one or two of the contacts fusing. When the coil was de-energised (to open the fused coils) these contacts could not open which caused the third contact (which was trying to make the connection - producing the chattering sound) to arc and produce intense heat.

The affected components have been replaced onboard **San Enterprise** and her sister ship.
