# Accident Report

*Santa Regina*

Navigational Error South of  
Pencarrow Head, Wellington on  
14 April 2005

REPORT NO.: 05 3730  
*SANTA REGINA* – NAVIGATIONAL ERROR

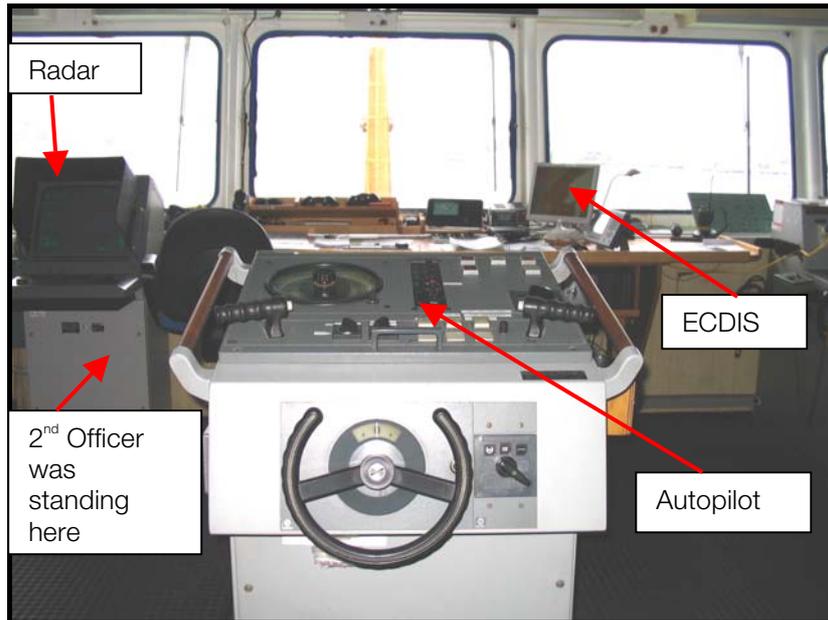
At approximately 1030 hours, the Cadet and the 2<sup>nd</sup> Officer became engaged in a conversation regarding the magnetic compass. They were standing at the front of the wheelhouse. The 2<sup>nd</sup> Officer was standing immediately to port of the steering consol and looking forward. From where the 2<sup>nd</sup> Officer was standing, it was possible for him to see both the Electronic Chart Display & Information System (ECDIS) and radar. This conversation distracted the 2<sup>nd</sup> Officer and caused him to forget to alter course at the charted position in order to bring the vessel round onto a heading of 016°(T) and thus onto the approach leads into Wellington Harbour.

**Photograph 1**  
View of wheelhouse from centreline looking forward

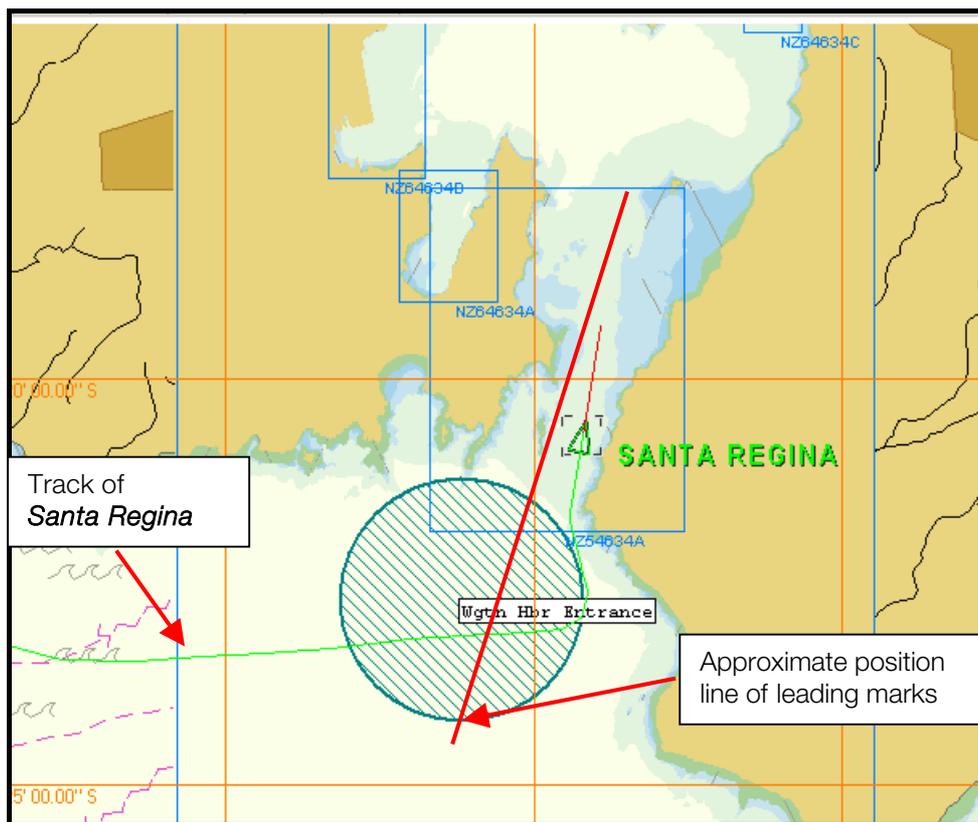
**Diagram 1**  
Chartlet obtained from Maritime Operations Centre (MOC), showing AIS (Automatic Identification System) track of *Santa Regina*

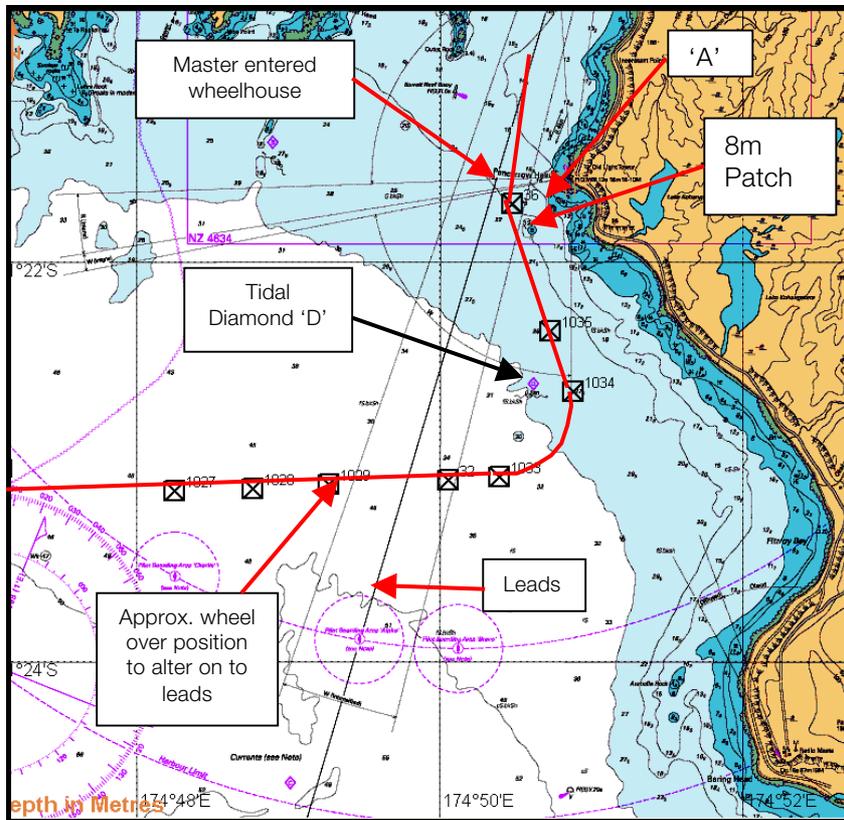
Diagram 3  
Extract of Chart NZ4633

The closest that ***Santa Regina*** got to shallow water was when the vessel had shallow water and rocks approximately 1.8 cables or about 330 metres on its starboard side when in a position to the South West of Pencarrow Head. (See *Diagram 3 - Position 'A' of chartlet*)
