# Accident Report

Crane Failure

*Sea Angel*

REPORT NO.: 05 3888

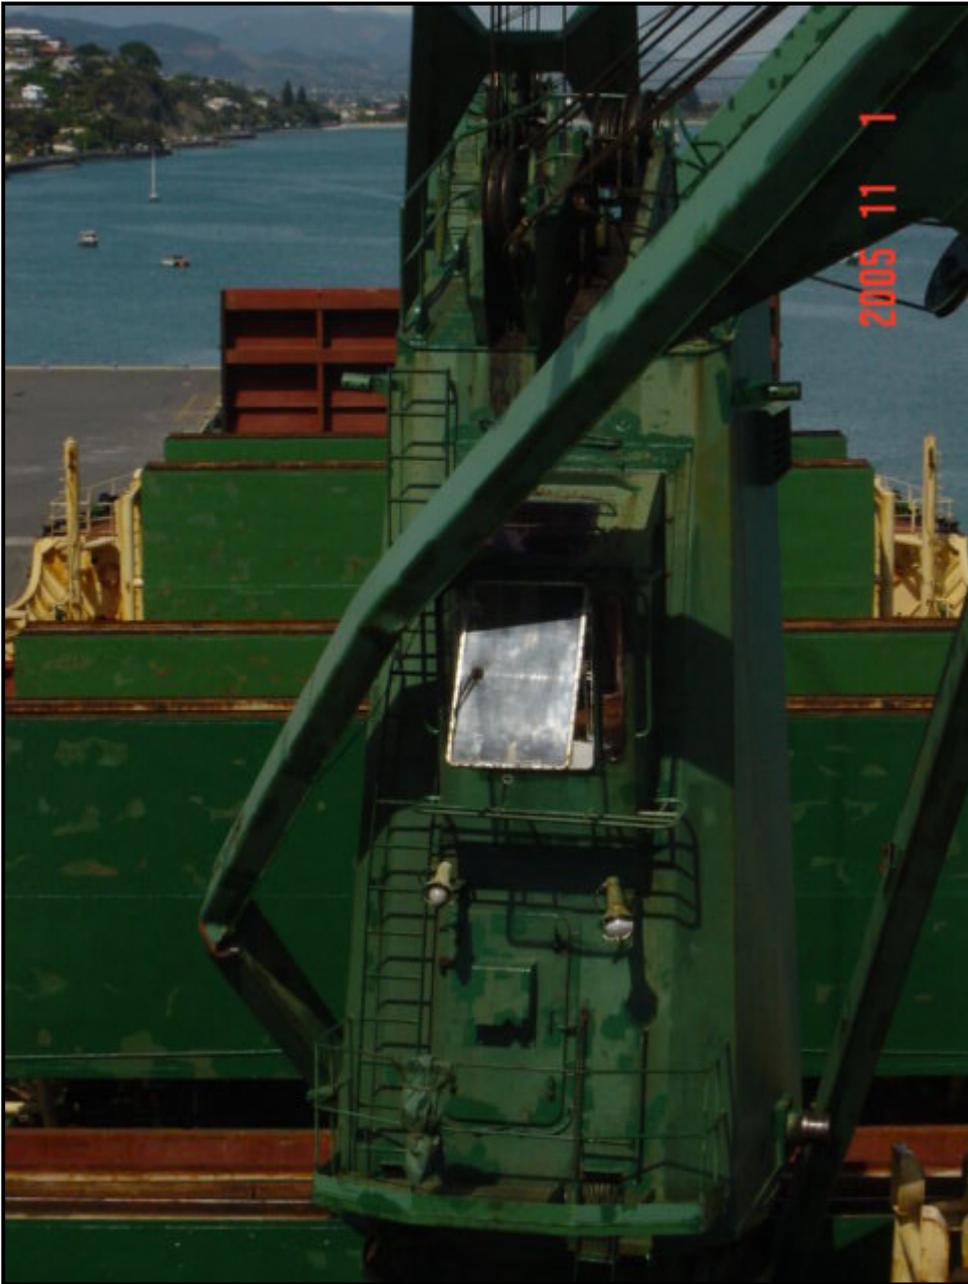
**Photograph 2**  
Photo showing damaged No. 3 crane jib.

Crane Driver 2 looked down and saw the after end of the port crane jib start to collapse (See *Photographs 2 & 4*). Crane Driver 2 then heard a loud bang and saw the aft port side crane jib slipping off its mounting cone. The crane jib then dropped back and under the tower of the crane until it became jammed against the raised hatch covers at the after end of No. 3 hatch (See *Photograph 2*). As a result of the two crane jibs failing, the bundle of logs landed on log stow and the load on the hoist wire was released. When the load settled down, the crane jib stopped toppling further. As soon as this stopped, Crane Driver 2 climbed down from the crane and spoke to the Shift Foreman. Crane Driver 2 suggested they should stop work and check the rest of the cranes to ensure that they were safe before work resumed. However, no action was taken at that time because the stevedores had a tight schedule to enable the ship to sail. Work was continued using the other three cranes, without incident, until the next 'smoko'.

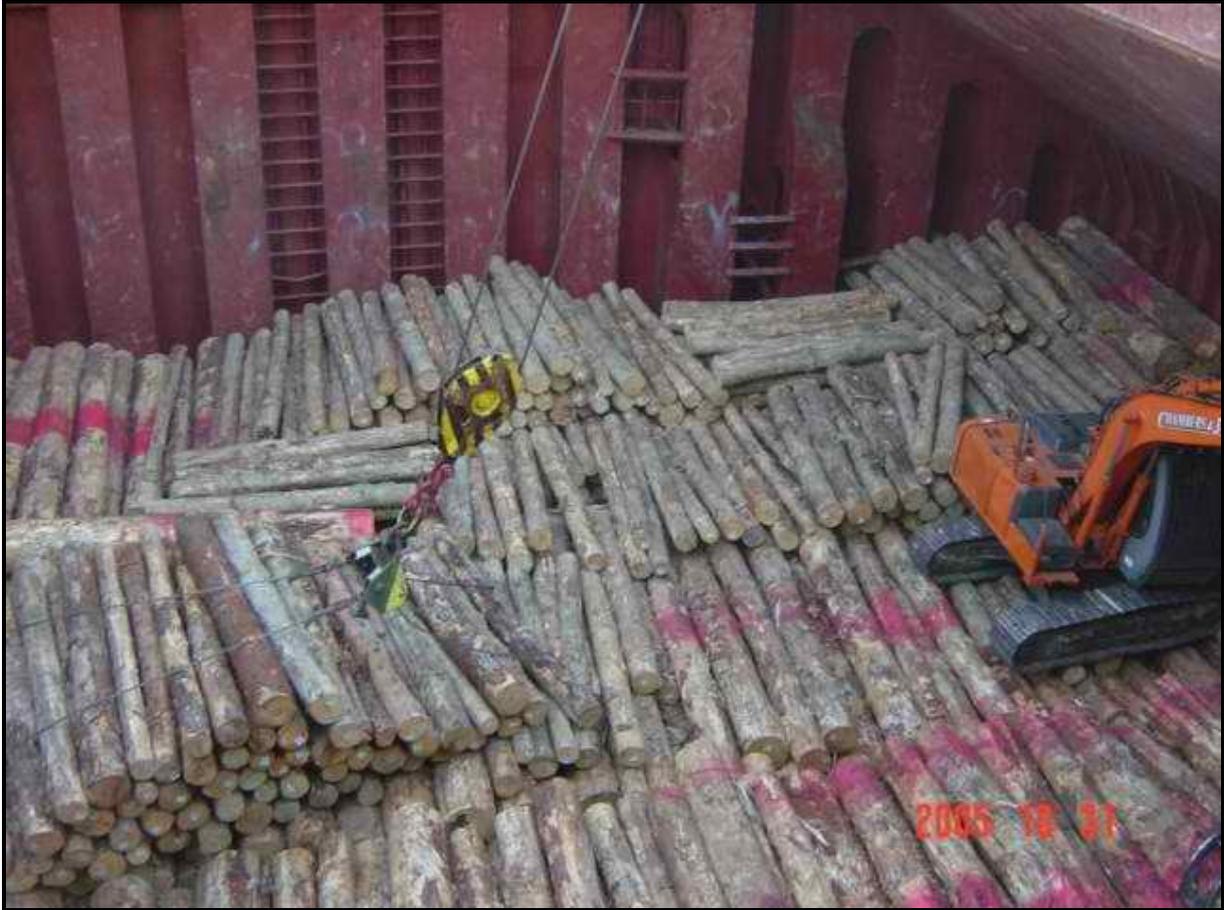
**Photograph 3**  
No. 4 cargo hold. Note condition/position of log sling and digger.

No. 3 crane's luffing and hoisting wires did not part before the load of logs landed on the stow of logs and the weight was released. The two wire slings around the bundle of logs did not release and the whole bundle was laid and tilted towards the aft starboard side of the cargo hold at an angle of about 5 to 10 degrees (*See Photograph 3*).

The Investigator is of the opinion that the crane driver tried to reposition the bundle of logs to make it more convenient for the digger driver to stack them in the required position within the hold. When Crane Driver 2 lifted the bundle of logs to a height of approximately 400mm to move it towards the starboard side of the hold, the port heel pin bolts suddenly failed and the port crane jib heel bearing became detached from the shaft/pin. As a result, the port jib arm dropped and struck against the raised hatch covers at the after end of No.3 hatch. At the same time as this occurred the bundle of logs fell back onto the log stow in the manner shown on *Photograph 3*.

The crane's starboard jib arm became weaker and continued to swing to the left, until the lower end of the starboard jib arm started to fail and bend. The mid section of the starboard jib arm then bent after it struck the crane driver's cabin (*See Photograph 3*).

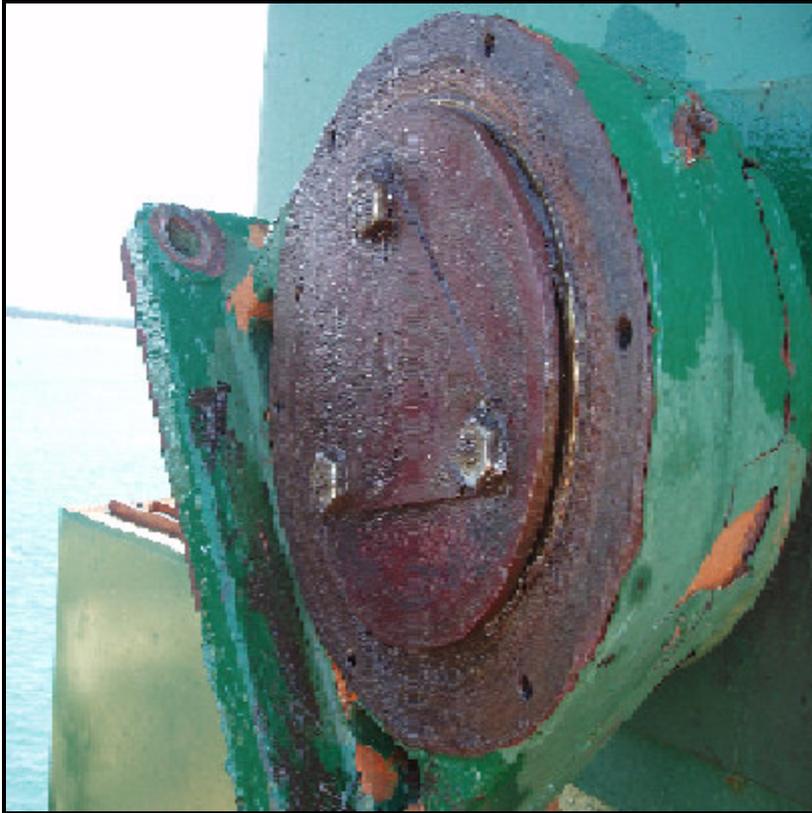
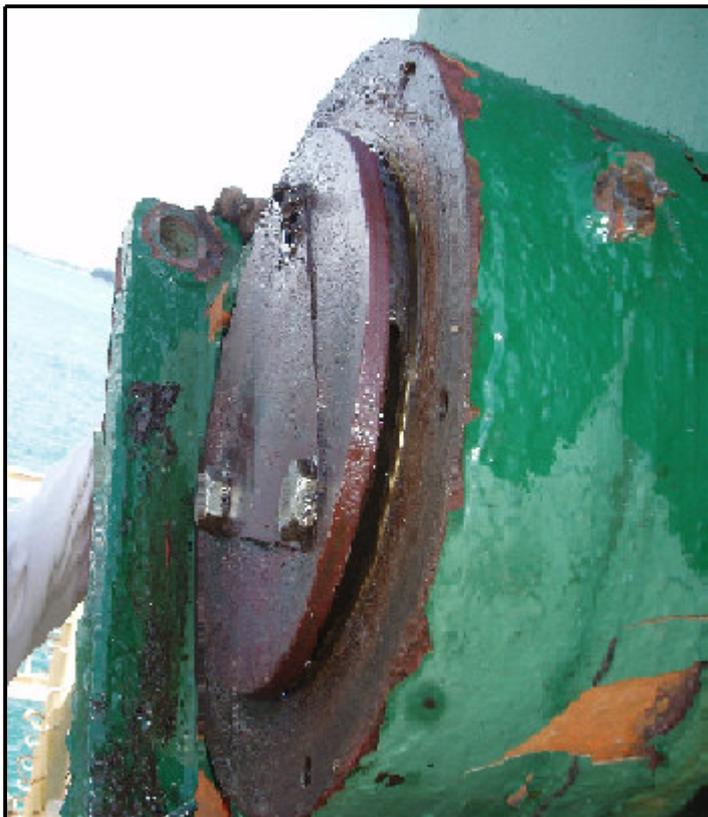
Both photographs show the No. 3 crane's right heel pin bolts and securing arrangement (*Note – a hammer test failed to detect the fractured bolt and it was found only by using a spanner*).

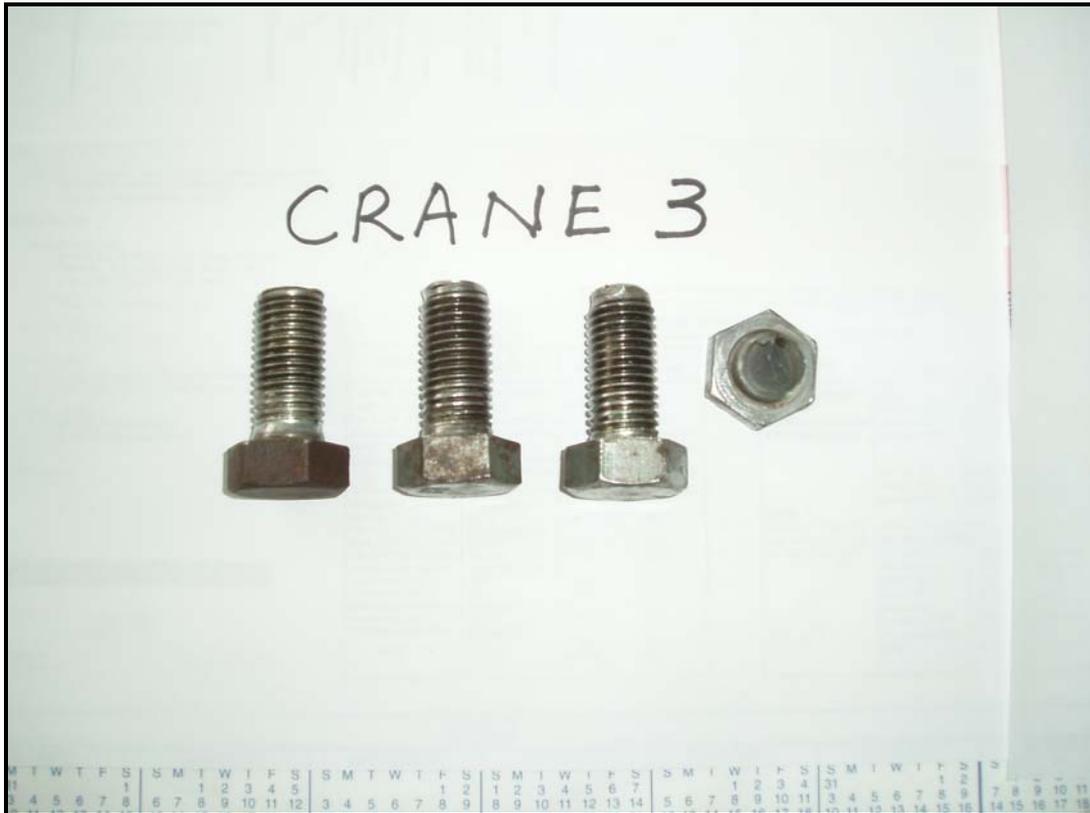
**Photograph 7**

A close visual examination of the three retaining bolts that had detached from No. 3 crane's port heel pin, showed that on all three, the last two threads, close to the bolts' outer edge, were stripped of any thread and that four of their threads, near the bolt heads, were partially stripped of thread. The remaining ten threads in the middle of all three bolts were found in good condition. When the three bolts were sent to the inspection company SGS, for a Non Destruction Crack Test, fatigue cracks on all three bolts were found at the bottom of the second threads and near the bolt head (See Appendix 1 - SGS Magnetic Particle Inspection Report and Photographs 8 and 9, showing the location of the cracks found on all three bolts that had detached from No.3 crane. Note also the position where No. 3 crane's right heel bolt fractured).

No. 3 crane heel bolts, 3 detached from left heel pin, 1 fractured at right heel pin.

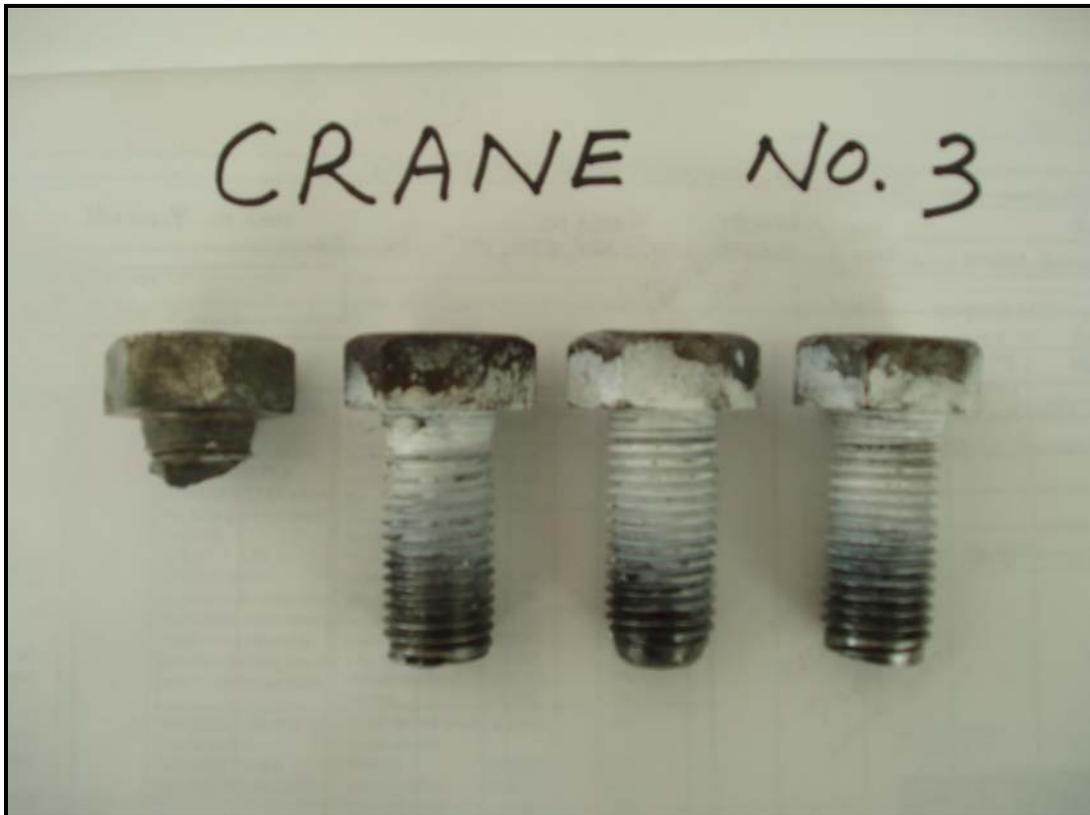
**Photograph 8**

No. 3 crane heel bolts indicating a crack, note position of cracks to fractured bolt.

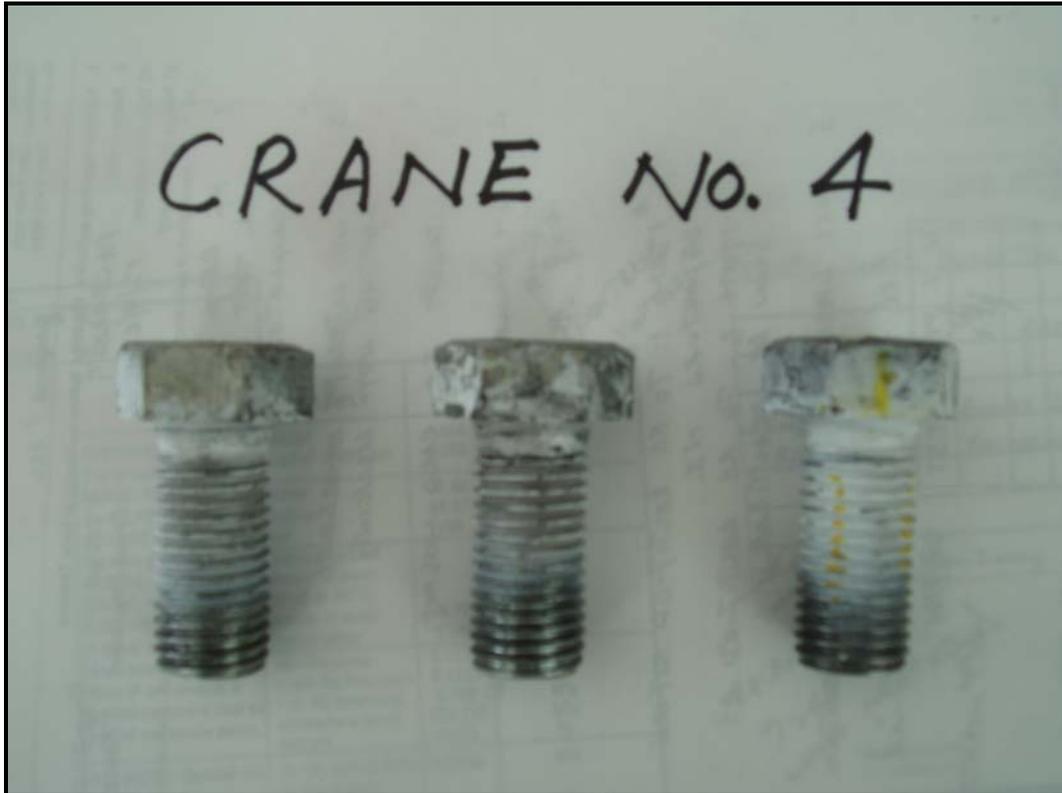
4 crane's six heel pin bolts, three of the heel pin retaining bolts were loose namely, two from the port heel pin and one from starboard heel pin/shaft. These bolts were removed and sent to SGS for a Non Destructive Test. Cracks were found on all three bolts. The cracks were similar to those found on the bolts on No. 3 crane's port heel pin/shaft (See Appendix 1 - SGS Magnetic Particle Inspection Report & Photographs below showing signs of crack on all three loose bolts found on No. 4 crane)

**Photograph 9**  
No. 4 crane heel bolts indicating crack by Magnetic Particle Test

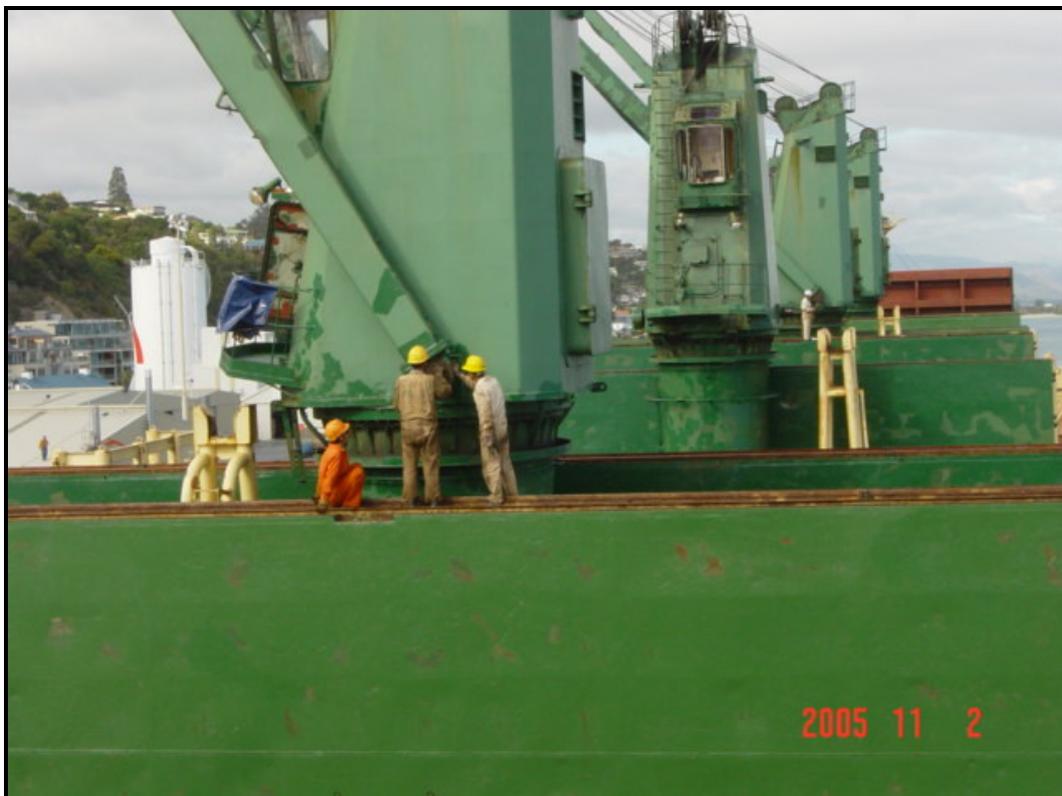
2. The ship’s crew did not follow the inspection & maintenance requirements/recommendations of *MHI Technical Information* because:
  - There was no safe access platform built on the cranes to facilitate inspection/maintenance (See *Photograph 10*).
  - The Master and Officers were not aware of the existence of the *Technical Information* that is attached in *Appendix 2* to this report.

**Photograph 10**  
Showing crew standing on hatch cover while working on No. 4 crane because there was no working platform fitted.

1. A copy of the report be forwarded to **Sea Angel's** owner/operator with the following recommendations:
  - A platform should be fitted on all their ship's cranes to facilitate safe access when carrying out the required maintenance and inspections of cranes

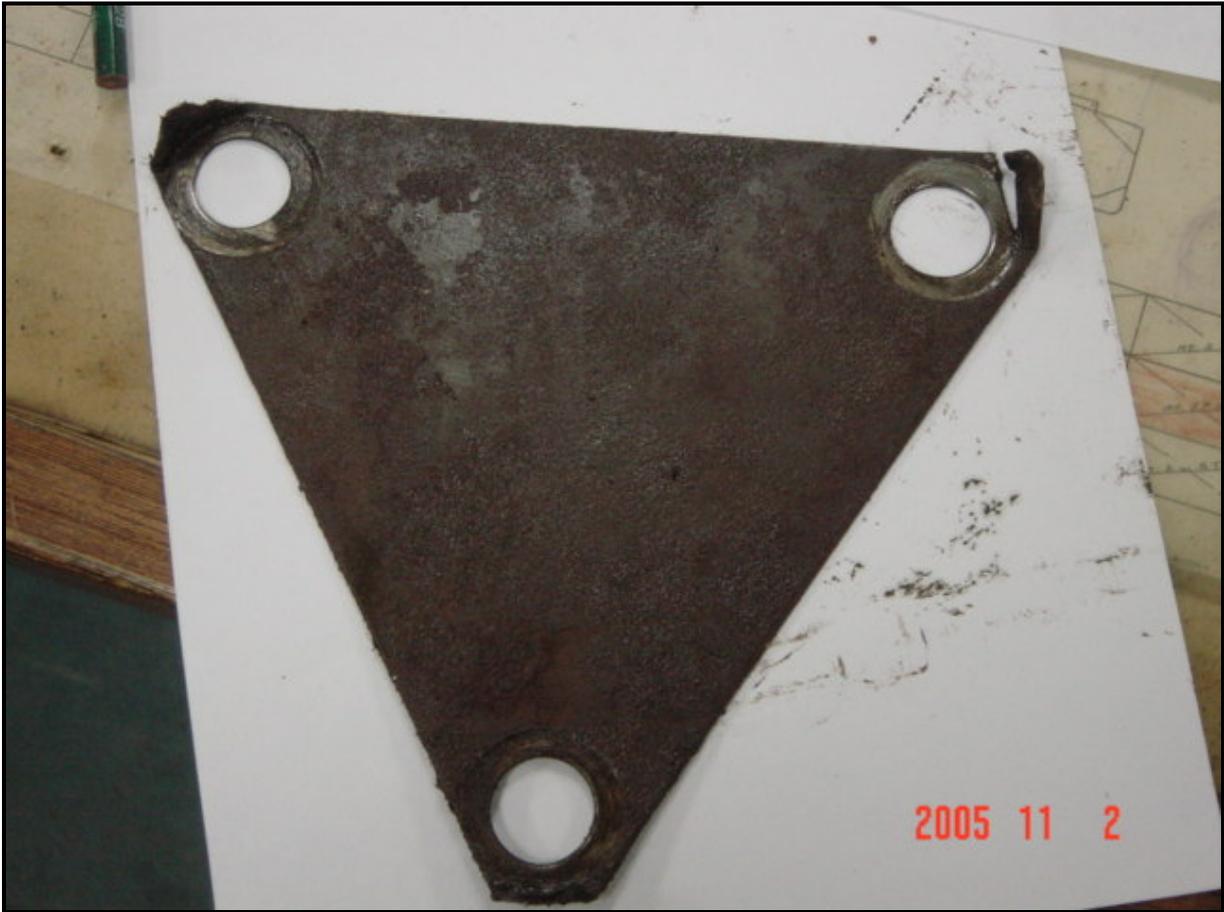
Examination of the heel pin threaded/tapped holes revealed that they were in good condition, except the outer most two threads that showed signs of damage. Examination of the triangular locking plate on No. 3 crane's port heel pin found that the locking plate edges were cracked or damaged through repeated use (See Photograph 11).

5. The poor condition of the heel pin locking plate/device was considered to be one of the possible contributing factors for the heel bolts to work loose. However, the discovery of cracks on all the loose bolts found on No. 4 crane and all the detached bolts from No. 3 crane would make the condition of the heel bolt locking plate/device only a minor contributing factor to the eventual failure of the crane jib, because, if the bolts were properly locked up, they could still fracture and fail, as occurred in the failure of the MHI crane aboard *S Venus* in 2004.

**Photograph 11**  
No. 3 Crane heel bolts locking plate showing crack
