Accident Report

Grounding

Shangri-La

SHANGRI-LA GROUNDING

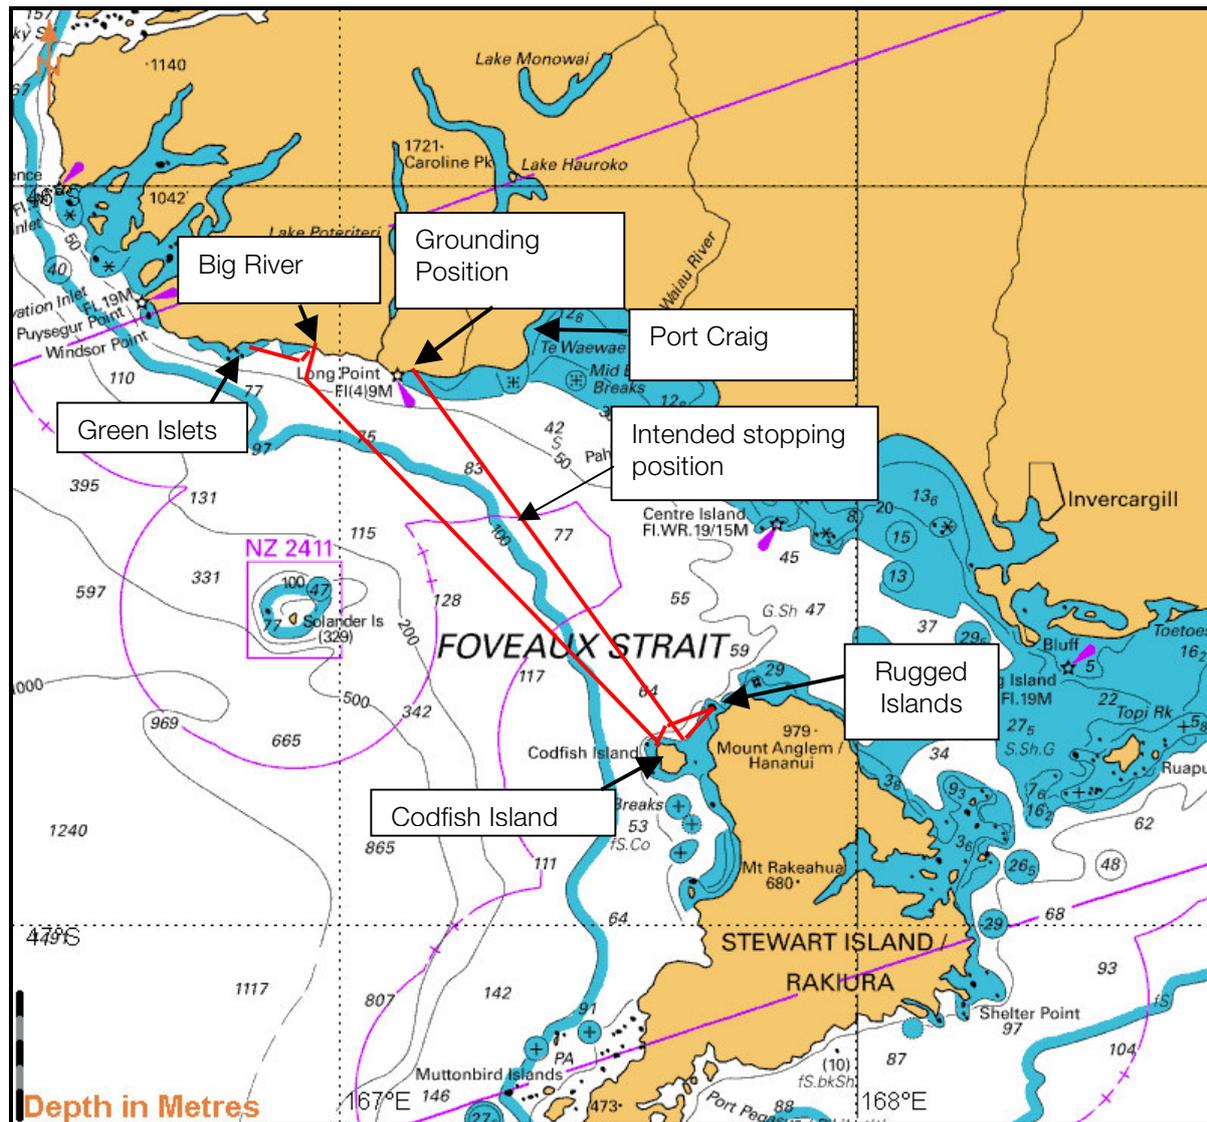
Figure 1

The next thing that any of the crew recalled was the shuddering and the noise of the vessel running aground. This occurred at 0200 hours on 14 September 2005 in position 46° 15.2'S 167° 07.3'E (See Figure 1).

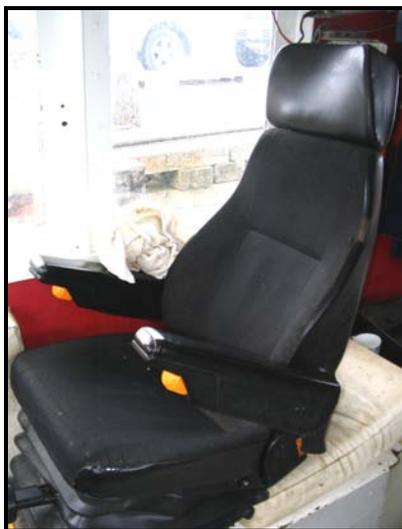
Photograph 1
Wheelhouse Chair

The wheelhouse chair is a comfortable high-backed truck driver's chair (See *Photograph 1*).

- a) The large meal and two beers may have been sleep inducing.
- b) In order for the crewmember to be sitting in the chair and cancelling the alarm with his toes, he would have had to lay back in the chair.
- c) He fell to sleep sometime after approximately 2330 hours, which was past the normal time he went to sleep.
- d) The environment was non-simulating (calm sea and autopilot engaged).
- e) The crewmember was not active.
- f) In drifting overnight, this was different to the usual pattern of sleep and work followed onboard **Shangri-La**.
- g) The probability that the wheelhouse doors and windows were closed.
- h) The decision of Crewmember (1) to remain sitting/lying in the chair instead of getting up on a regular basis and walking around.

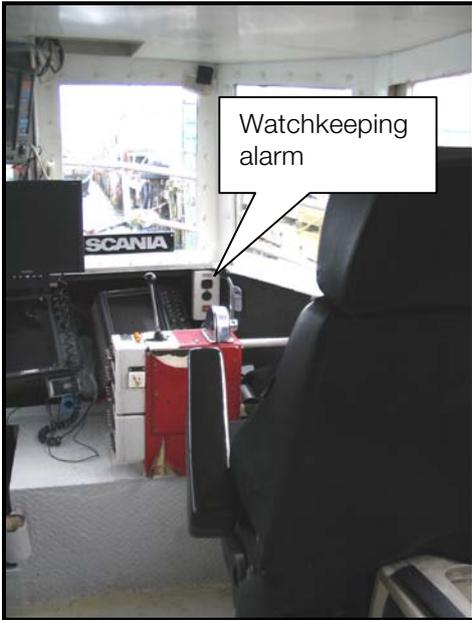
Photograph 2
Conning Position

The watchkeeping alarm box was relocated at the beginning of 2005 when a new seabed mapping system was installed in the wheelhouse. The alarm box was re-sited on the consol in front of the wheelhouse chair (See *Photographs 2 & 3*). In this position, a watchkeeper, when sitting in the chair and with his feet on the consol could cancel the alarm, using his toes.

1. It is recommended that the owners of **Shangri-La** relocate the watchkeeping alarm so that is not possible to cancel the alarm from a seated position.
2. It is recommended that Crewmember (1) be censured for his failure to maintain a safe navigational watch.
3. It is recommended that the owner of the vessel refrain from the practice of allowing all crewmembers to sleep whilst the vessel drifts.

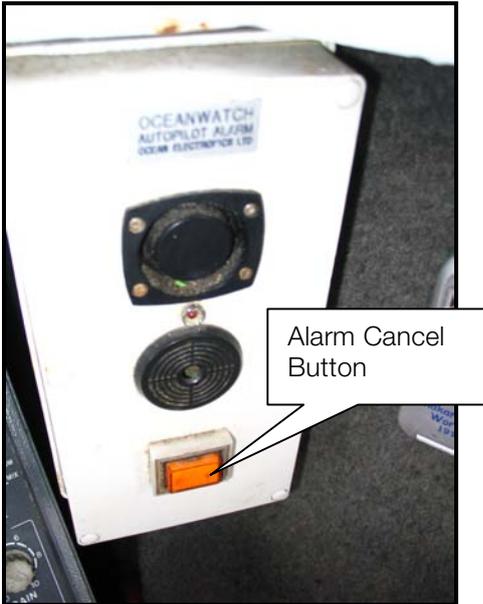
Photograph 3
Watchkeeping Alarm

Shangri-La is fitted with an operational watchkeeping alarm. The alarm is automatically activated once the autopilot is engaged. After 20 minutes, a low level alarm is sounded which the watchkeeper must cancel by pressing a button on the alarm box. If this low level alarm is not cancelled, after 2 minutes, a higher level louder alarm is activated. This alarm is loud enough to wake the rest of the crew.

As the higher level alarm never activated, Crewmember (1) must have cancelled the low level alarm at least six times during the time he remained asleep.
