Class A Accident Report

Shinano Reefer Stevedore Fatality

At the Port Napier on 19 January 2005

**REPORT NO: 05 3644*****SHINANO REEFER – STEVEDORE FATALITY***

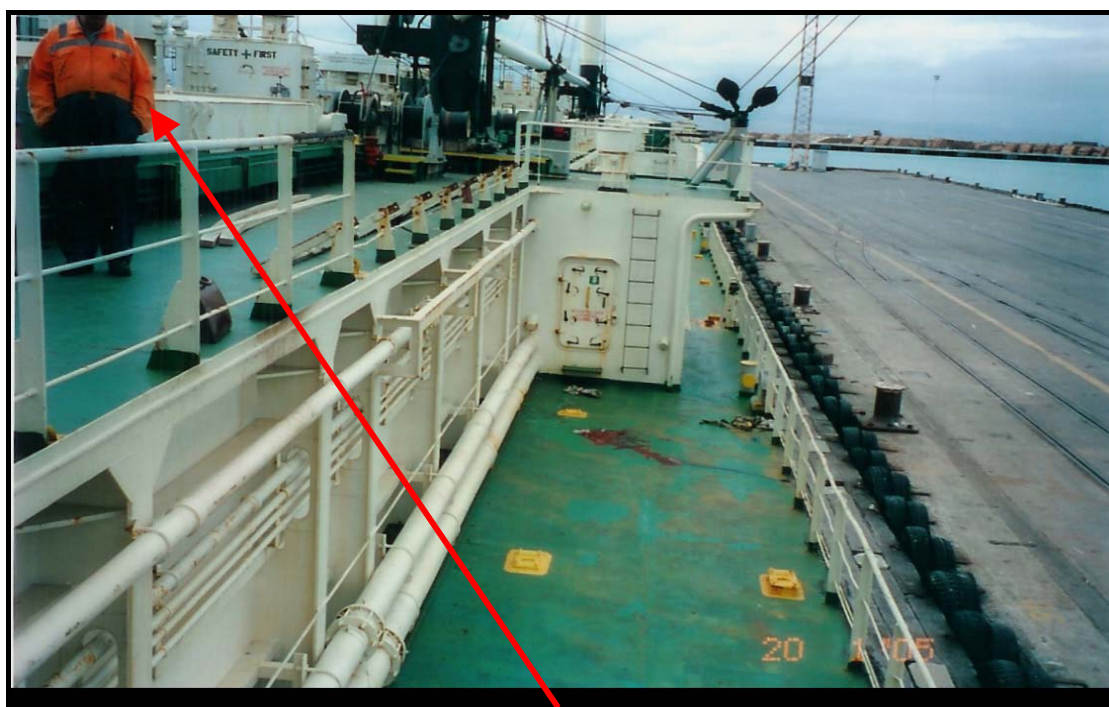
Two Stevedores, (the Winchman and Hatchman) were walking along the hatch deck when one turned and saw the Hatchman falling to his left down to the deck below (*See Photograph*). He and a number of other Stevedores from shore side rushed to the scene and gave first aid while an ambulance was called.

PHOTOGRAPH OF HATCH DECK (MAN IN ORANGE) AND IMPACT AREA ON MAIN DECK BELOW.

The Hatchman and Winchman were walking along the hatch deck with the Winchman slightly ahead. The Winchman turned and saw the Hatchman off balance and falling to his left down to the main deck, 3 metres below. He rushed down to the main deck and was met there by other Stevedores from the wharf. They gave first aid and an ambulance was called.

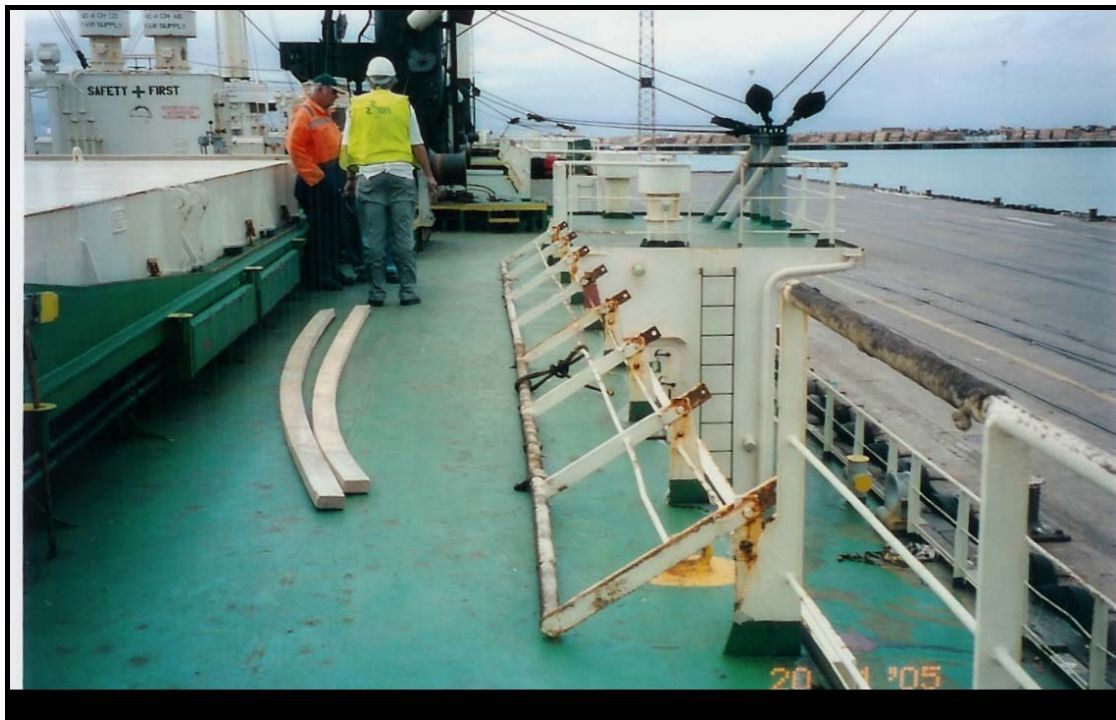
PHOTOGRAPH OF HATCH DECK WITH LOWERED SAFETY RAIL.

The vessel also has a fold down safety rail as part of its design; this allows the cargo runner from the union purchase derricks to pass over it and into the holds.

HBSS and all of the Stevedores working that day have worked this ship design many times before. The rail is lowered and raised by the vessel’s crew before and after cargo operations. It had not been identified as a specific hazard by HBSS but was widely known by all the Stevedores.

The fold down safety rail had yet to be raised after loading was completed.

The Hatchman was seen to overbalance and fall over the edge of the hatch deck. The Winchman who was the nearest eyewitness is not sure whether he lost balance or tripped over the lowered safety rail.

The hatch deck safety rail is lowered to prevent the derricks luffing out too far and therefore putting excessive load on the wires.

1. That Southern Cross Stevedores Ltd (SCS) critically review their Health and Safety manual to include the need to always wear all personal safety equipment including safety helmet until well clear of any work area and clear of the vessel and surrounding areas.
2. That SCS also direct all of their subsidiaries to identify and list the fold down safety rail as a hazard.
3. That where possible, the hatch deck safety rail remain in the raised position and cargo operations are managed in such a way as to minimise the luff of the outboard derrick.
