Class A Accident Report

Southern Winds Grounding

At Charles Sound on 14 October 2004

REPORT NO: 04 3581

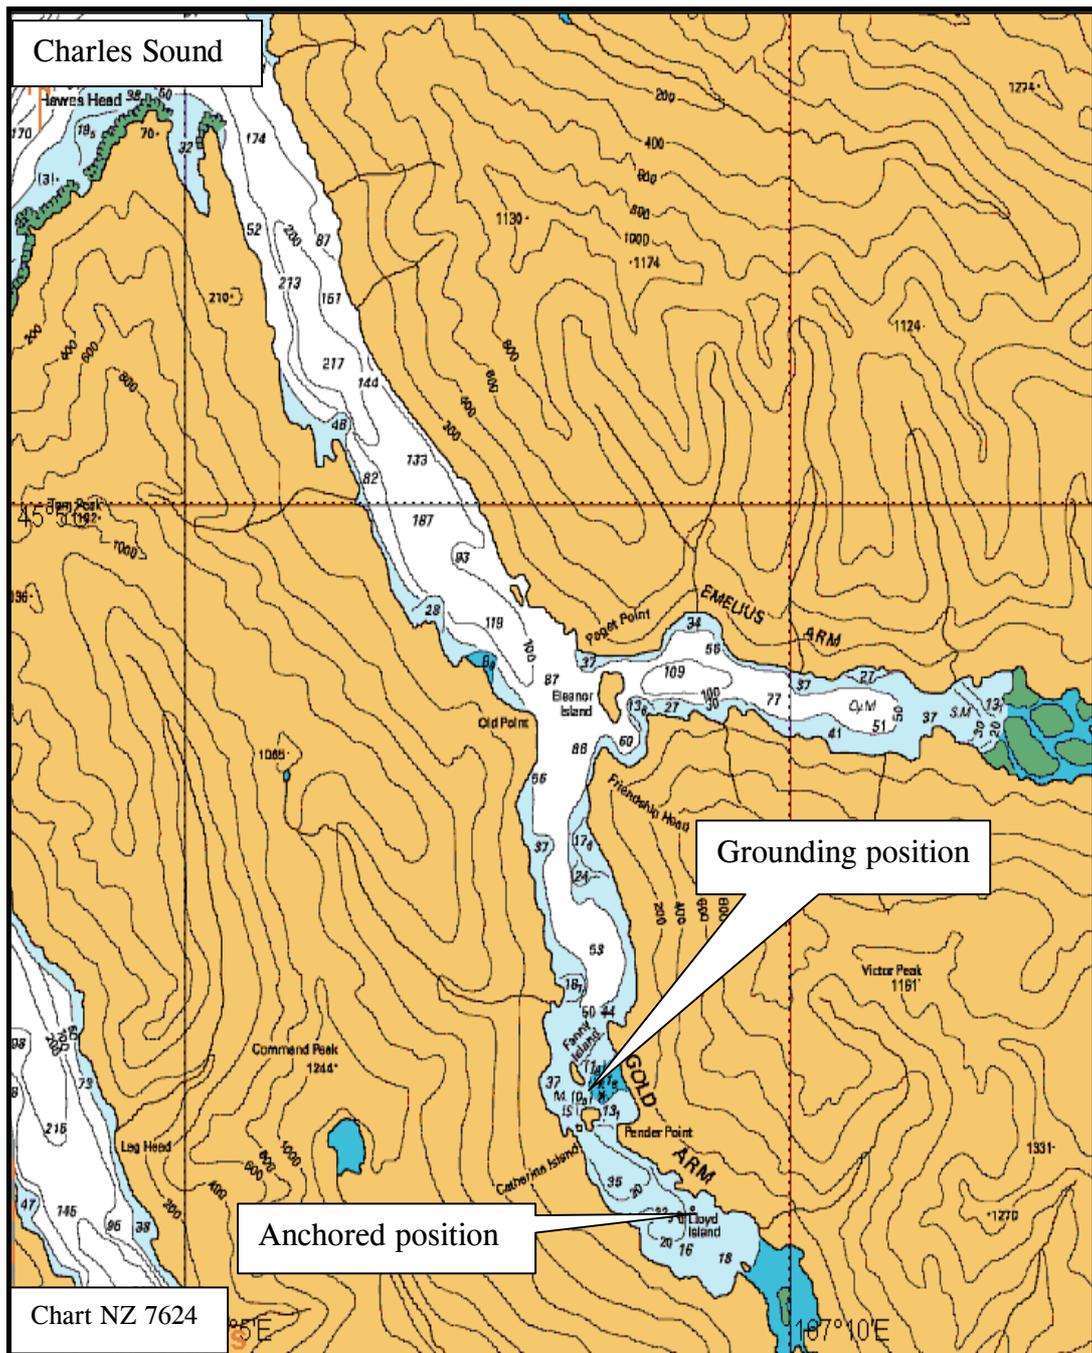
FIGURE 1

On Thursday 14 October at 1915 hours New Zealand Standard Time, the Skipper anchored the vessel in Gold Arm of Charles Sound (*See Figure 1*). At 1928 hours, after the vessel had settled at anchor, the Skipper shut down the main engines and the electronics. He then joined the other DOC staff and had a barbeque on the main deck of the vessel.

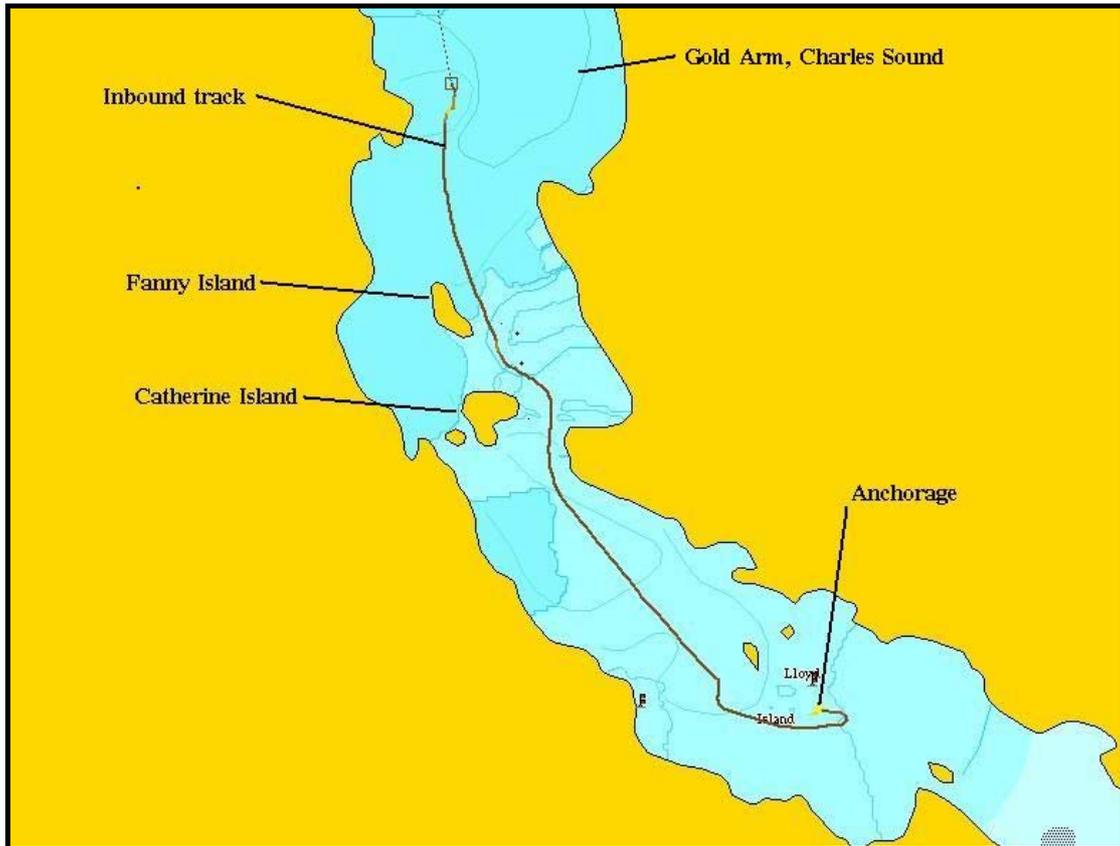
FIGURE 2 - INBOUND *SOUTHERN WINDS* GPS TRACK FROM VESSEL.

At approximately 1800 hours, the Skipper conned the vessel into Gold Arm of Charles Sound. He passed Fanny and Catherine Islands, leaving them both to starboard. The Skipper made passage towards Lloyd Island and came to anchor at approximately 1915 hours, 1.3 cables south east of Lloyd Island in 16 metres (m) of water (*See Figure 2*).

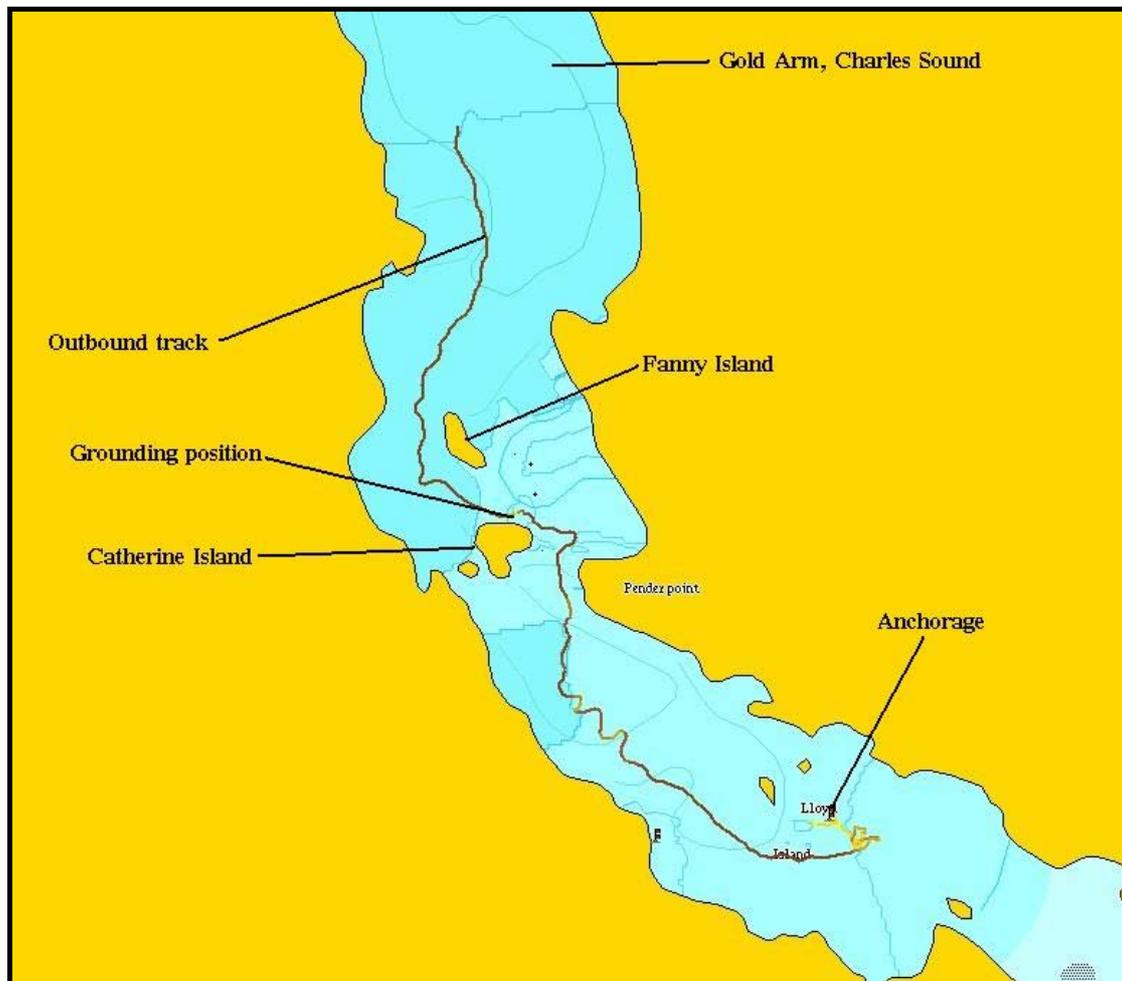
FIGURE 3 - OUTBOUND *SOUTHERN WINDS* GPS TRACK FROM VESSEL

At this point the Skipper decided to abort deploying the anchor, instead electing to steam the vessel at steerage speed north towards Pender Point (See Figure 3). Steerage became difficult to maintain however as the bow of the vessel was blown off track repeatedly due to the high wind speed. The Skipper decided to steam out of Gold Arm and look for a more sheltered position within Charles Sound.

The Skipper attempted to retrace his inbound track past Catherine and Fanny Islands. While at anchor the GPS plotter had been shut down and when restarted it had opened a new file with a clean chart display and he did not recall the inbound track.

Using the radar and GPS plotter, the Skipper positioned the vessel midway between Catherine Island and the area of shallow ground to the immediate northeast.

At approximately 2330 hours, as the vessel was midway between Catherine Island and the shoal ground, the vessel struck a submerged rock, rode up and then slipped off the side of it.

The Skipper conned the vessel to the south west of Fanny Island (*See Figure 3*) while all staff donned lifejackets. The damage was assessed and a check made for any ingress of water. Initially, no water was found on board. However, about 5 minutes later, crew reported that water was coming out of the deck floorboards in a forward space near some access stairs. They made some temporary repairs to reduce the flow of water using a bedroll, foam and sealant. The level of water could be controlled using the vessel's pumps. The Skipper made passage towards Eleanor Island and turned into Emelius Arm of Charles Sound (*See Figure 1*). At this juncture the Skipper slowly steamed up and down Emelius Arm. At about 0030 hours, on 15 October the Skipper was able to make a radiotelephone contact to his wife notifying her of the accident and asking her to contact the DOC project manager.
