Accident Report

Collision with Bridge

Spirit of Resolution

8 October 2005

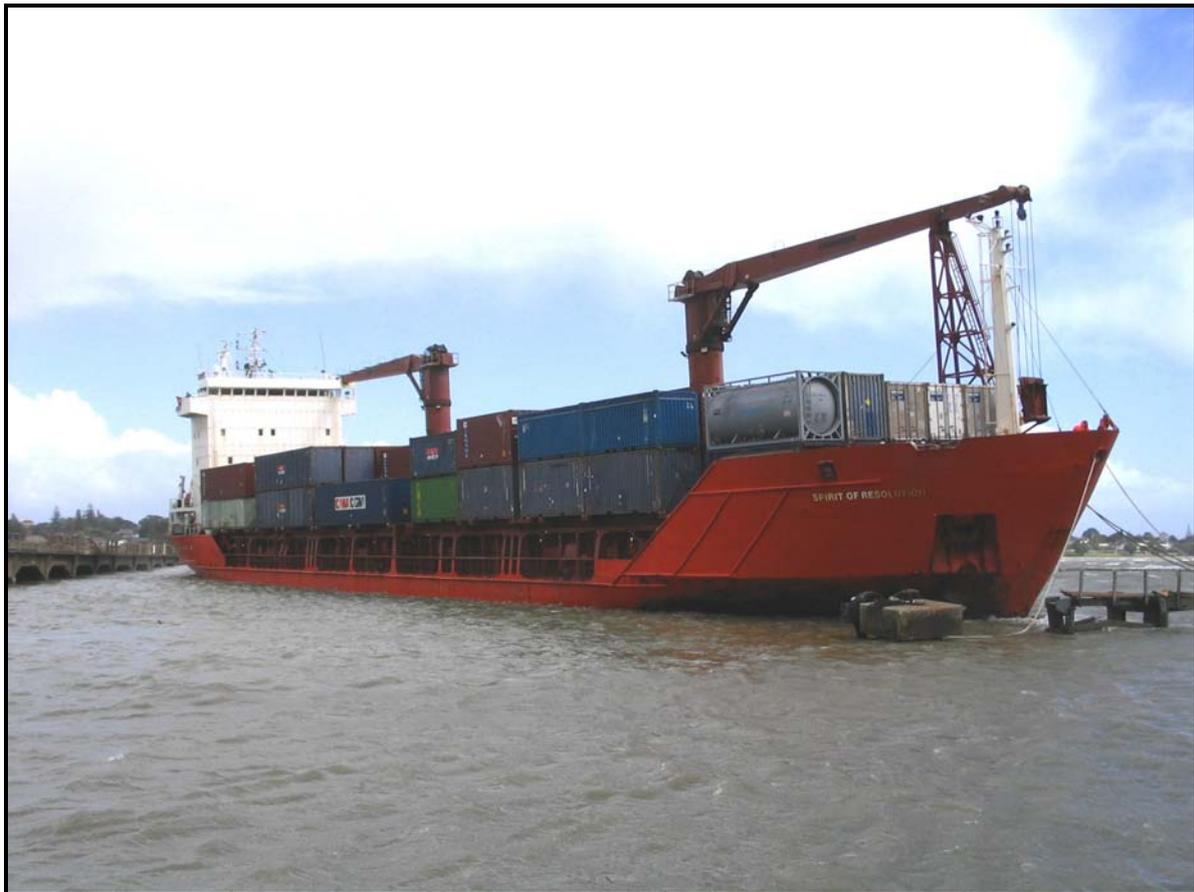
Photograph 1
Spirit of Resolution – Taken at the time of the incident.

Given the prevailing adverse weather and tidal conditions; the vessel's high windage area with containers on deck (*See Photograph 1*); a tug with a low bollard pull; the lack of a fully functional Becker rudder (*see below*); the limited sea room in which to manoeuvre off the berth and the fact that the Manukau bar was closed, the Master should have seriously questioned the need to sail at that time. The proper application of BRM practices would have showed him that by sailing he was taking unnecessary chances and that there were risks of his losing full control of the vessel.

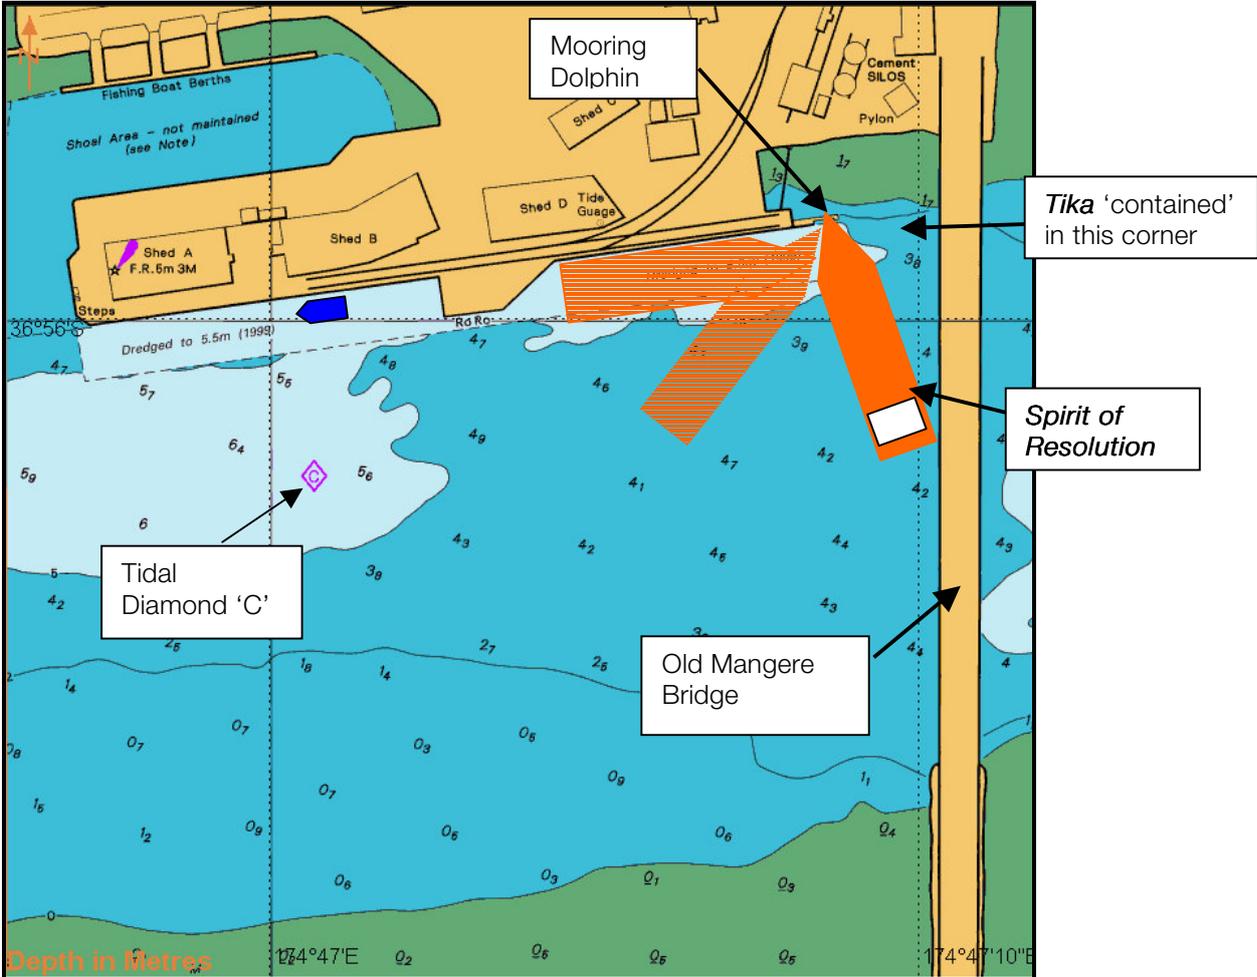
Figure 1
Approximate position of vessel when it contacted bridge

The charted tidal information for tidal diamond 'C' (See Figure 1) was as follows:

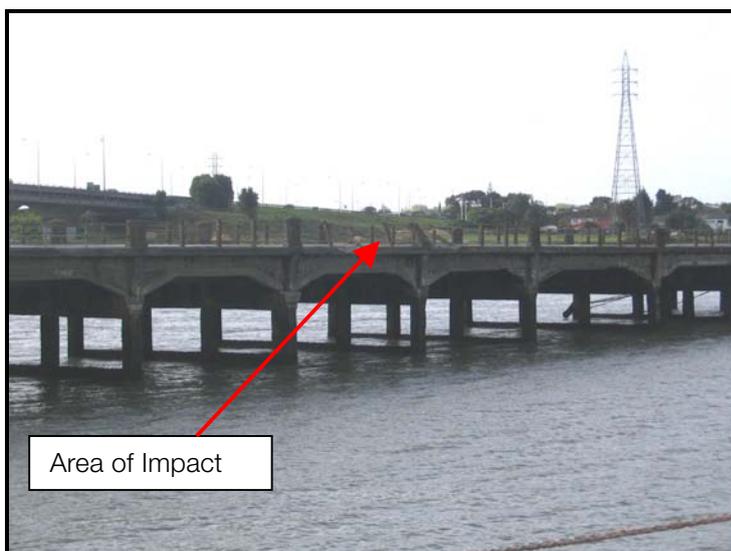
There is no fendering of any description on the Old Mangere Bridge. The bridge is constructed of reinforced concrete. The bridge is closed to vehicular traffic but is still used as a public footpath.

There was damage to the concrete capping of the bridge and to the handrail over a distance of about 20 metres.

Photograph 2
Old Mangere Bridge

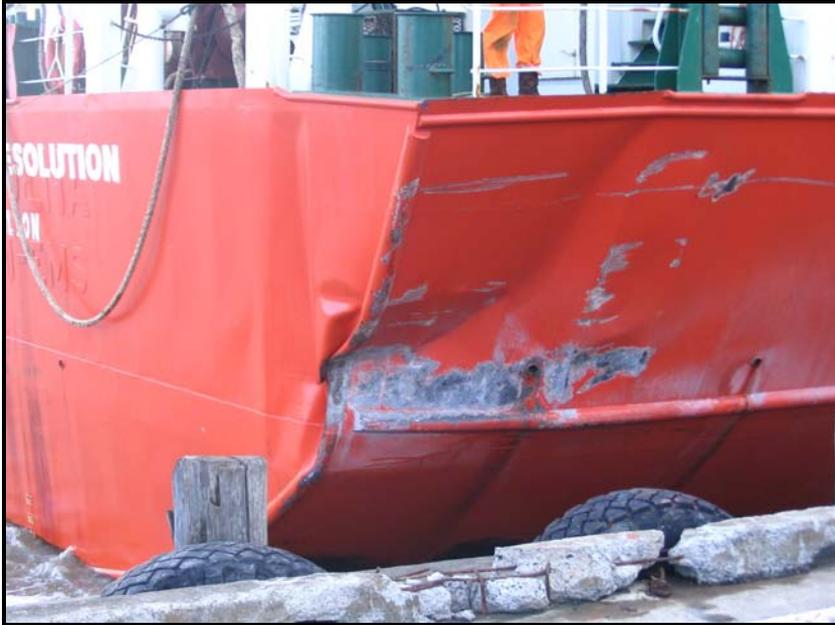
The damage to **Spirit of Resolution** included a small indentation to the bulbous bow and stove in shell plating with a small hole above the waterline on the vessel's starboard quarter.

Photograph 3
Damage to starboard quarter of *Spirit of Resolution*

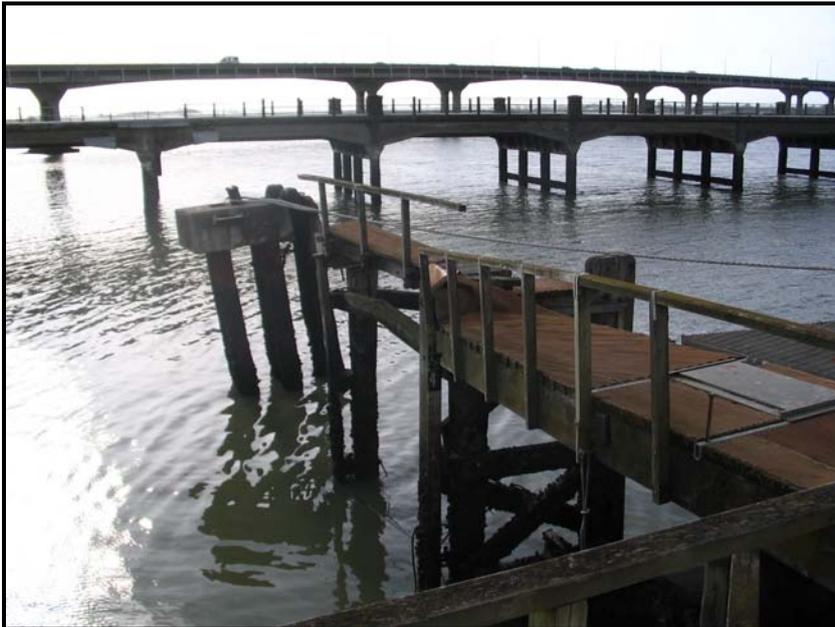
The mooring dolphin and supporting piles were damaged and the catwalk connecting the dolphin to the wharf was destroyed. The estimated cost of damage to the wharf and pilings is \$ 670 000.

Photograph 4
Damage to the mooring dolphin
