Accident Report
Tasman Independence
Cargo Gear Failure
Port of Bluff on 14 January 2004

REPORT NO.: 04 3557

Casualty Type: Cargo Gear Failure

Casualty Location: Port of Bluff

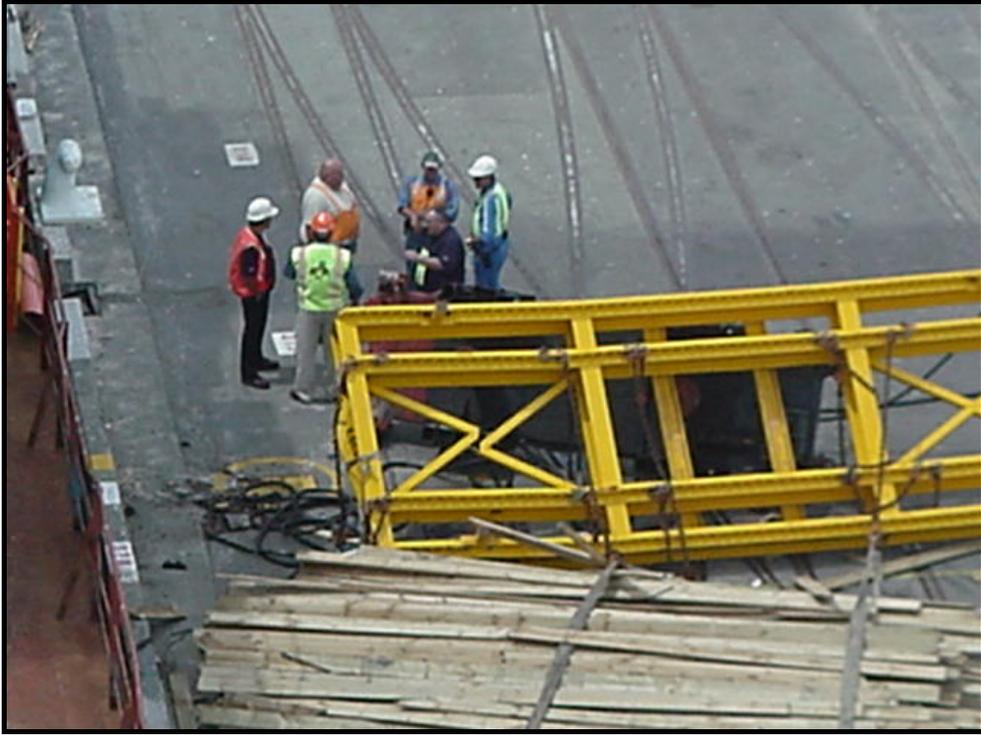
PHOTOGRAPH 1

- 1.7 At 1300 hours, the stevedores (who were now in control of the No. 2 after gantry crane) continued to prepare No. 5 hold for cargo. This included the need for a sling of dunnage to be lowered into the hold (*See Appendix 1 – Photograph No. 1*).

- 1.9 At approximately 1305 hours, during the first lift of the day with the No. 2 gantry crane, the MDF spreader and sling of dunnage, that was connected to the pulley frame of the crane, fell onto the quay. The resulting impact caused damage to the pulley frame and spreader as well as causing damage to the quay. All four hoist wires of the crane and the electric multi core wire, were severed (*See Appendix 1 – Photographs Nos 1 & 2*).

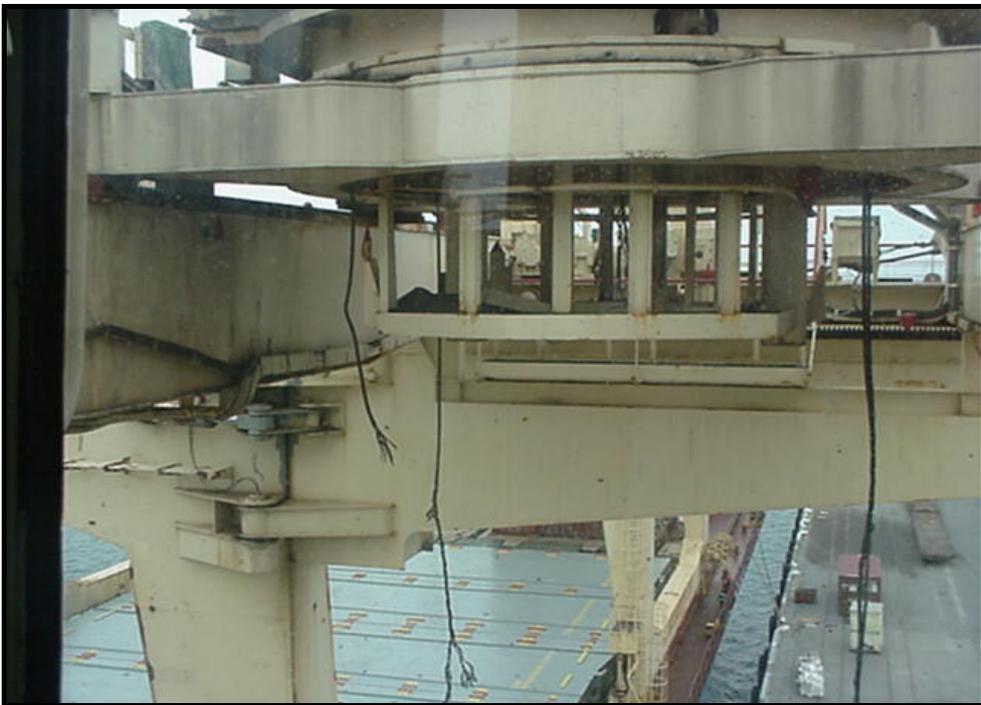
PHOTOGRAPH 2

- 2.2.10** The fact that the length of the wires hanging below the pulley frame after the accident was short (*See Appendix 1 – Photograph No.2 - Broken wires hanging down loose*), indicates that the pulley frame was up to or close to the turntable (upper housing) at the time the wires severed.

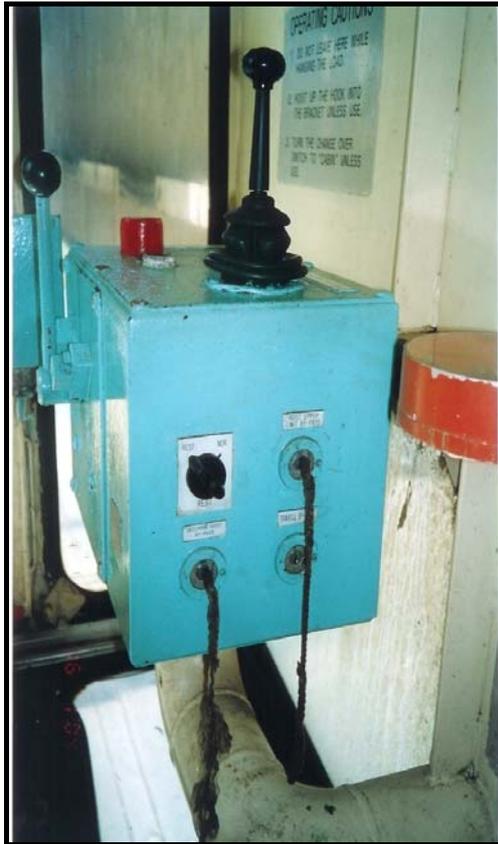
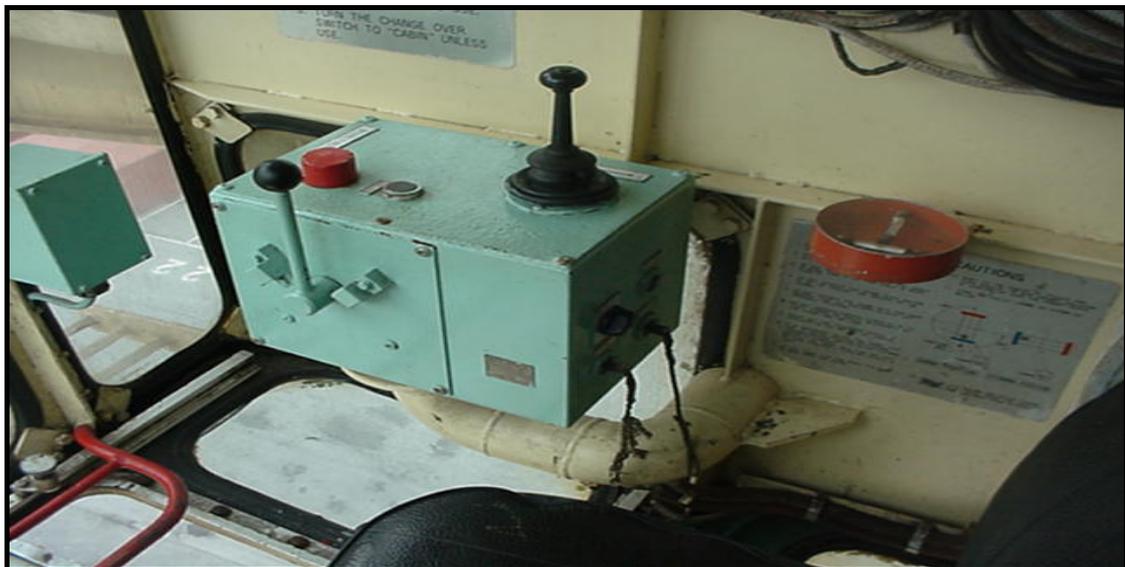
PHOTOGRAPH 3

- 2.2.5** Although statements from the witnesses contradict each other, it appears that the gantry crane was put in the hoist mode to lift the dunnage from the quay and that the pulley frame, with the spreaders and dunnage attached, was inadvertently hoisted hard up against the housing on the underside of the gantry frame turntable, (*See Appendix 1 – Photograph No. 5 - Damage to underside of Gantry turntable*). This, in turn, probably caused the hoist wires to sever and the pulley frame, spreader and dunnage to fall onto to the quay (*See Appendix 1 – Photograph No 6 – Equipment and dunnage, on quay*). For the above to have occurred the two limit switches for park and hoist respectively, would have had to be switched off i.e. switched from ‘safe cargo mode’, with the appropriate keys, to ‘housing/ stowing mode’ (*See Appendix 1 – Photograph No. 3*).

- 2.2.6** At the time of the accident, the limit switch keys had been left in place in the operating cab by the ship’s crew (*See Appendix 1 – Photograph Nos. 3 and 4 – showing keys in place*).

- 5.1 It is recommended that designated crews members only should hold the limit switch keys and that this should be formally documented in shipboard procedures. Limit switch keys should be removed by the said designated holders before cargo operations commence.
- 5.2 It is recommended that the operators of the vessel implement on board procedures to ensure the safe operation of gantry cranes by stevedores. This is to include the instruction that safety limits switches are correctly set prior to stevedore operations.
- 5.3 It is recommended that stevedoring companies implement formalised procedures to check that gantry cranes are in good working order before cargo operations commence; this is to include that safe working of limit settings.
- 5.4 It is noted that since the accident both the ship and stevedores have commenced implementing these new procedures.

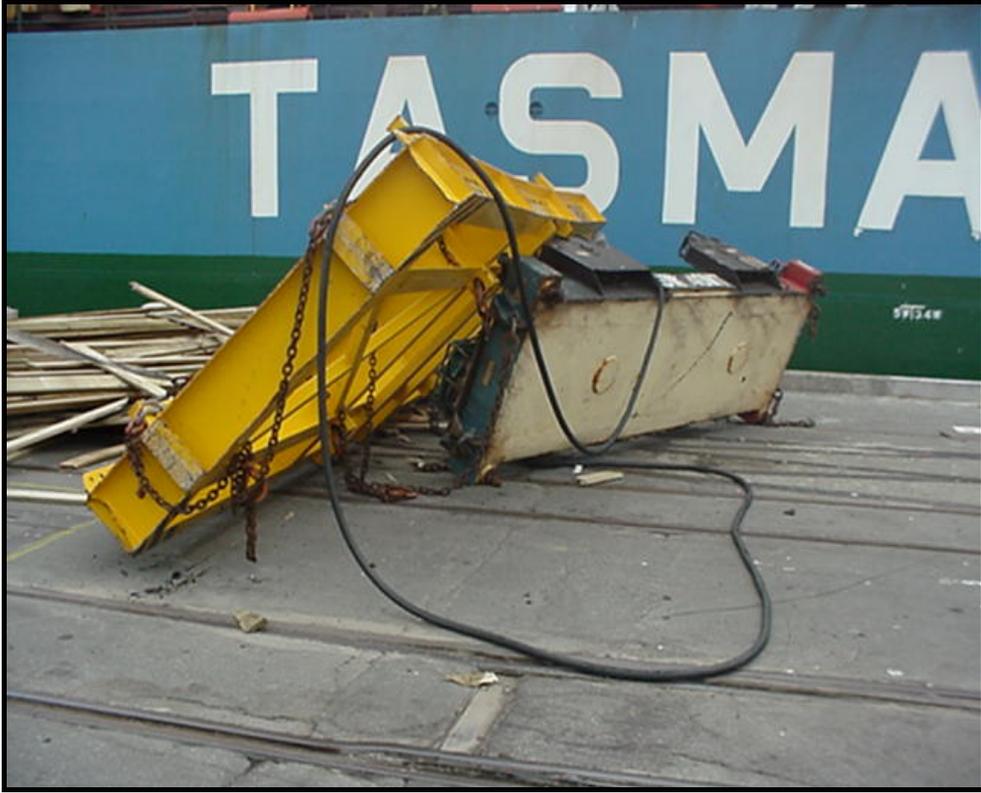
PHOTOGRAPH 6

- 1.8 A medium density (MDF) spreader (*See Appendix 1 – Photograph Nos. 1 and 6*) with a safe working load (SWL) of 28 tonnes, which belonged to S.S.S, was slung below the pulley frame of the No. 2 after gantry crane. A sling of dunnage was then attached to the spreader. This was the first lift of the day by the stevedores with No 2. gantry crane. The gantry turntable was positioned in the athwartship position, to facilitate the movement of the sling of dunnage between the legs of the gantry crane.

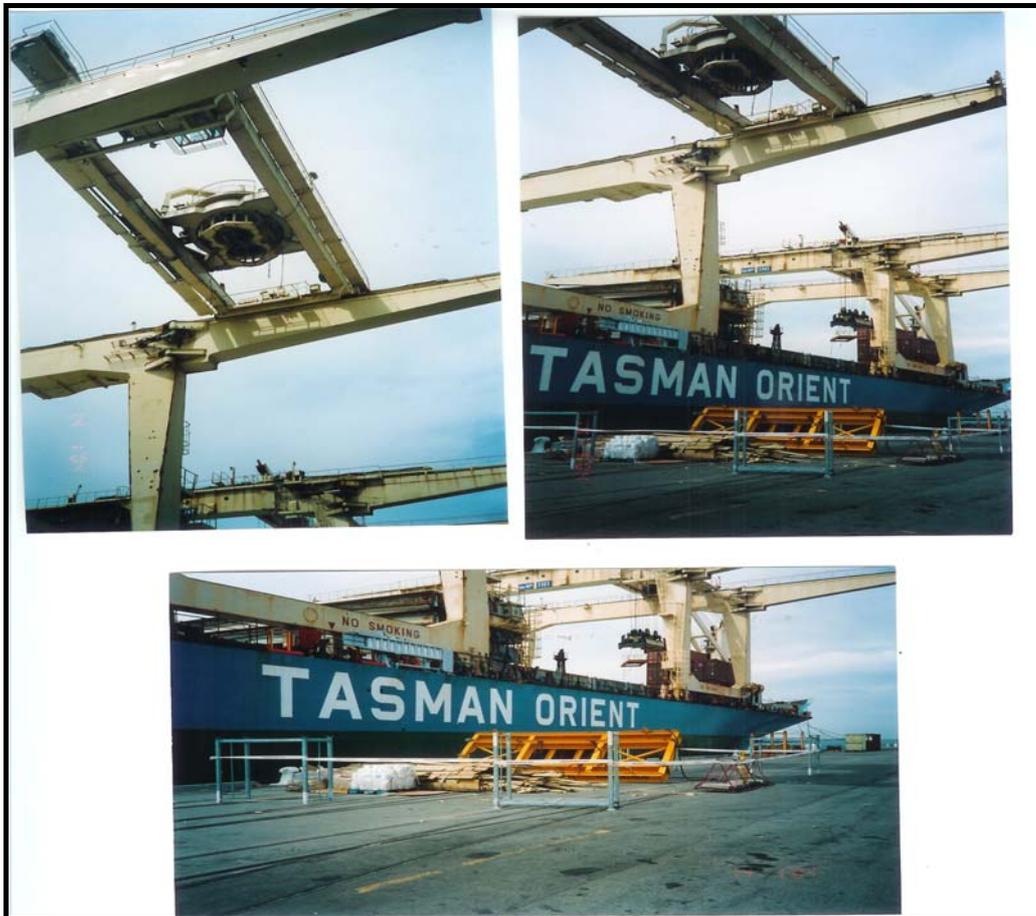
PHOTOGRAPH 7

- 1.5 When preparing the ship for cargo operations, the ship's crew lifted four hatch lids at No.5 hold. Two hatch lids were lifted by the forward gantry crane and the other two by the No. 2 after gantry crane. Each hatch lid weighed approximately 35 tonnes (*See Appendix 1 – Photographs Nos. 7 and 8*).

2.2 Gantry Crane Details – (See Appendix 1 – Photograph Nos. 7 & 8).
