# Accident Report

Failure of No. 2 Crane

*Tasman Mariner*

REPORT NO.: 05 3847

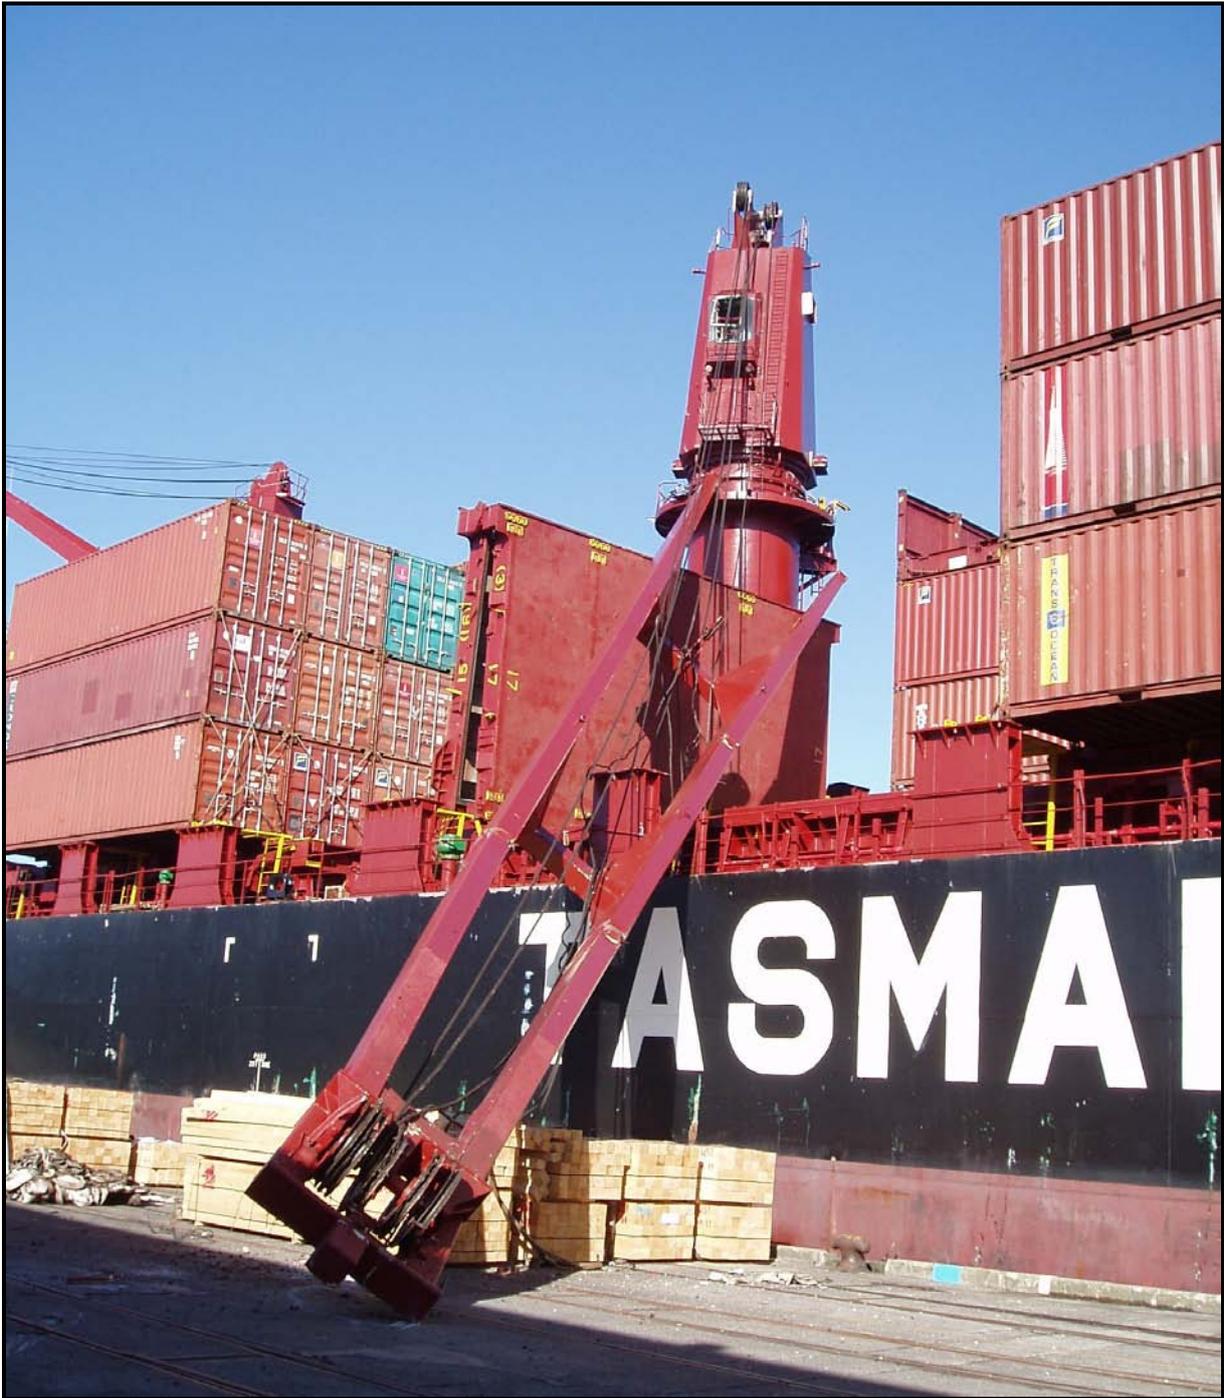
Cargo work stopped. The Ship's Master and officers and the Stevedore Supervisor assessed the situation. The jib of No. 2 crane had become detached from its gooseneck and was resting on the wharf and across the raised hatch-cover at the after end of No. 3 hold (See *Photograph 2*). Although its movement was restrained by the hoist wire, it was liable to settle and fall with movement of the ship, making it dangerous to approach. Low water was at 0219 hours and the tide was rising. The wharf near the crane was cordoned off with hazard tape and the stevedores asked the Port Company to notify ships to reduce speed while passing No. 6 berth (See *Photograph 3*).

**Photograph 2**  
No. 2 crane resting on the wharf and the No. 3 hatch cover

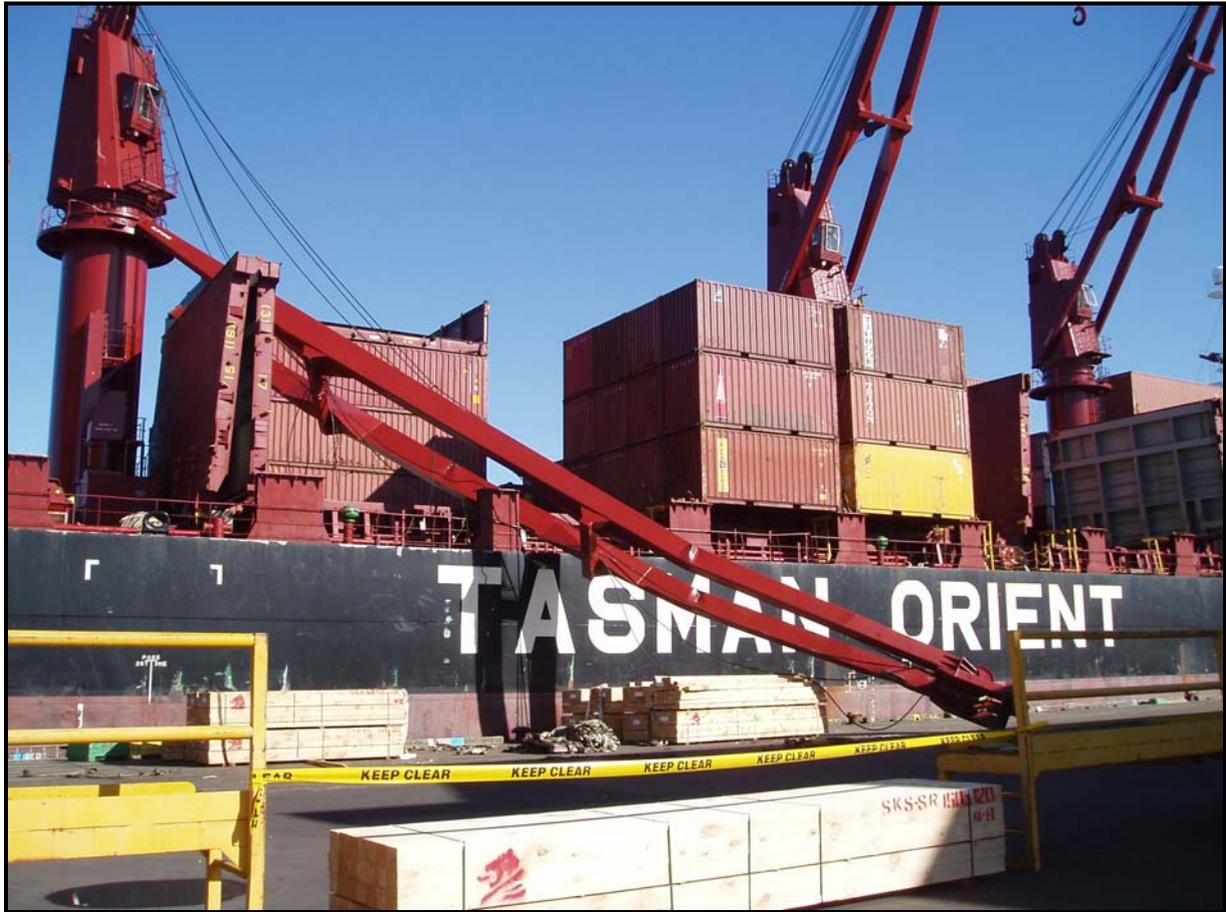
**Photograph 3**

No. 2 crane showing area cordoned off with hazard tape.

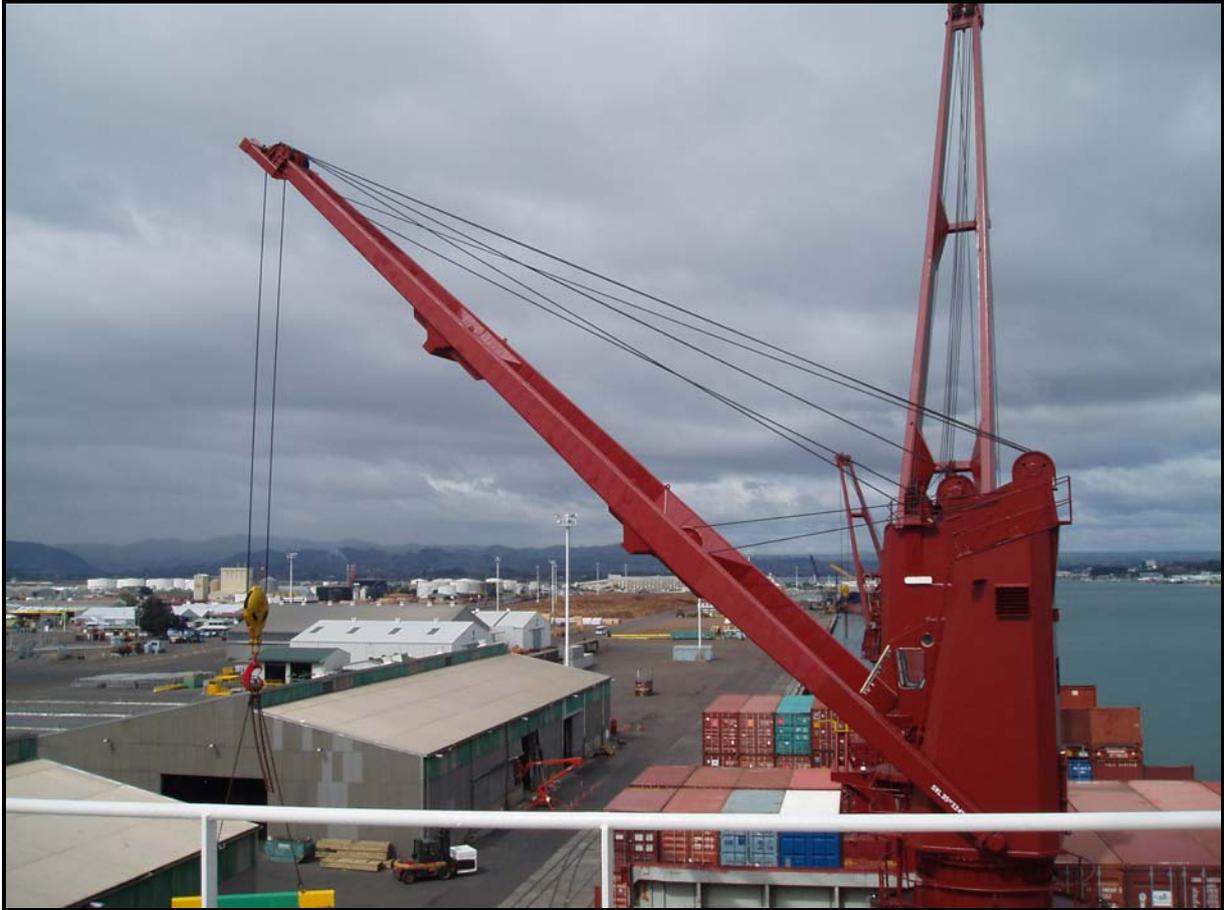
**Photograph 4**  
No. 4 Crane (SWL 35 tonnes)

The rigging shown in *Photograph 4* is the same as for No. 2 crane. The topping lift wire rope was attached to the head of the crane, from where it was rove through the sheave fitted approximately four tenths of the length of the jib from its base. The wire rope then led back to a sheave at the crane head and from there to a sheave in the head of the jib. From the jib, it was led to another sheave at the crane head, then down through a guide to the topping winch.

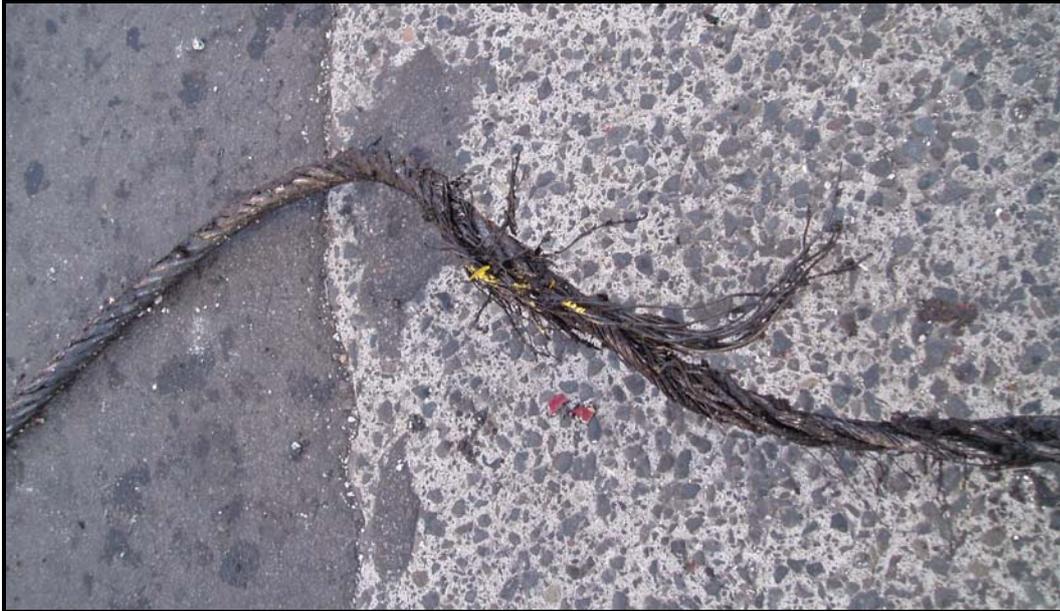
**Photograph 5**  
The broken topping lift wire from the No. 2 crane

1. The accident was the result of No 2 crane topping lift wire rope parting. Since:

- The cable failed due to severe abrasive wear predominantly of the crown wires of the outer strands. However, considerable wear also occurred in wires below the surface in the outer strands and on inner (core) strand wires.
- The cause of the wear was not determined. However, it is very likely to be associated with rotation of the cable relative to one or more contacting component(s).
- The material of manufacture was unlikely to have contributed to the failure.
- Fatigue was not observed to have been a significant factor in the failure.

1. It is recommended that the China Navigation Company Ltd urgently reviews its ISM procedures for the inspection and replacement of wire ropes to take account of these findings. It is requested that the Company advises Maritime New Zealand in writing of any steps taken to prevent a recurrence of this type of accident within two months of the final report being published.
2. It is also recommended that copies of this report be sent to all New Zealand stevedoring companies and to Mitsubishi Heavy Industries Ltd.

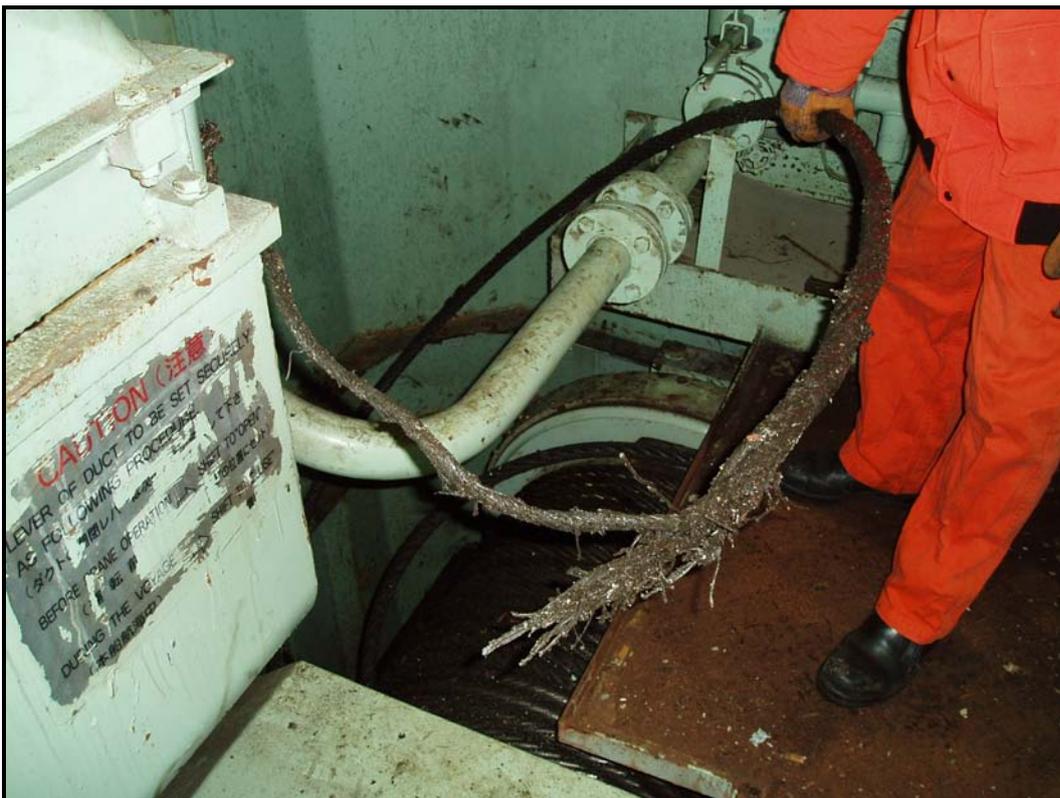
**Photograph 6**  
Inside the No. 2 crane, showing the broken topping lift wire.
