Accident Report

Fatality

Tasman Resolution

11 January 2007

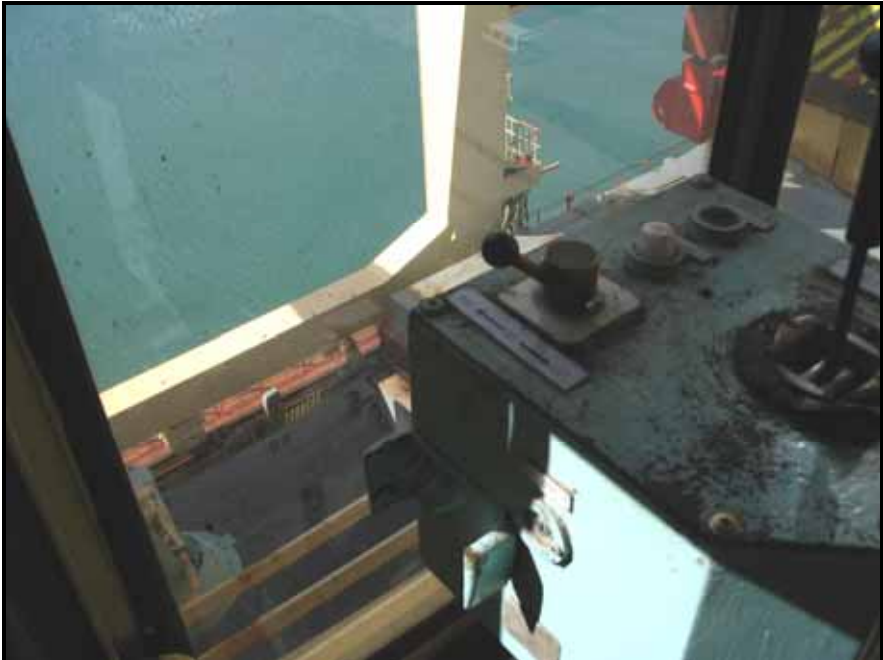
Photograph 4
View from cab of Number 1 gantry looking to port.

Two gantry cranes straddle the hatches and run on rails set on the main deck, each side of the vessel. Each gantry crane has a Safe Working Load (SWL) of 40 tonnes and is controlled from a cab located in the centre of the traveller. The cab of Number 1 gantry crane (*See Photograph 4*) is located at the forward end of the gantry and faces aft. It is in a fixed position longitudinally, but moves athwartships, across the vessel, in conjunction with the crane hook. The drivers' position in the cab is approximately 14m above the main deck.

The crane driver's visibility is restricted from the driver's position within the cab. The crane driver therefore relies on either radio contact or hand signals from a man on deck when he is operating the crane. The cab has glass windows, one of which was open at the time of the accident.

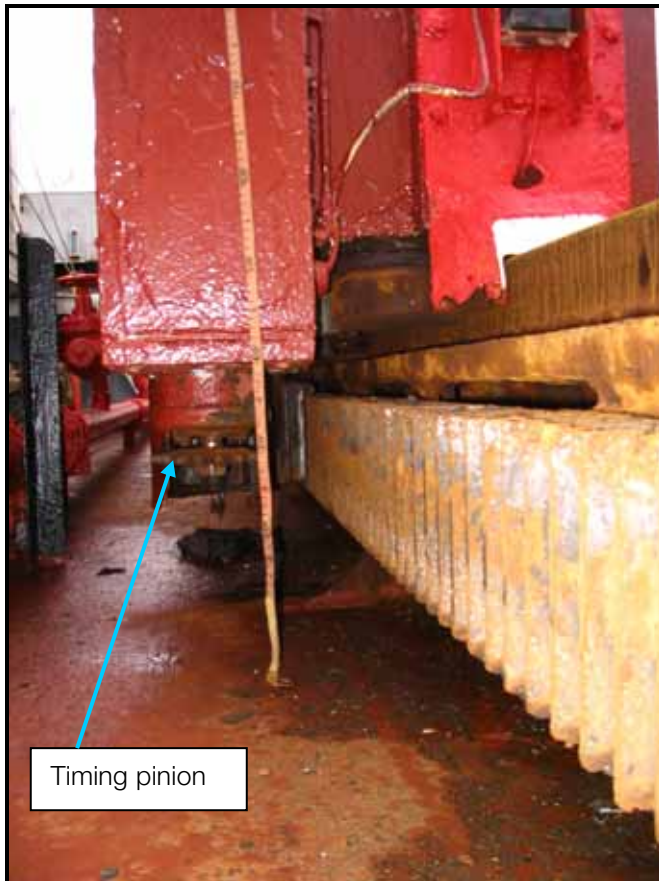
Photograph 5
Unguarded pinion viewed from aft

At the after end of Number 1 gantry crane on the starboard side, there is a timing mechanism (*See Photograph 5*). At the time of the accident, this mechanism was incomplete. It consisted of a pinion which did not mesh with any other and which rotated when the crane moved. It was located 280mm above the deck and was only guarded on the forward side such that the after side was left unguarded (*See Photograph 5*).

It is probable that at some stage, damage had occurred to the timing mechanism and that a temporary repair had been effected. This damage would likely have been inflicted by a lashing bar that had incorrectly been stowed in a bin inboard of the gantry track.

Subsequent to the accident, and before the vessel returned to New Zealand, the mechanism was repaired and a guard was fitted which covered the after end of the mechanism.

The timing mechanism now consists of three pinions as designed. When questioned, the ship's senior officers denied all knowledge of any repairs having been carried out and attributed them to the Chief Engineer who had recently paid off.

4. Install guards around the pinion gearing on both vessels.
5. Formalise procedures for ensuring crew keep clear of gantry cranes when moving pontoon covers.

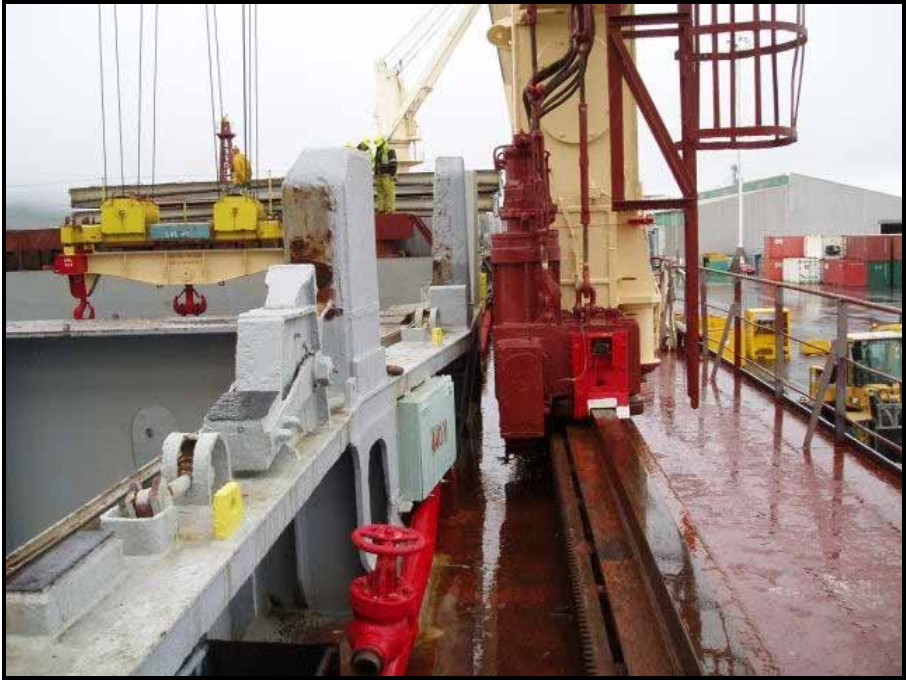
The two gantry cranes travel close to the hatch coamings. In places, there are additional obstructions such as electrical boxes, fire hydrants, hose boxes and lashing gear bins that protrude from the side of the hatch coaming, thus further reducing the distance between the hatch coaming and the inboard side of the gantry cranes. On numbers 3 and 5 hatches, the hatch coaming protrudes outwards, due to the location of a king beam in the centre of the hatch (*See Photographs 6, 7 & 10 and Figures 1 & 2*). In this position, the distance between the hatch coaming and the machinery at the after end of Number 1 gantry crane, measures approximately 150mm compared to the average distance of approximately 500mm away from the king beam protrusion.

Photograph 6
View of number 5 hatch coaming from aft showing the gantry crane adjacent to the restricted space in way of the king beam
