Accident Report

Tasnui

Person Overboard, 70 kilometres
South of Stewart Island on
24 January 2004

REPORT NO.: 04 3365

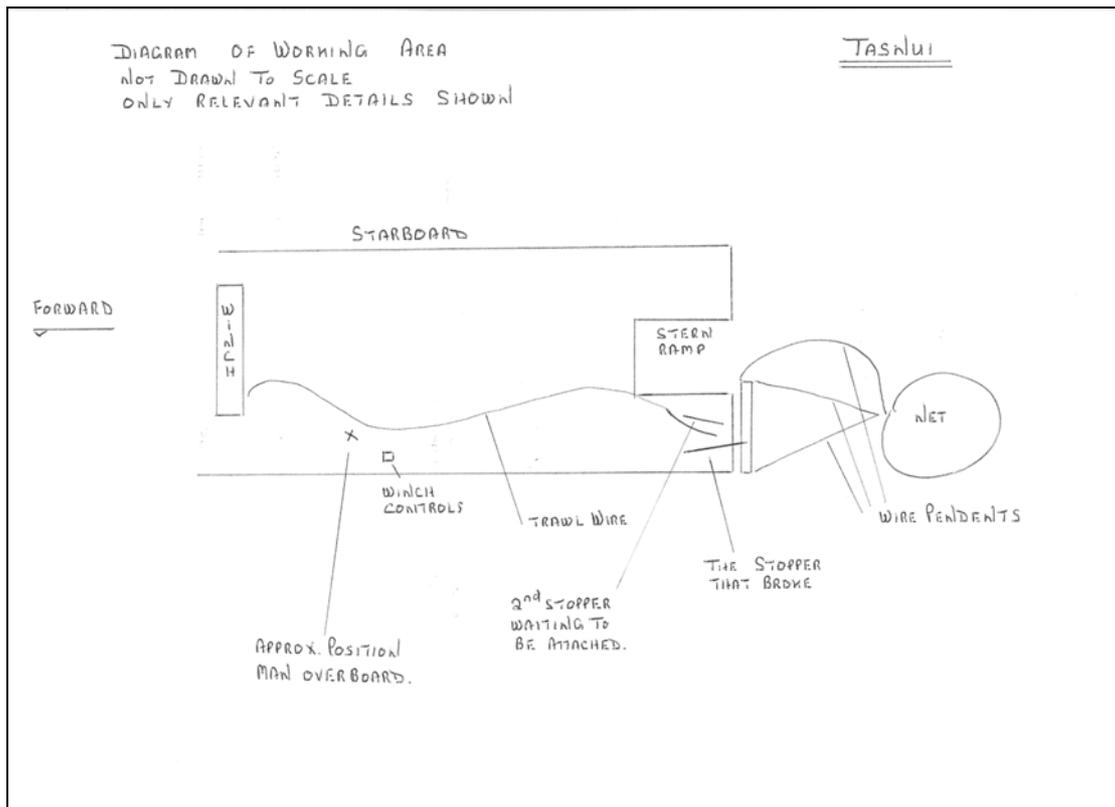
- 1.2 The Master was on the bridge in command of the trawler.
- 1.3 The deceased was working in the midship area of the trawler. He was making his way over to the port side to commence operating the winch controls (See Appendix I).

Diagram 1 – Working Area (not to scale)
 See also photograph of the working deck to appreciate how cluttered the working area is

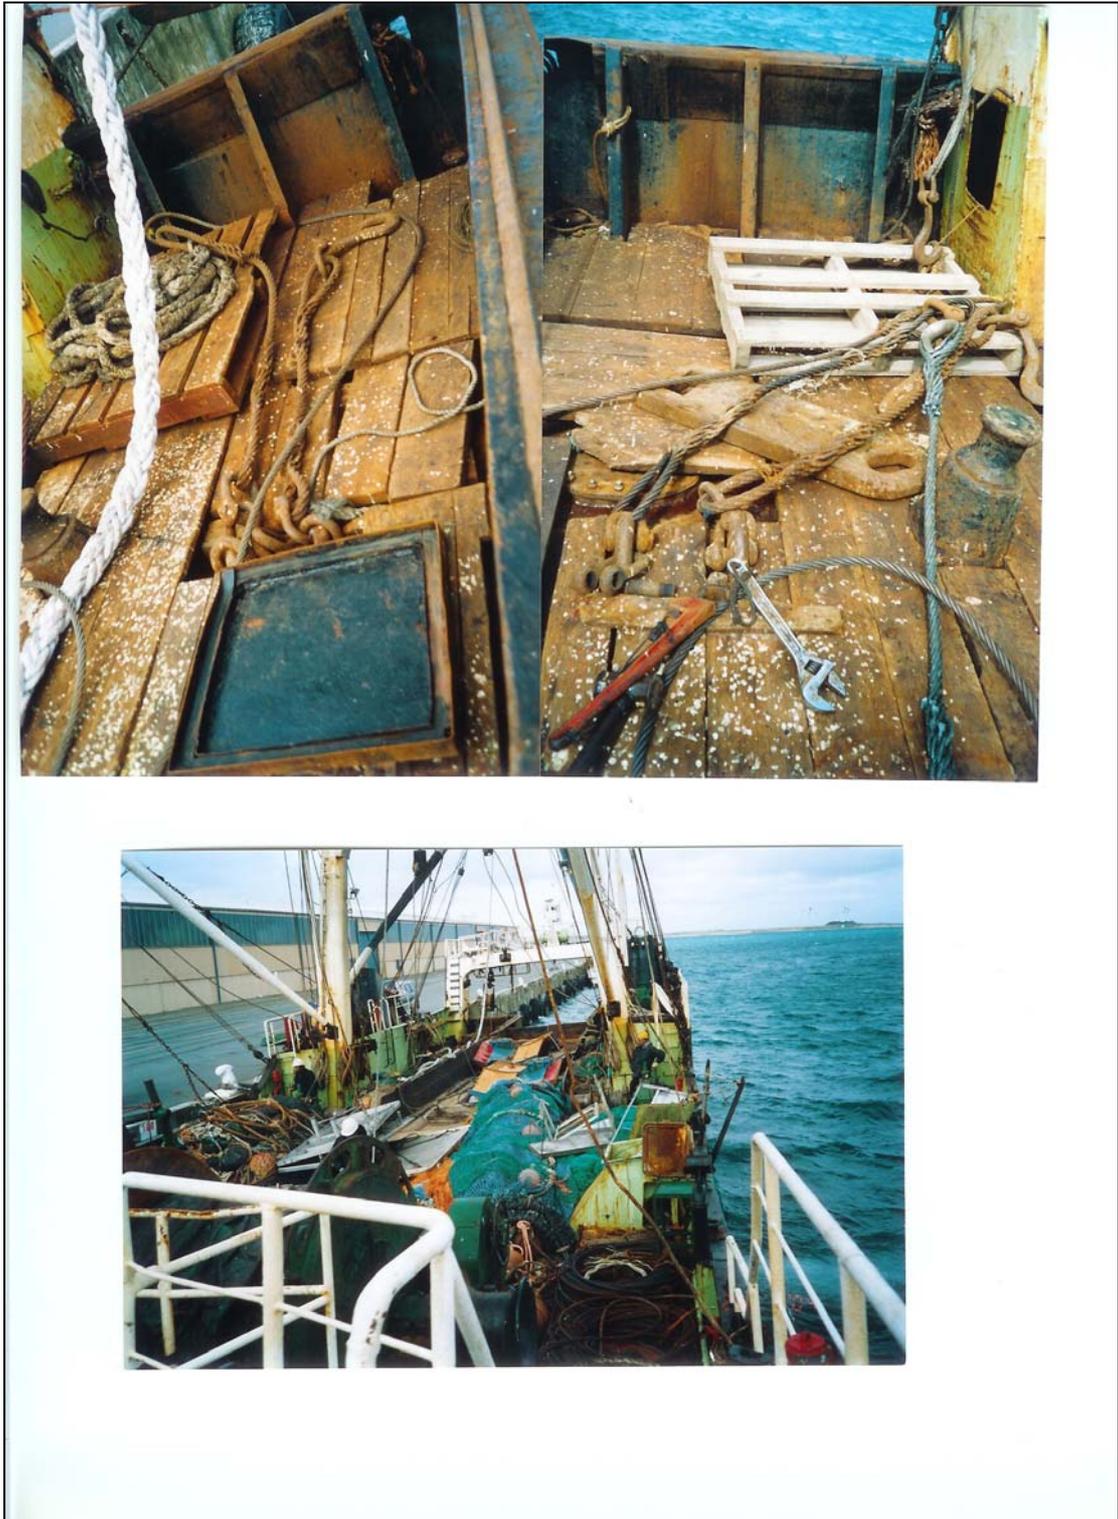
Top Left – After deck starboard quarter, starboard stopper wires lying on deck

Top Right – After deck port quarter new wire on deck with thimble.

Lower Photo – Main working area with various equipment lying everywhere

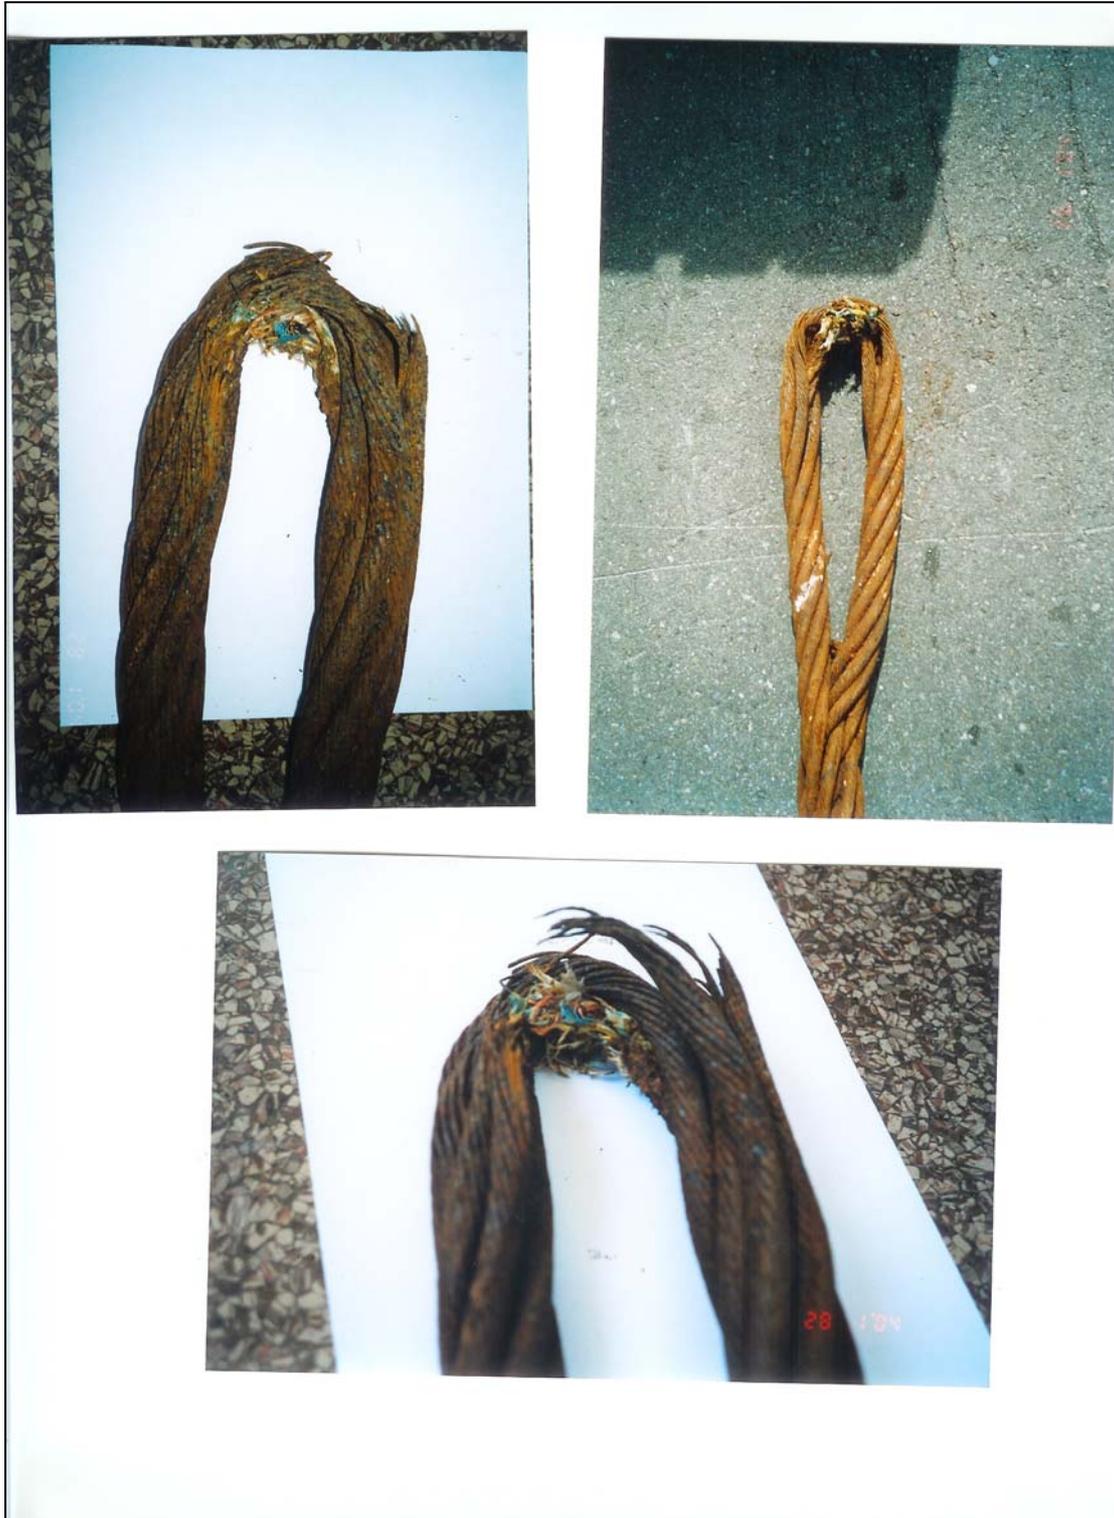
- 1.5 At approximately 1745 hours, as the deceased stepped over the trawl wire, the stopper holding the trawl door gave way and the door fell back into the sea. This resulted in the weight coming back onto the trawl wire quickly (See Appendix 2 – Broken wire). The wire tightened and returned to its normal working height above the deck. This sudden change in the wire's position, resulted in flipping the deceased over the side of the trawler.

2.4.2 It was the opinion of the Master that because of the pitching of the vessel, extra weight was put on the stopper wire with the result that it broke.

- 3.6 The poor condition of the stopper wire that parted.
- 3.7 The failure to establish and implement procedures to ensure that all wires on the vessel were inspected regularly; were maintained properly and changed at appropriate intervals as soon as any sign of wear and/or tear became evident.

- 4.1 The accident was caused by the poor condition of the stopper wire and the lack of a rescue boat.

Broken Wire

- a) *Tasnui* and other vessels operated by Sea Jho Cho Ltd, be equipped with a suitable rescue boat with appropriate equipment to include survival suits and lifejackets.
- b) The crew wear suitable P.F.D's when working on deck.
- c) The vessels SSM Manual to be translated into Korean.
- d) That the wires used for stoppers are suitable for the job, have appropriate certificates and that thimbles are used in the eye.
- e) Procedures are to be put in place for regular changing of the wire stoppers and structured maintenance programs are drawn up for this.
- f) Safe working procedures are put in place for fishing operations.
- g) Man over board and search and rescue drills are implemented and documented.
