Investigation Report  
Grounding of *Te Ika*  
17 June 2010

**Maritime New Zealand**

## Executive summary

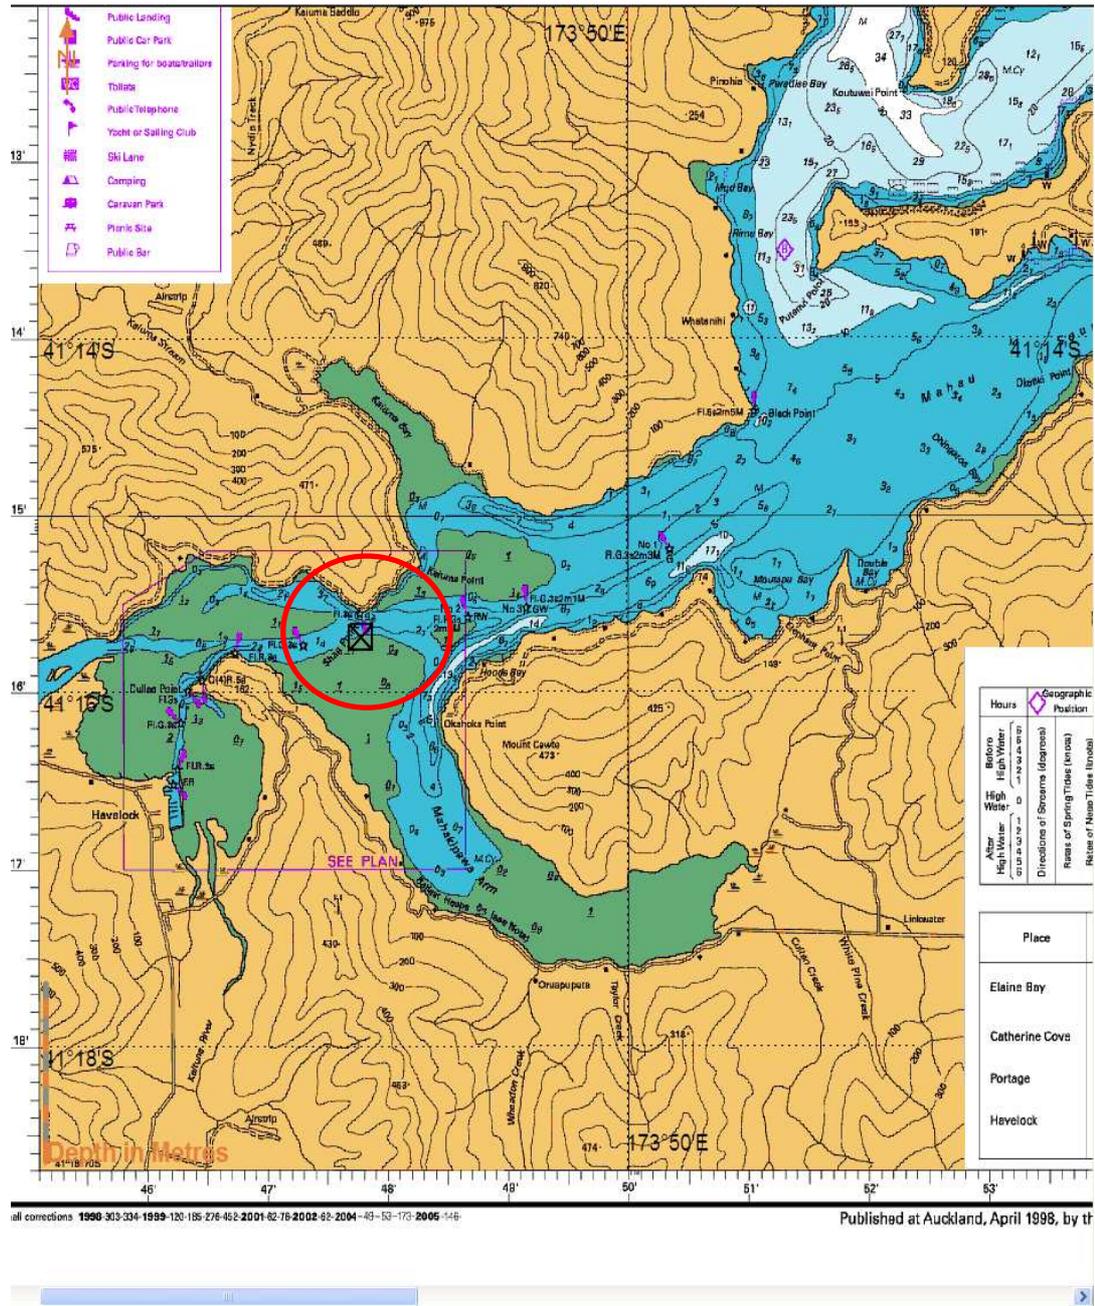
Figure 2 Havelock approaches (grounding position marked with boxed X)

14. The vessel's outboard started to take the ground so the skipper reduced revolutions down to neutral as the hull slowly grounded. The vessel slowly listed over and came to rest on a mud bank south of Shag Point. Low water was predicted by the New Zealand Nautical Almanac for 0647 hours which was approximately the time of the grounding.

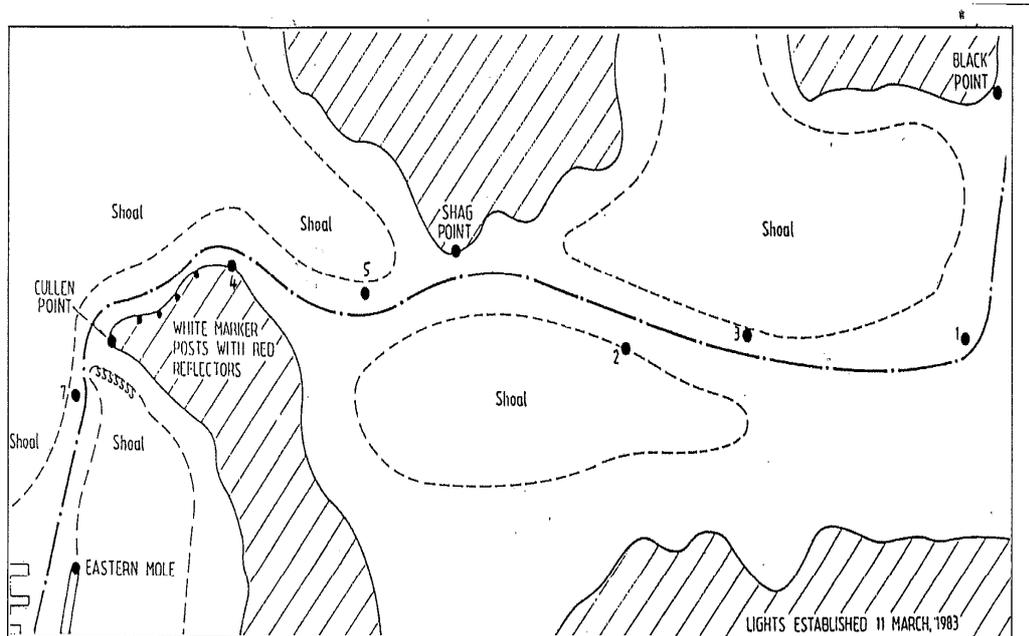
**Figure 5** Chartlet of Havelock approaches

13. The skipper cleared beacon number 5 and headed broadly towards beacon number 2. He said he could see the light of the next beacon through the fog (see figure 5).

2. Do not attempt to head DIRECTLY from No. 2 Beacon to No. 5 Beacon, and to be safe your vessel should be within 50 metres adjacent to Shag Point before approaching No. 5 Beacon.

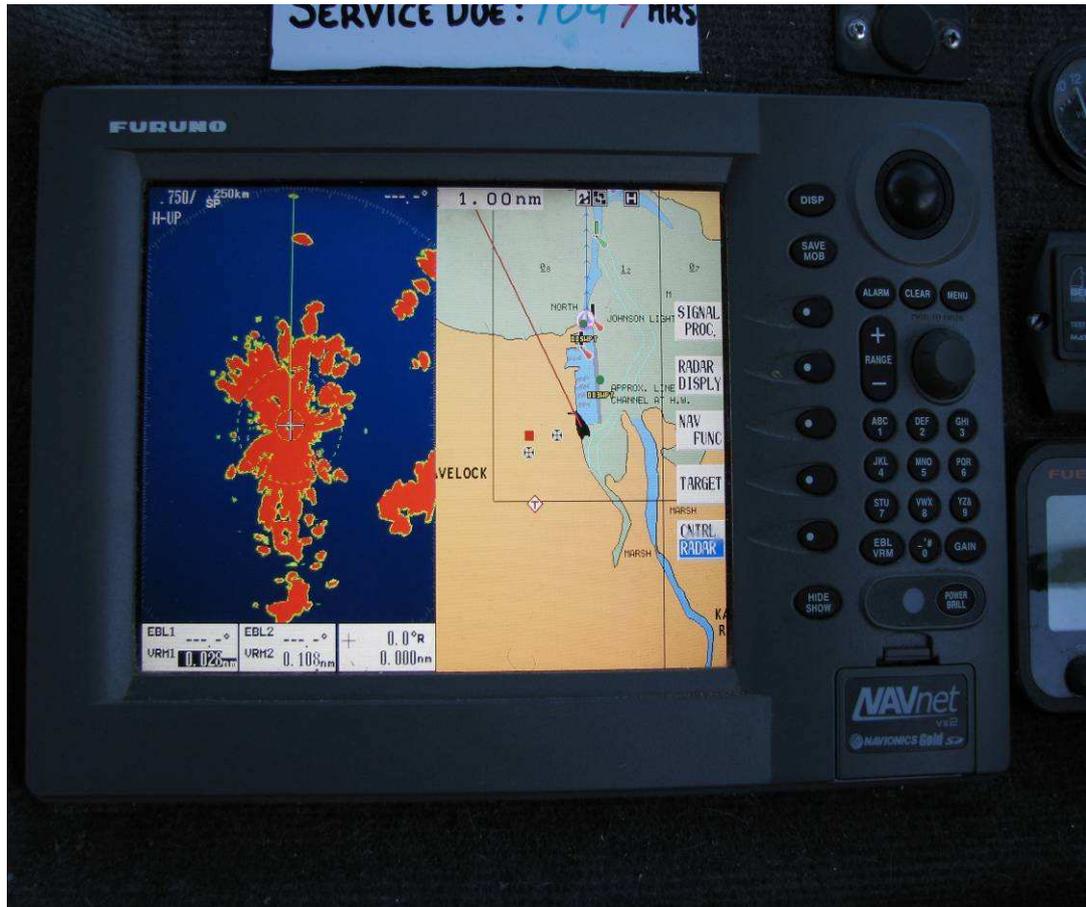
Figure 6 Furuno Navnet in split screen mode

52. The chart-plotting function uses Navtronics Gold© charting software. This receives a GPS signal from the internal receiver which is in-turn displayed in real time on a navigational chart of the area. The skipper confirmed that he thought the position as displayed on the chart was 20 to 30 metres off. He had become aware of this over a period of time although had not made it known to the Seafarms Manager until after the grounding.

59. The RADAR that **Te Ika** is fitted with has an auto tune function. This allows the unit to automatically tune to ensure that a clear picture is presented at all times. The skipper had this function activated at the time of grounding and was not sure how to change this or how to manually tune the RADAR. Operators need to know how to manually tune the RADAR particularly when there is a change in operating conditions such as rain, sea state or visibility. This helps to ensure that the unit is being used at its maximum potential and helps to give the operator confidence that the display is true.
60. The skipper said the following regarding manual tuning during his first interview:
- "...but if I'd had in hindsight if I had been using it on the manual setting and I might have been able to pick up that drying ..."*
