Accident Report
The Gem
Grounding and Foundering at
Taieri Island, Otago on
20 July 2005
Class A

REPORT NO.: 05 3797

VESSEL NAME: THE GEM

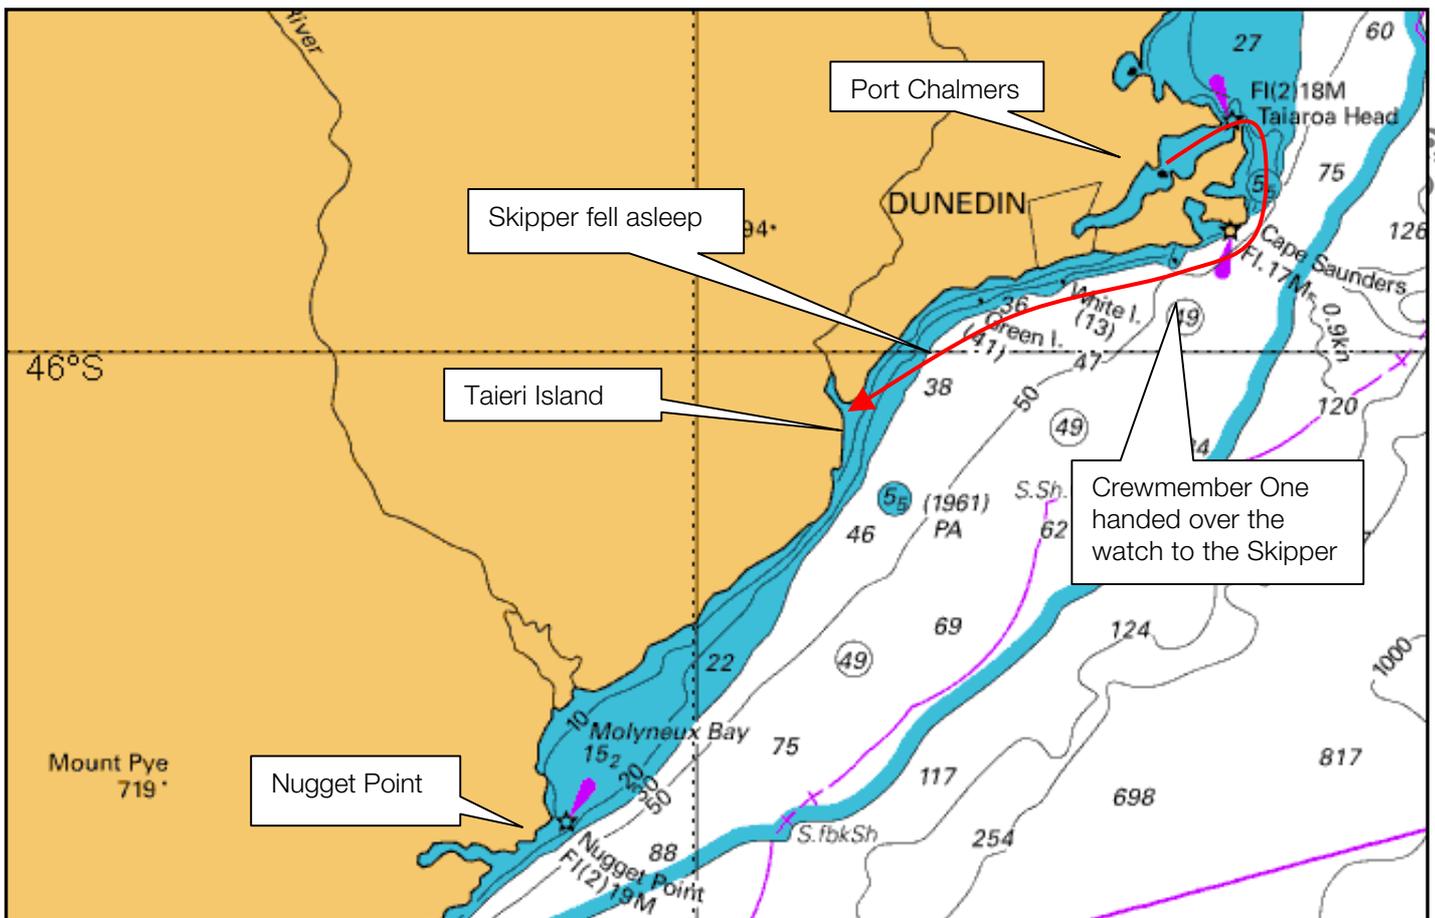
At 0400 hours, they sailed from Port Chalmers (See Figure 1 - Chart 1). The Skipper took *The Gem* out of the harbour. Once they were clear of the entrance to the harbour at Tairaroa Head, the Skipper handed the watch to Crewman A. The Skipper instructed him to wake him once they were south of Toe Rock. The Skipper then went below to try and sleep for an hour. He stated that he thought he may have got about 15 minutes sleep.

The Skipper remembered seeing Taieri Island three miles ahead on the radar (See Figure 1 - Chart 1). The radar was on the six-mile range scale. The next thing he woke up as he heard and felt the vessel ground. He looked at the GPS to check their position and saw that they had grounded on Taieri Island (See Photograph 1).

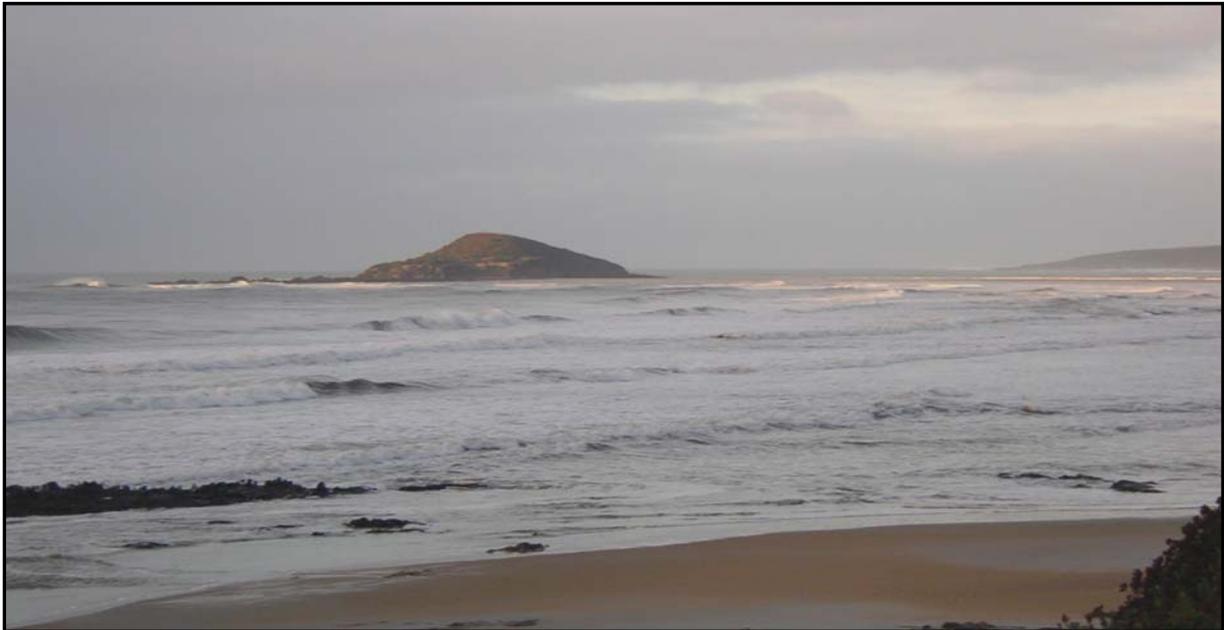
Photograph 1 - Taieri Island. The vessel grounded at the far side of the island

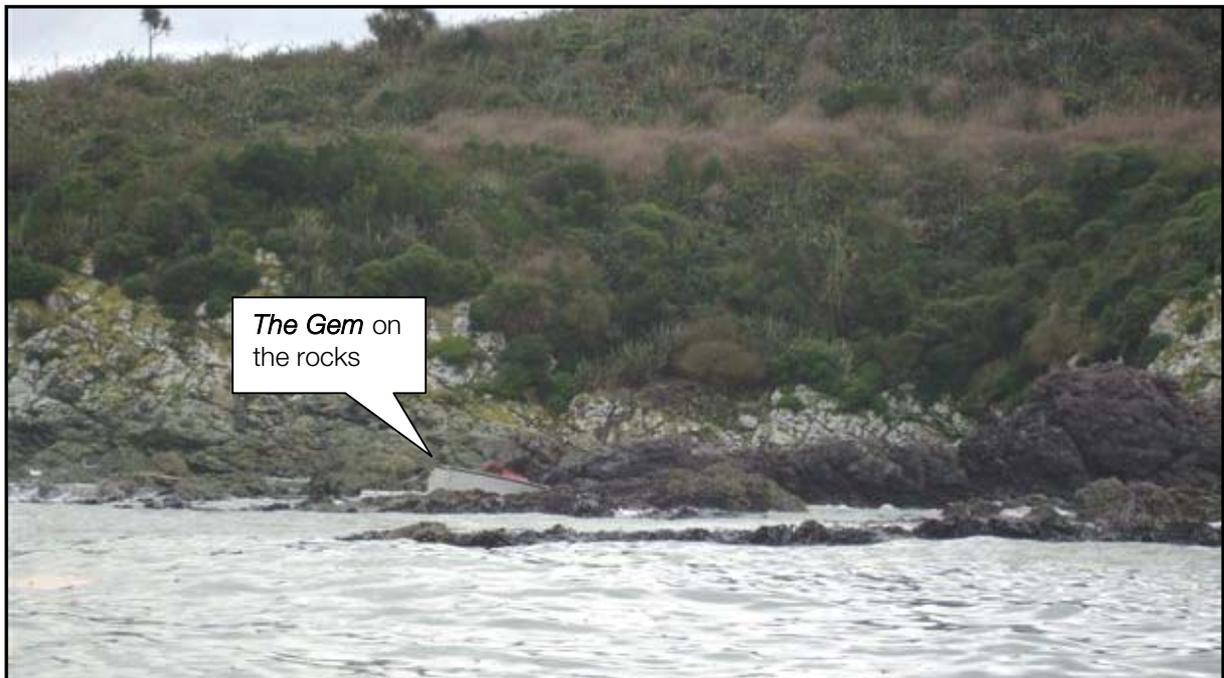
During this time the vessel was taking a pounding from the swell which was lifting it further up onto the rocks (See Photographs 2, 3 & 4). About 30 minutes after the grounding, cracks started appearing in the hull. The crew tried to stem the flow but they could not stop the flooding.

Photograph 4 - The rocks that *The Gem* grounded on. Part of the vessel can still be seen.
