# Accident Report

Capsize

*Time to Burn*

31 August 2008

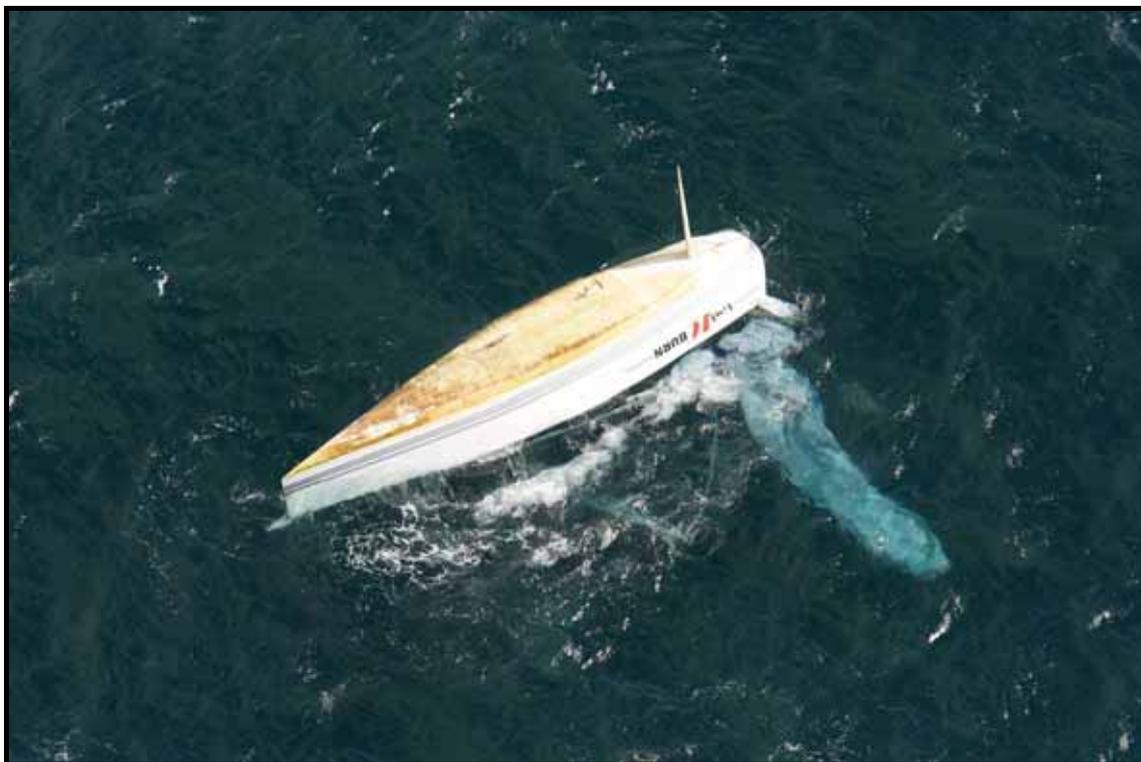
Photograph 2

*Time to Burn* in a state of capsize after the keel became detached from the vessel's hull.

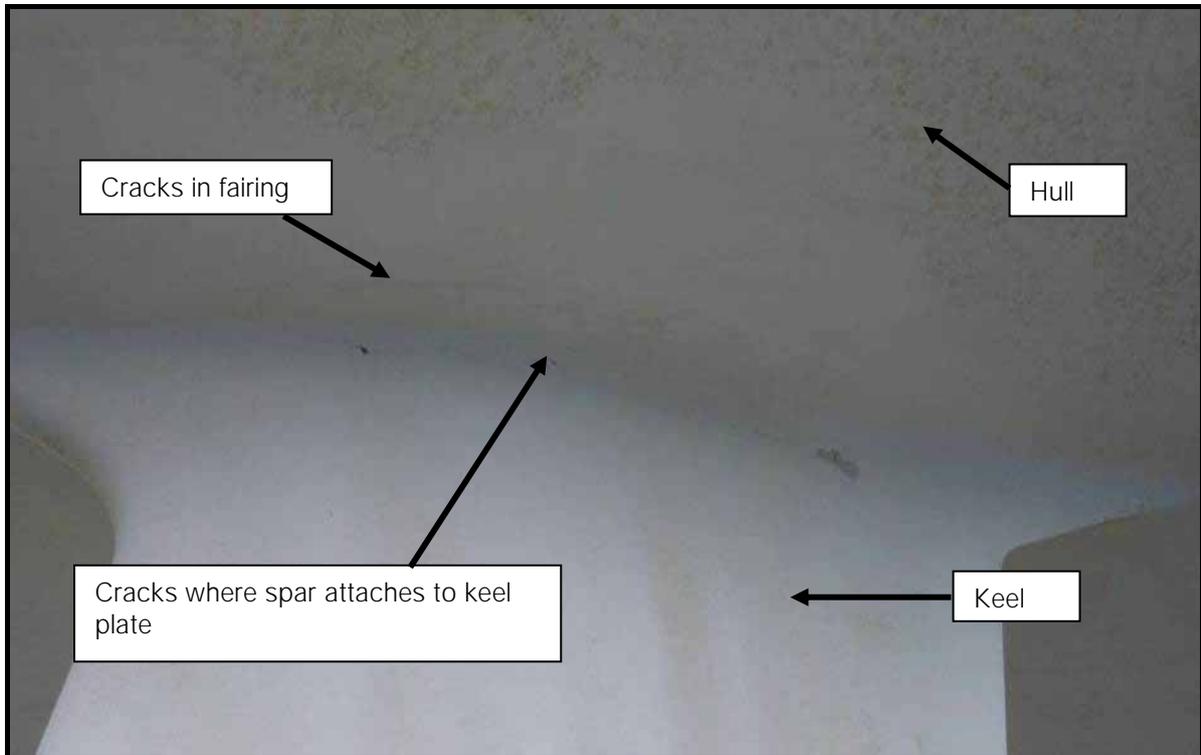
**Photograph 4**  
(Courtesy of Hunter Marine Surveying Ltd) *Time to Burn's* keel showing cracks in the outer fairing after the impact from the whale.

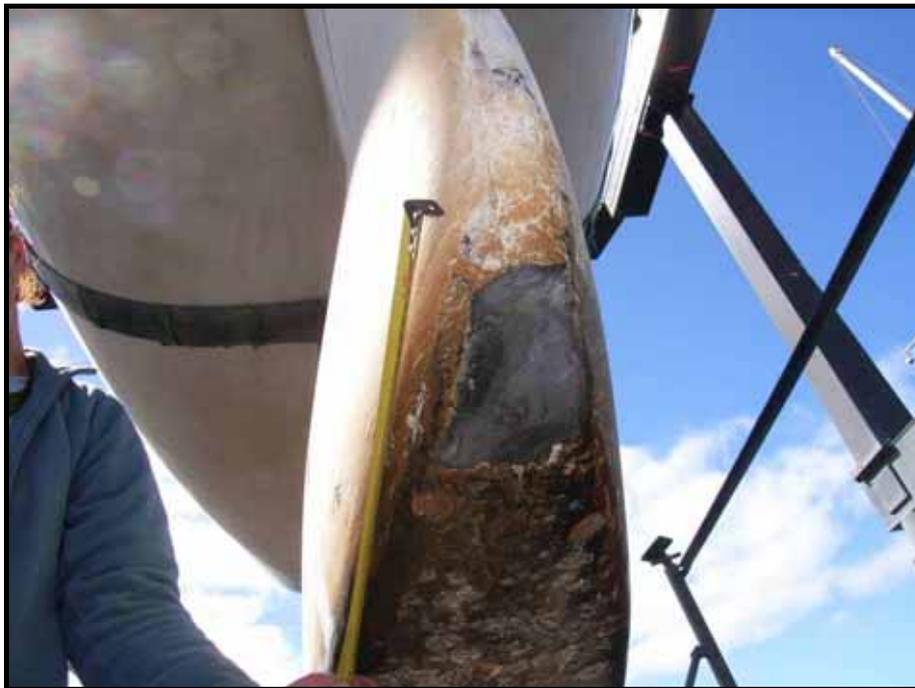
3.18 On this occasion Stevensons again replaced the rudder and repaired the damage to the keel's fairing on the Z keel. (See photograph 5 of damage to the keel.) The fairing was not removed to examine the main structural components of the keel.

**Photograph 5**  
(Courtesy of Hunter Marine Surveying Ltd) Damage to the lower keel.

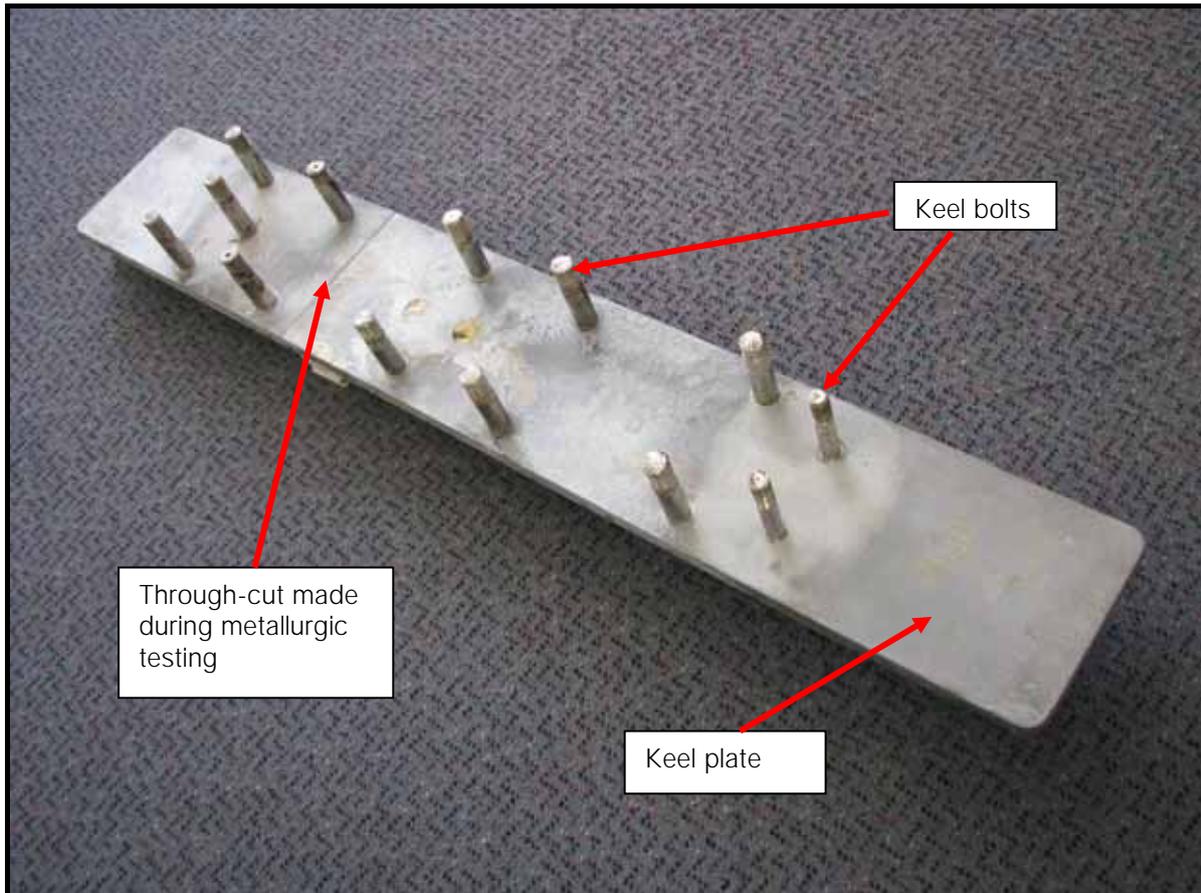
**Photograph 6**  
Upper-section of keel plate.

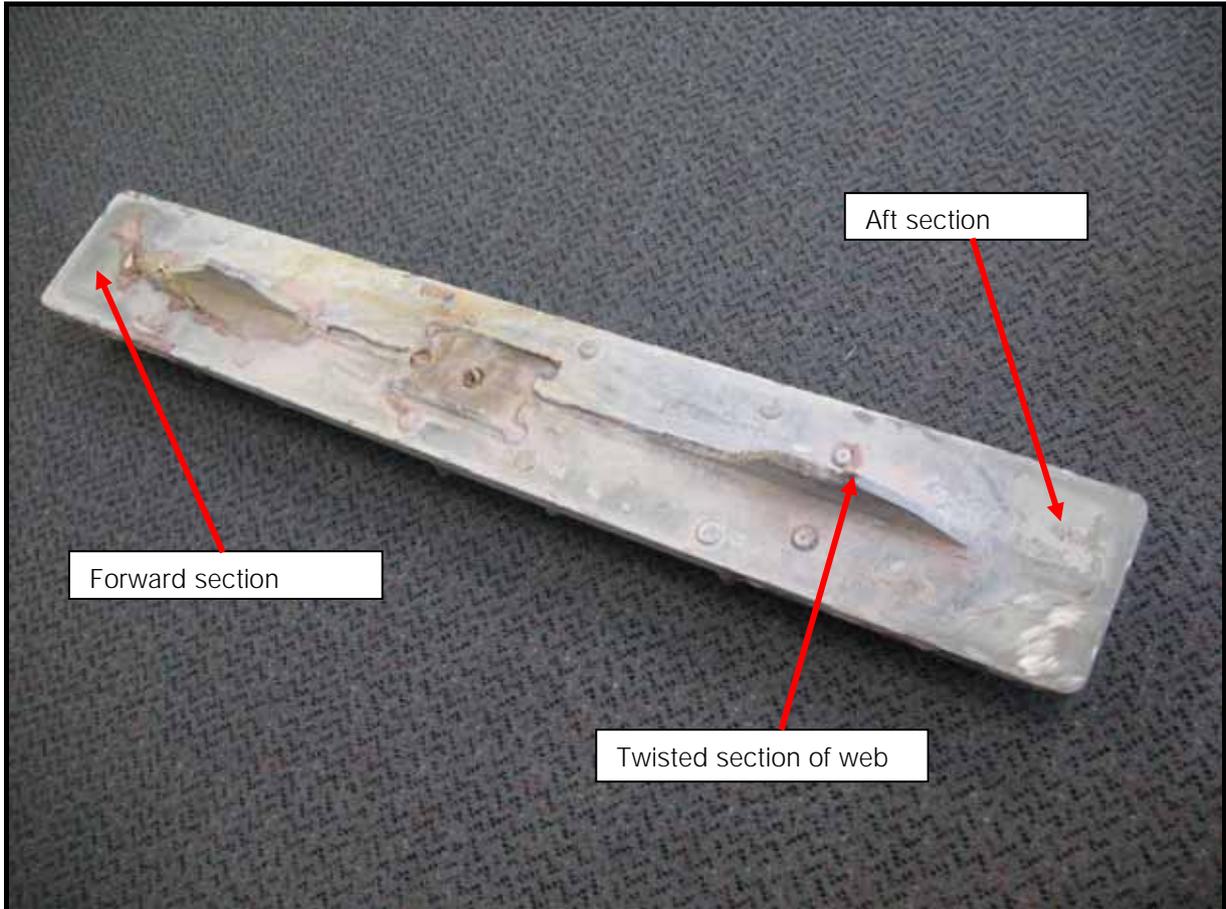
**Photograph 7**  
Under-section of keel plate.

- 3.46 The remaining section of web on the keel plate has been twisted. (See photograph 7.) This indicates it may have been the last section to fail. The reduction in speed described by the survivor may well have been caused by the failure of the forward section of weld, allowing the keel to twist sideways (most likely to port, as indicated by the angle of twist in the remaining aft section of web). This would have caused the vessel to slow down as described until the aft section tore through under the pressure. Once this occurred, the stability of *Time to Burn* was compromised and resulted in its eventual capsizing.

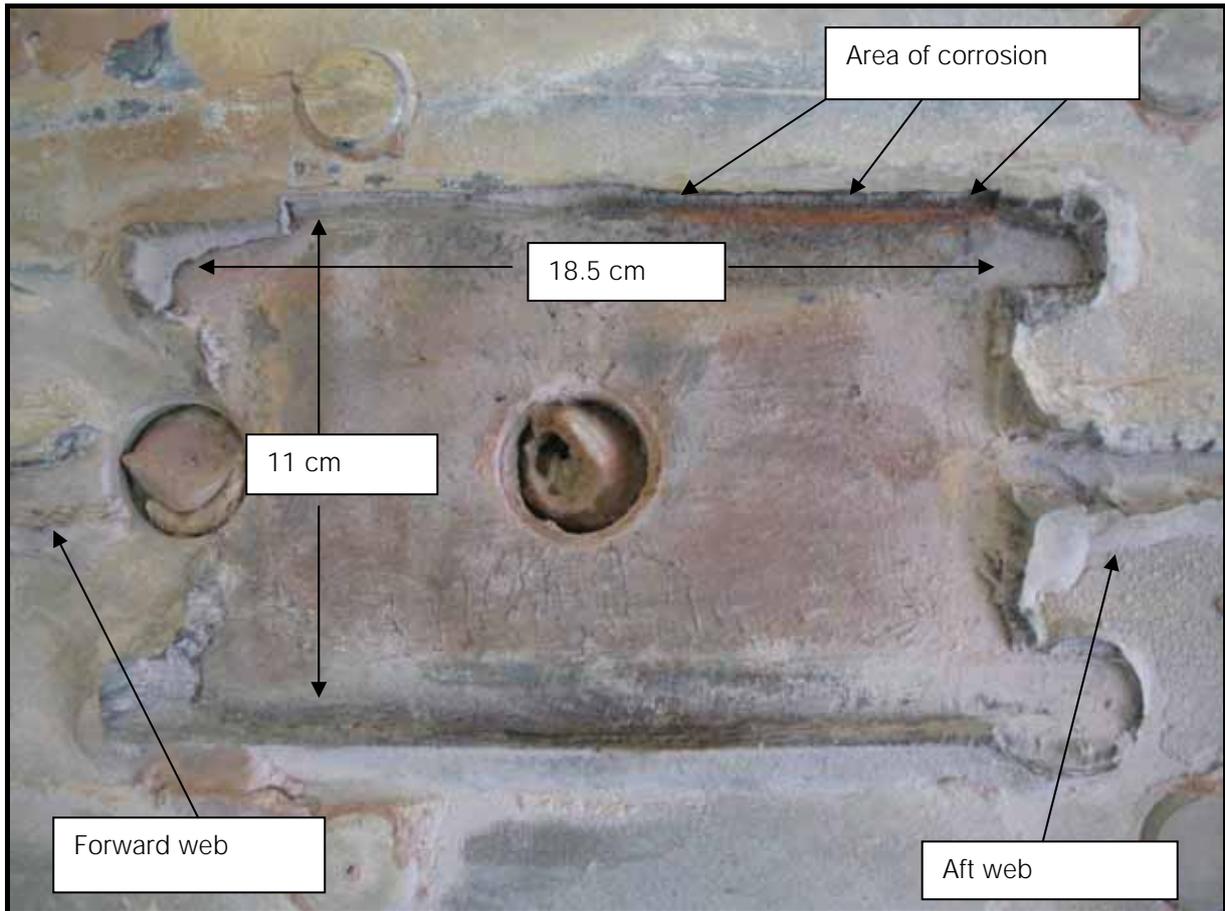
**Photograph 8**

- 3.43 When first viewed, the section of the weld on the port side of the rectangular hollow RHS spar where it attached to the keel plate showed signs of corrosion that suggested a section of weld may have been compromised prior to the capsizing. (See photograph 8 of failed section of keel plate.)

The weld failure where the spar was welded to the keel plate.

- 3.44 In the opinion of the MNZ investigator, it is not unreasonable to speculate that the weld failure may have started with the collision with the whale in 2006.

- 3.45 With one section of the weld compromised this may have caused additional pressure on other sections of weld. As a result, latent incremental degradation of the remaining intact sections of weld occurred causing the spar section to detach from the keel plate.

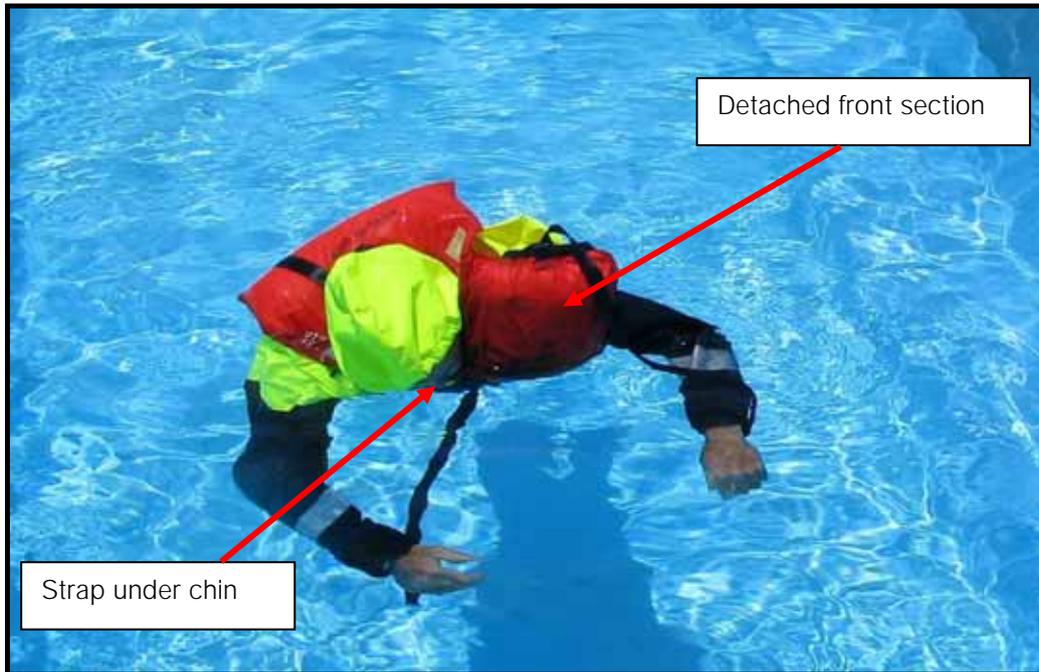
**Photograph 9**

Salt water trial of incorrectly fitted lifejacket.

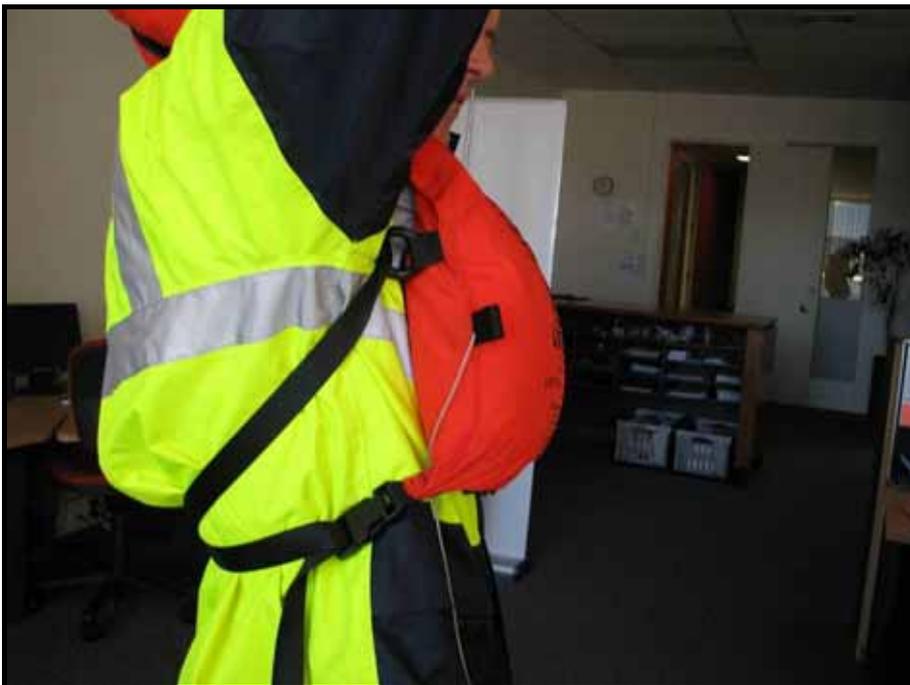
- 3.74 The survivor also commented that the skipper may have donned his lifejacket incorrectly with the front section of the jacket toward his chest. If this was the case this may have caused the skipper to floated face down after losing consciousness.

**Photograph 11**  
Incorrectly fitted lifejacket.
