Accident Report
Tobamoray
Swamping & Fatality
Manukau Bar on 5 March 2005
Class A Accident Report

REPORT NO.: 05 1184

VESSEL NAME: TOBAMORAY

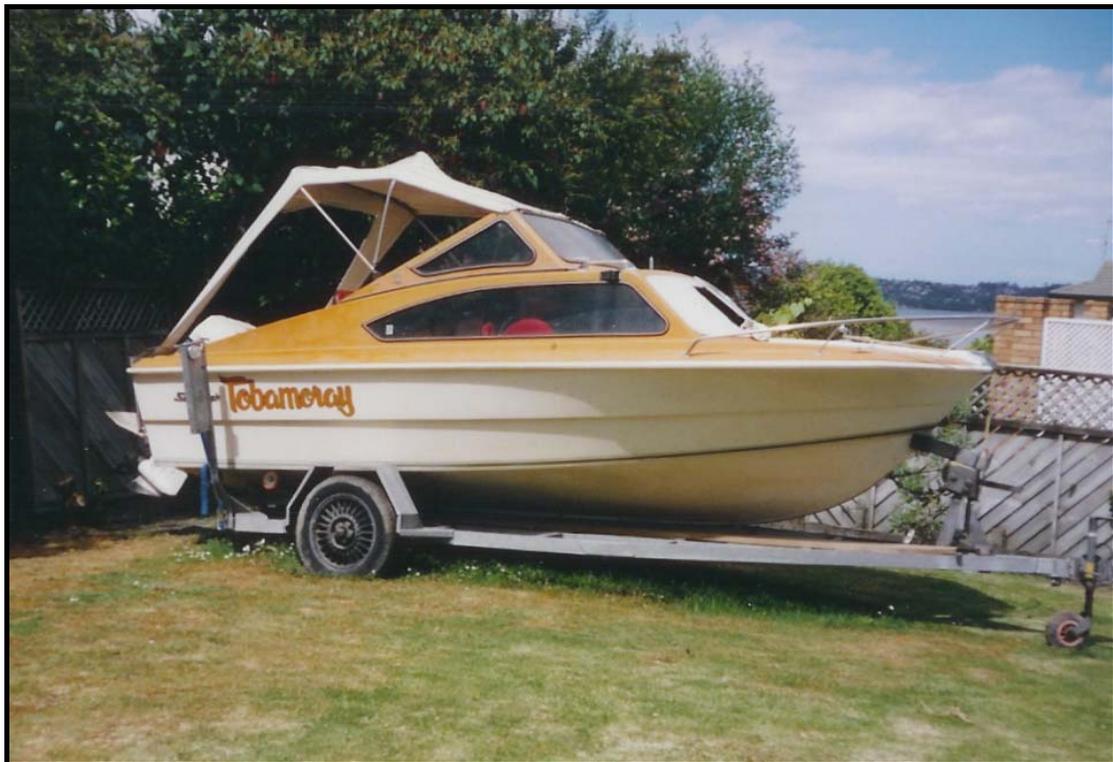
Tobamoray was designed with its reserve buoyancy situated in the floors below the water line, with the result that, in conjunction with a heavy outboard motor at the stern, it adopted a "bow up" attitude following the capsizing.

The built-in buoyancy alone that was provided by the under-floor enclosed compartment was insufficient to keep the boat afloat.

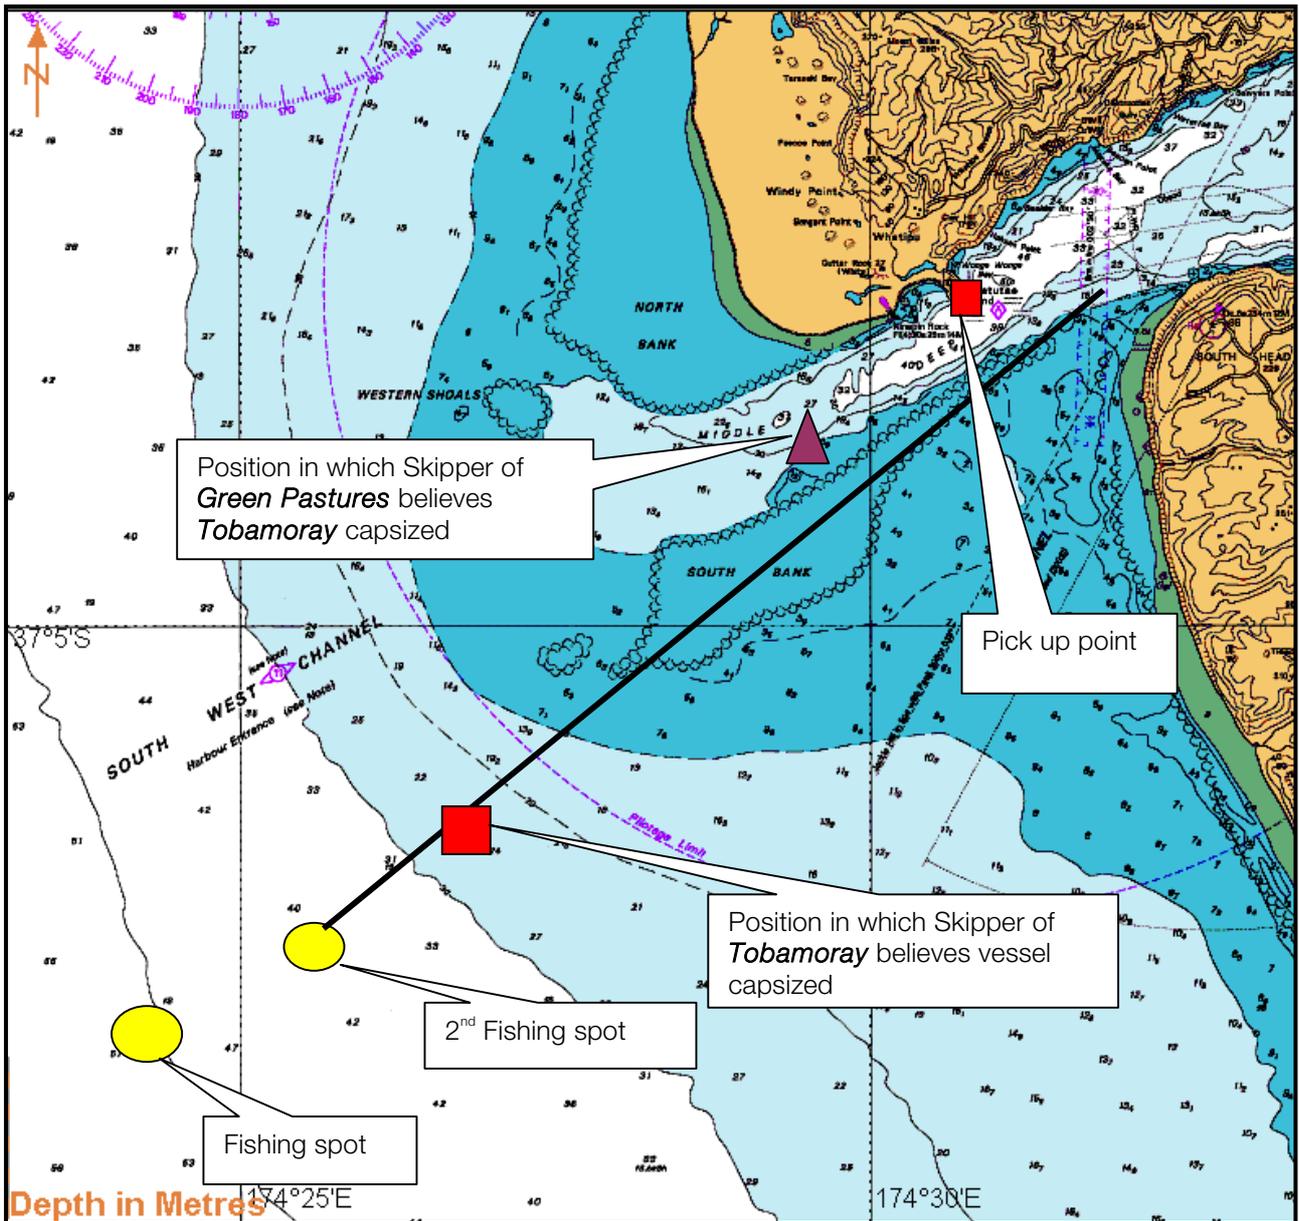
Figure 1 - Approximate Positions

Before *Tobamoray* reached the bar and whilst in approximately 22 metres of water Passenger One saw a large swell coming in behind them. The vessel rode it out. He then saw another large swell behind and told the Skipper. The Skipper opened up the throttle to keep ahead of the swell and it passed beneath them without any problems.

Immediately after, Passenger One saw a huge wave behind (about 5 metres high). The wave broke over the vessel from the stern, swamped it and then capsized the vessel, throwing the occupants well clear.
