Accident Report

Trident

Serious Injury

REPORT NO. 96 293

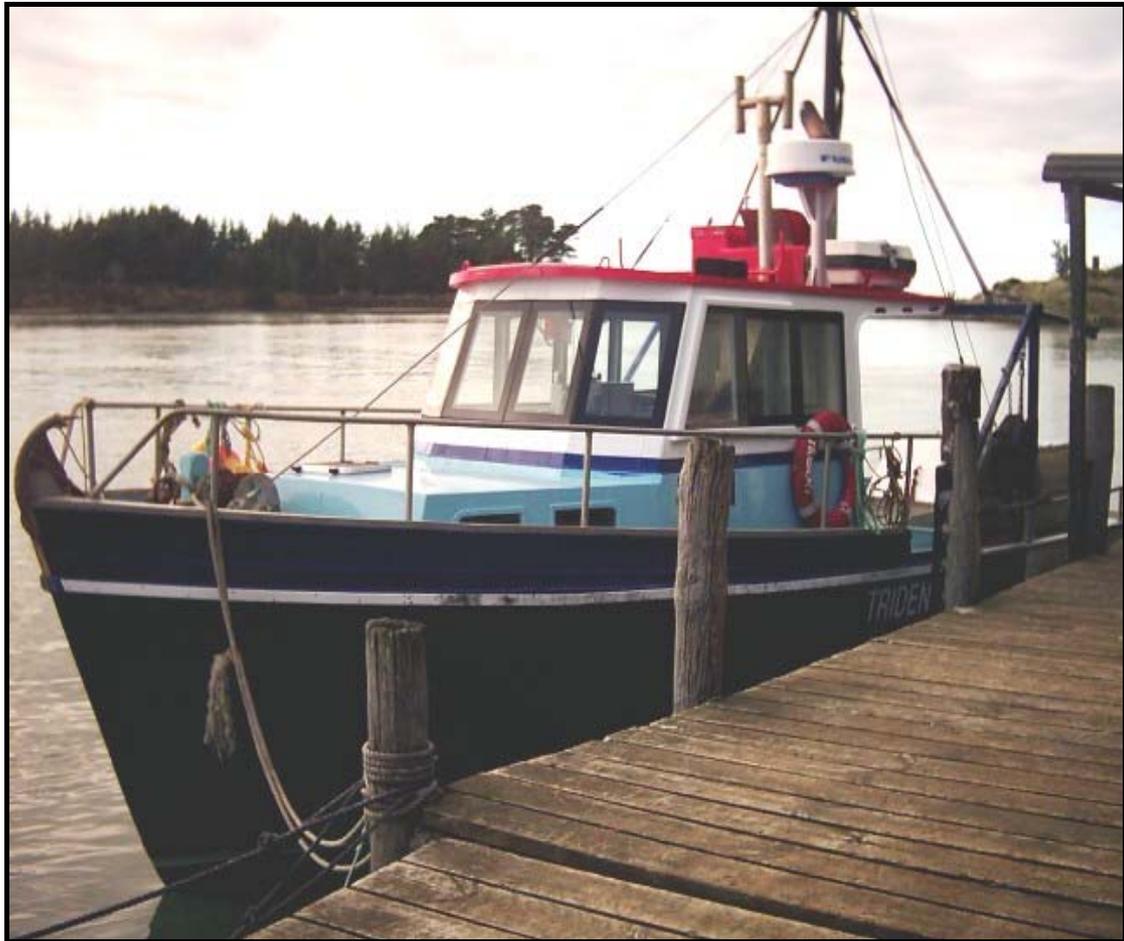
APPENDIX 1
PHOTO OF *TRIDENT*

- 2.1 *Trident* (See Appendix 1 – Photograph) is a wooden hull fishing boat, built in 1978 by R D Scotts of Invercargill. She is used for trawling and cray fishing out of Riverton, Southland.

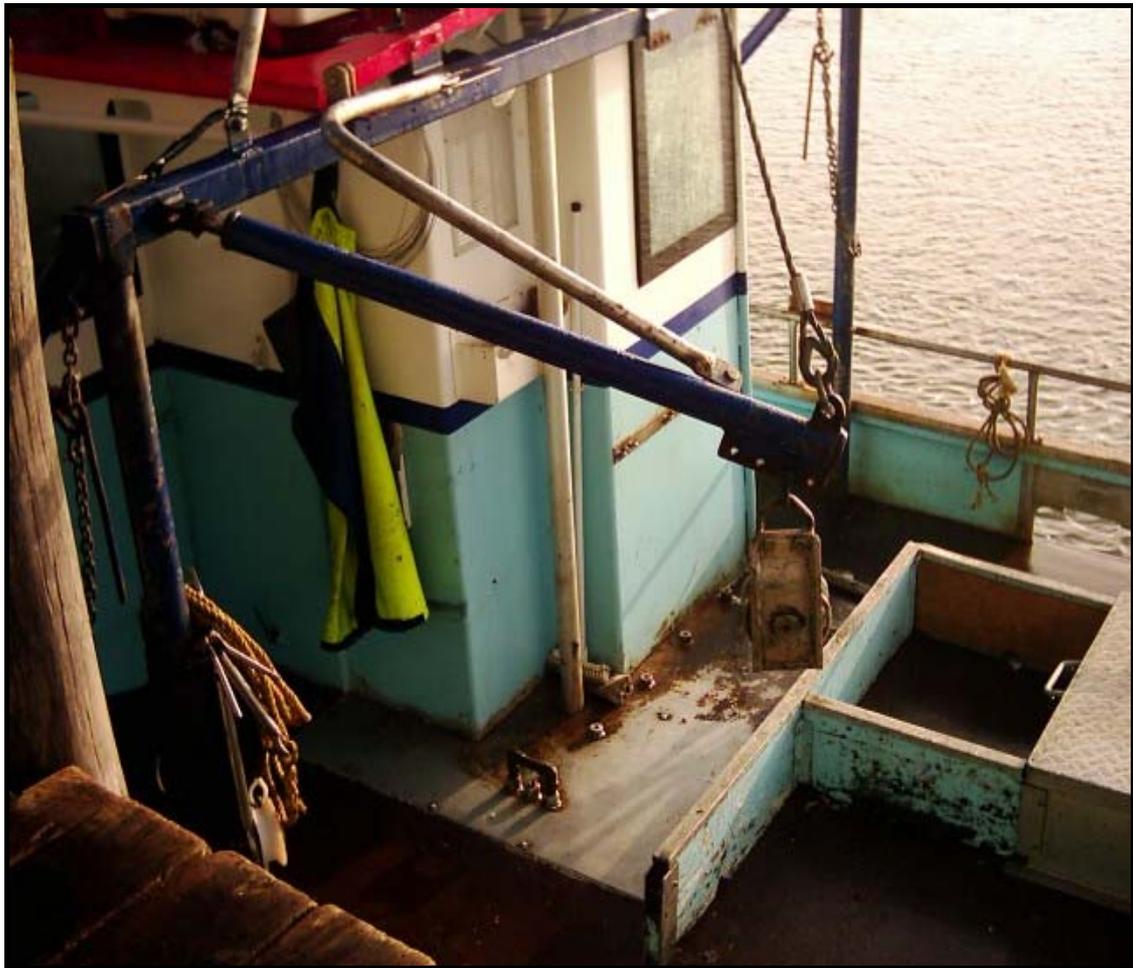
APPENDIX 2
PHOTO

- 3.2** The support stay was of a smaller diameter to that which it had replaced and was not as strong (*See Appendix 2 – Photograph*). In commenting on the draft report, the owners stated that the support stay was replaced by one of the same diameter, but made of heavy walled stainless steel. The previous one was made of mild steel.

- 4.1** The cause would appear to be due to excessive weight coming from the boom and associated equipment onto the stay causing the stay to be overloaded and subsequently giving way.
- 4.2** The exact cause of the increase in weight cannot be determined exactly. However, it is reasonable to assume that it may have been caused by a combination of the pot being fouled on the seabed, the boat riding to the top of a wave and possibly falling back from her position (the pot hauling line was leading slightly forward at the time of the accident) while still on the top of a wave and the vessel taking a roll to port or starboard. This sudden increase in weight then transferred onto the stay, which bent before the relief valve on the hydraulic system could come into play.

- 5.4** It is recommended that the Owners ensure the replacement support stay is of the same or similar construction and strength as the boom. In commenting on the draft report, the owners advised that this recommendation has been carried out.
