# Summary Report

Grounding

*Twofold Bay*

20 July 2006

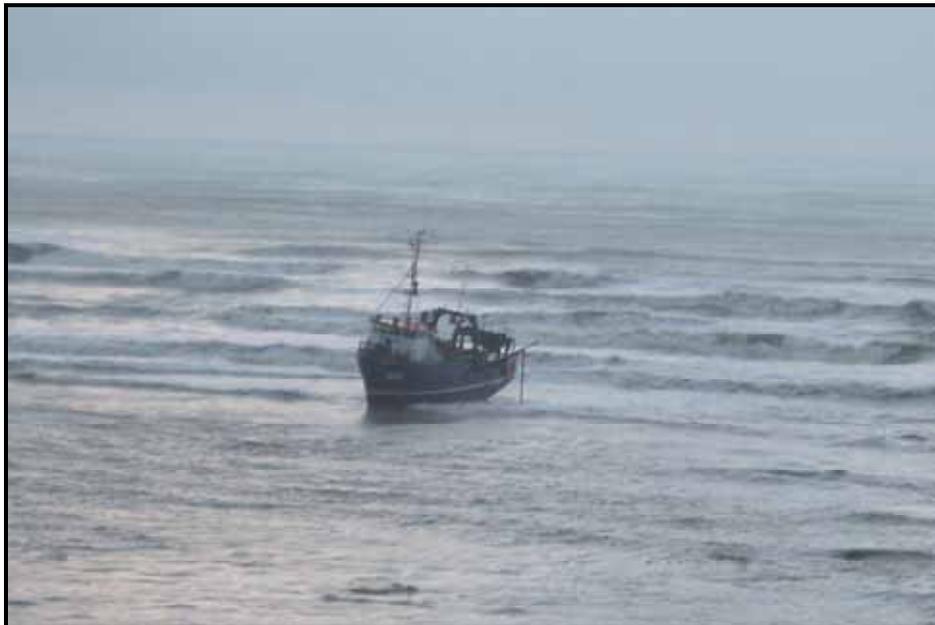
Photograph 1  
Twofold Bay aground

The vessel suffered damage to a hull mounted transducer.

The accident occurred because an unsatisfactory anchor watch was being maintained by the Skipper. The Skipper spent too long in the engine room without returning to the wheelhouse to check the vessel was safe. The Skipper acknowledges that he was away from the wheelhouse for too long a period and will ensure that, in future, if he is required to leave the wheelhouse for extended periods, that a deckhand will be tasked with maintaining an anchor watch in the wheelhouse.

The Investigator suspects that the reason for dragging is that the anchor did not 'bed in' when dropped. The upper side of the anchor had scratches on it which could have occurred if the anchor had been dragged 'upside down' along the bottom.
