Class B Accident Report

Unnamed Dinghy

Swamping

REPORT No: 04 1135

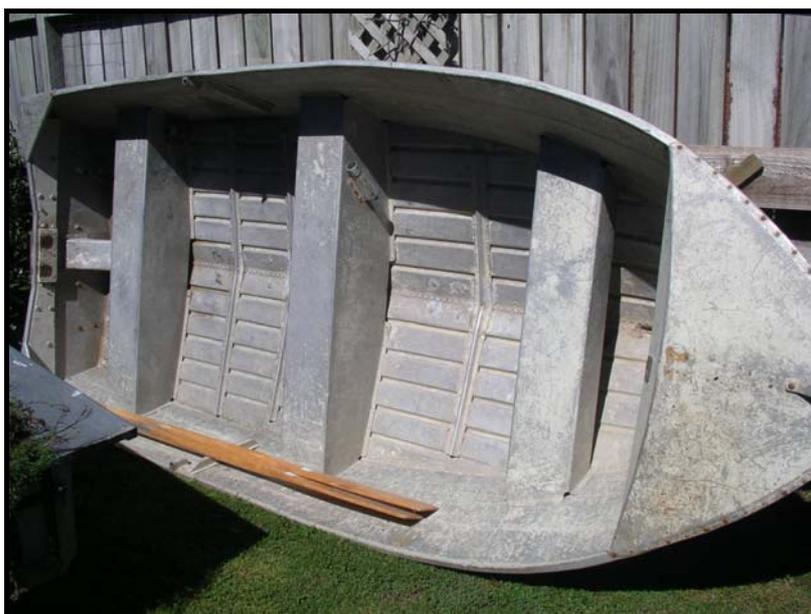
At about 1200 hours on 3 October 2004, it was decided to take the *Unnamed Dinghy* (See Photograph below) to Lake Hood to trial the recently repaired outboard engine. The Skipper ran the engine and found it to be working. After a couple of circuits around the upper lake, he asked if his friends wanted to go for a ride in it.

There were six adults and a small child in the dinghy with no lifejackets. As the vessel came across their own wake or that of another boat, they started to ship waves over the bow. The boat started to fill with water, and then the whole boat swamped bow first. Witnesses to the accident rescued three of the group while the others swam to shore. The Skipper and small child were taken to hospital for observation, there were no injuries.

The dinghy was swamped after taking water over the bow, caused by the wake from its own propeller or other vessels in the vicinity. The dinghy rolled over and its buoyancy allowed it to float level bow up just under the surface. The dinghy was then towed by hand back to the beach.

With the dinghy loaded with six adults there was not enough freeboard to keep the vessel afloat as it took on water by the head. The freeboard was described as being approximately 30-50 centimetres.

It is recommended that the Skipper be censured for failing to look after the best interests of his passengers by overloading the vessel and not supplying them with lifejackets, and for failing to report the accident to the Maritime Safety Authority and the Regional Harbour Master.

It is recommended that the Skipper and the Owner sit the New Zealand Coastguard Day Skippers Course and provide a copy of the completion certificate to the Maritime Safety Authority by 30 July 2005.
