Accident Report
Capsize & Rescue of an Unnamed
Dinghy
30 June 2008

Maritime New Zealand

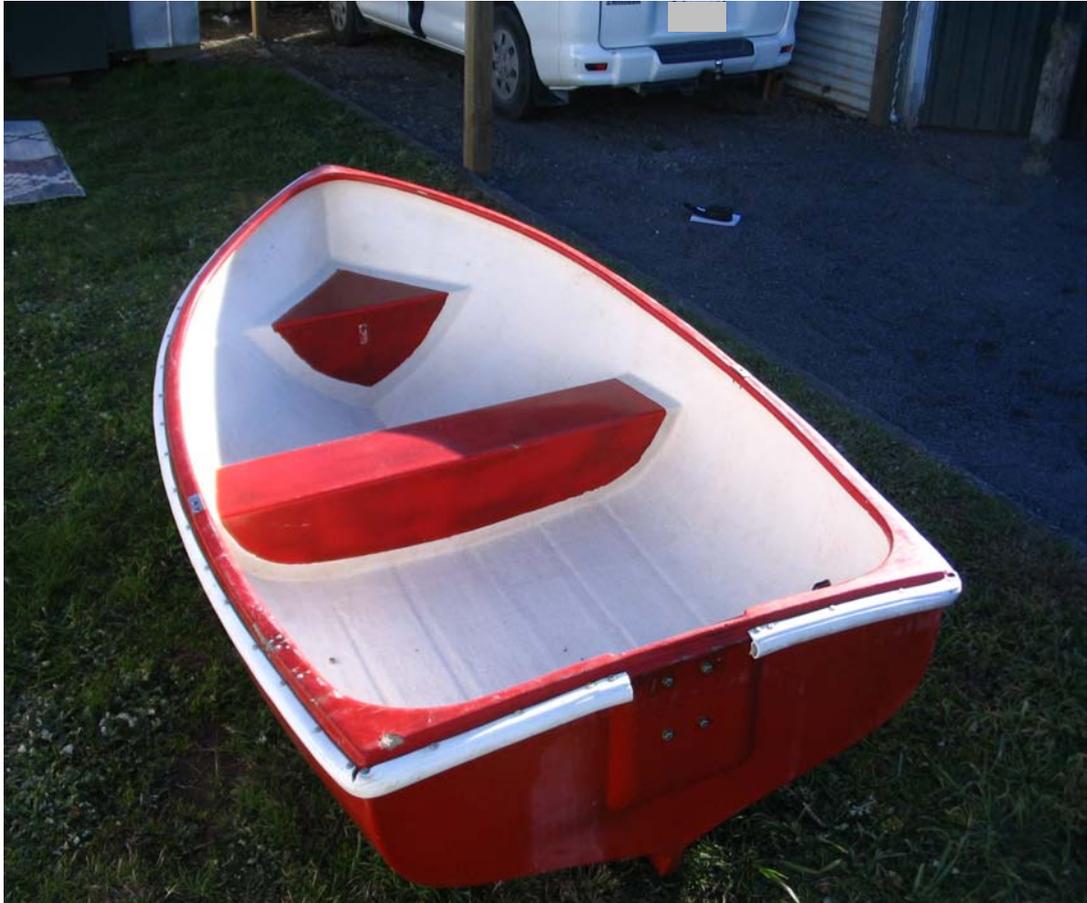
Figure 2 Unnamed Dinghy

9. The skipper purchased the unnamed dinghy around the start of 2008. His experience with the vessel was limited to 6 or 7 fishing expeditions on the Tukituki River Estuary; however, he claimed to have a lifetime of experience with recreational fishing in Kiribati.
10. The dinghy involved is approximately 2.5m and constructed of molded fiberglass (see Figure 2). At the time it had no motor, oars, rowlocks, anchor or lights and was simply propelled by paddles. A bow painter, which was a thin rope approximately 2 m long

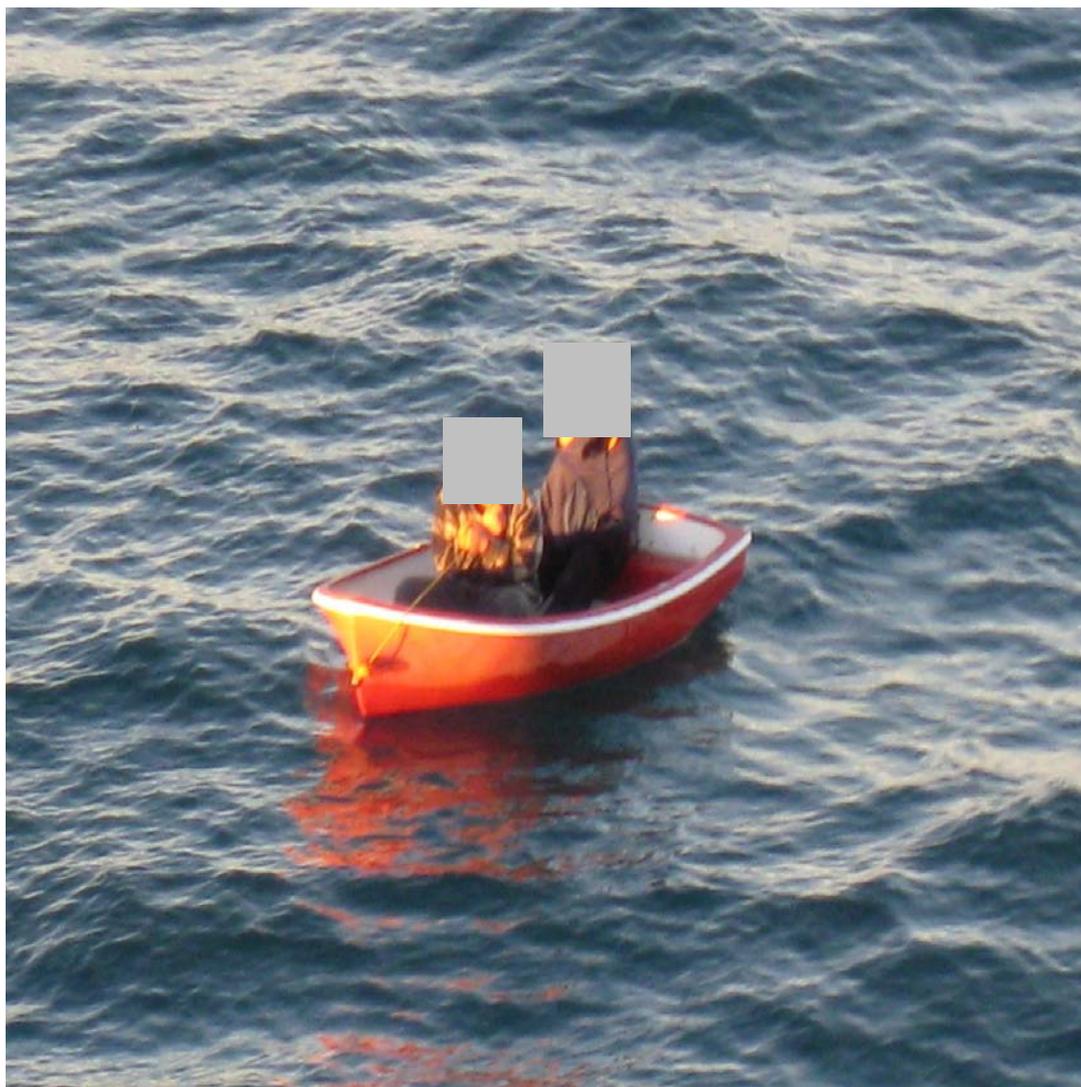
Figure 3 Both men inside the dinghy at the time of their rescue

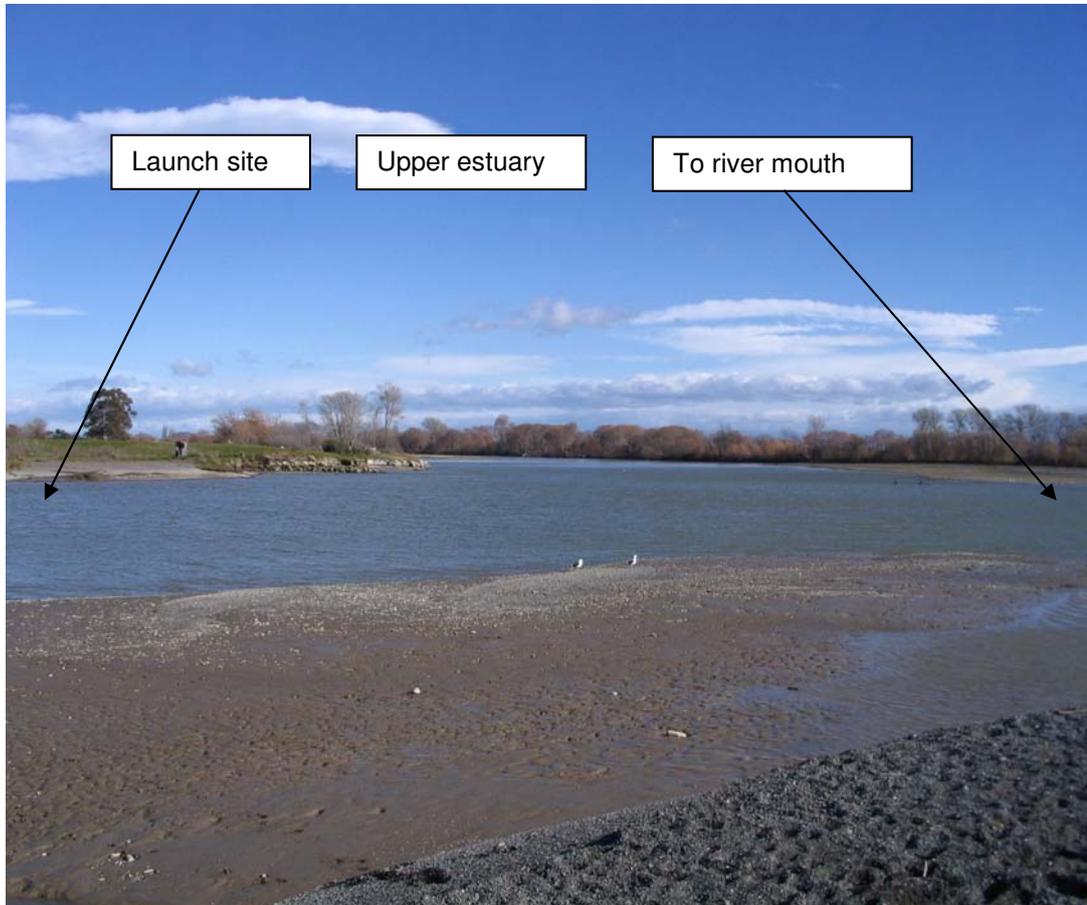
Figure 4 Taken from the spit looking upstream of the Tukituki River Estuary

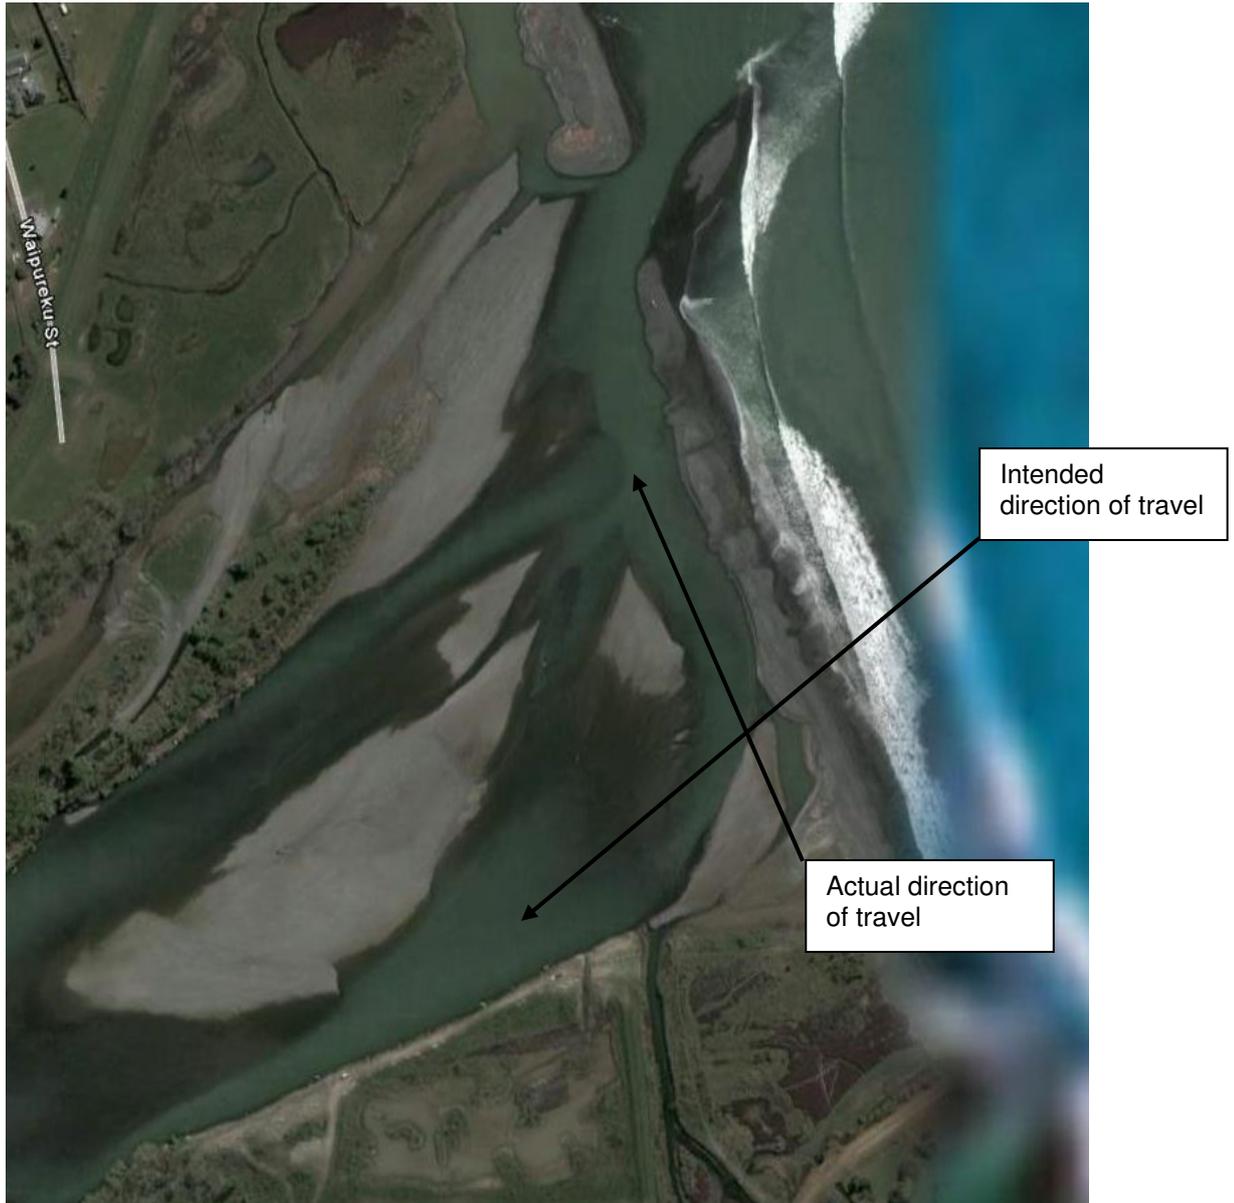
Figure 5 Direction of travel

19. The river mouth through which they were taken is approximately 30m wide and runs for approximately 60m before entering the sea. A gravel bar situated just out from the river mouth, coupled with outgoing and incoming tides, creates surf conditions.

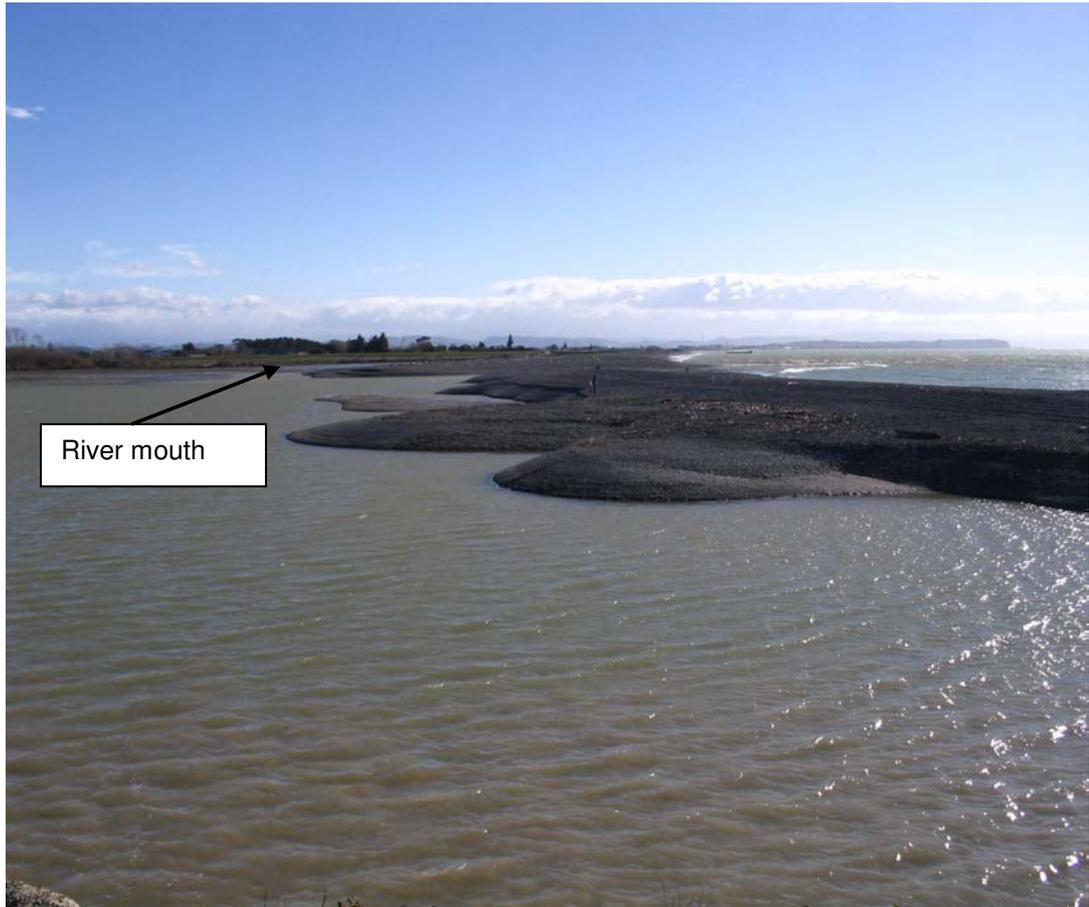
Figure 6 Taken from the launch site looking towards the river mouth

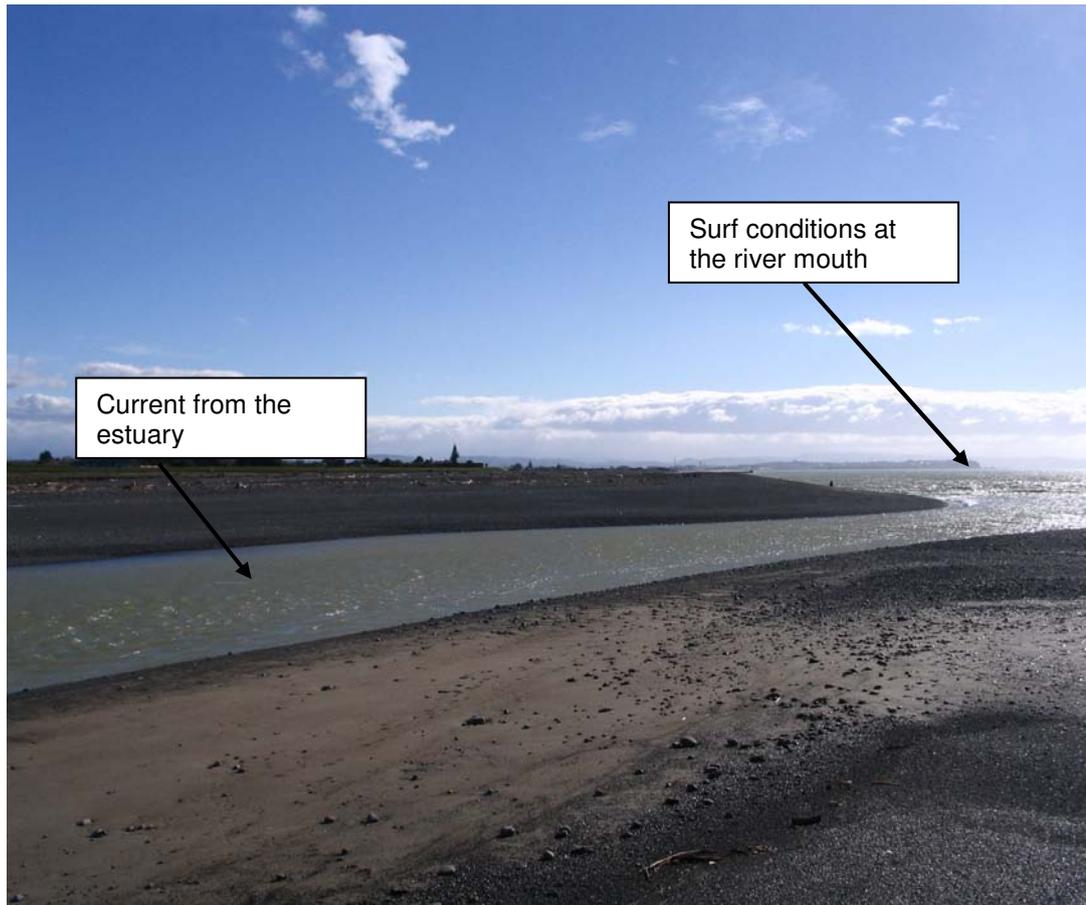
Figure 7 Taken from the spit where it joins the river and estuary

20. Once taken by the current the skipper lost all control of the dinghy and was unable to paddle to the edge of the channel. He considered abandoning the dinghy, but felt that the conditions far exceeded his swimming ability, which is limited.

21. The vessel was carried out into the surf where it was capsized by a wave breaking at the river mouth.
22. Both men were thrown into the water. The passenger become entangled in the fishing net and was held under for some time before managing to free himself and come to the surface. The skipper managed to grab hold of the painter and pulled himself to the dinghy, which he clung to while they drifted out through the surf.

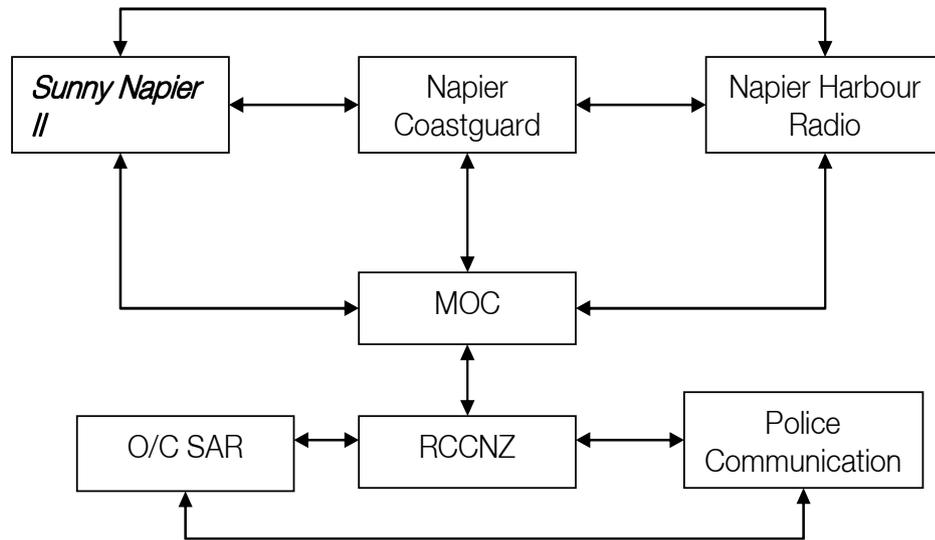
Figure 8 Lines of communication during the rescue operation

38. The following outlines the lines of communication during the rescue operation.

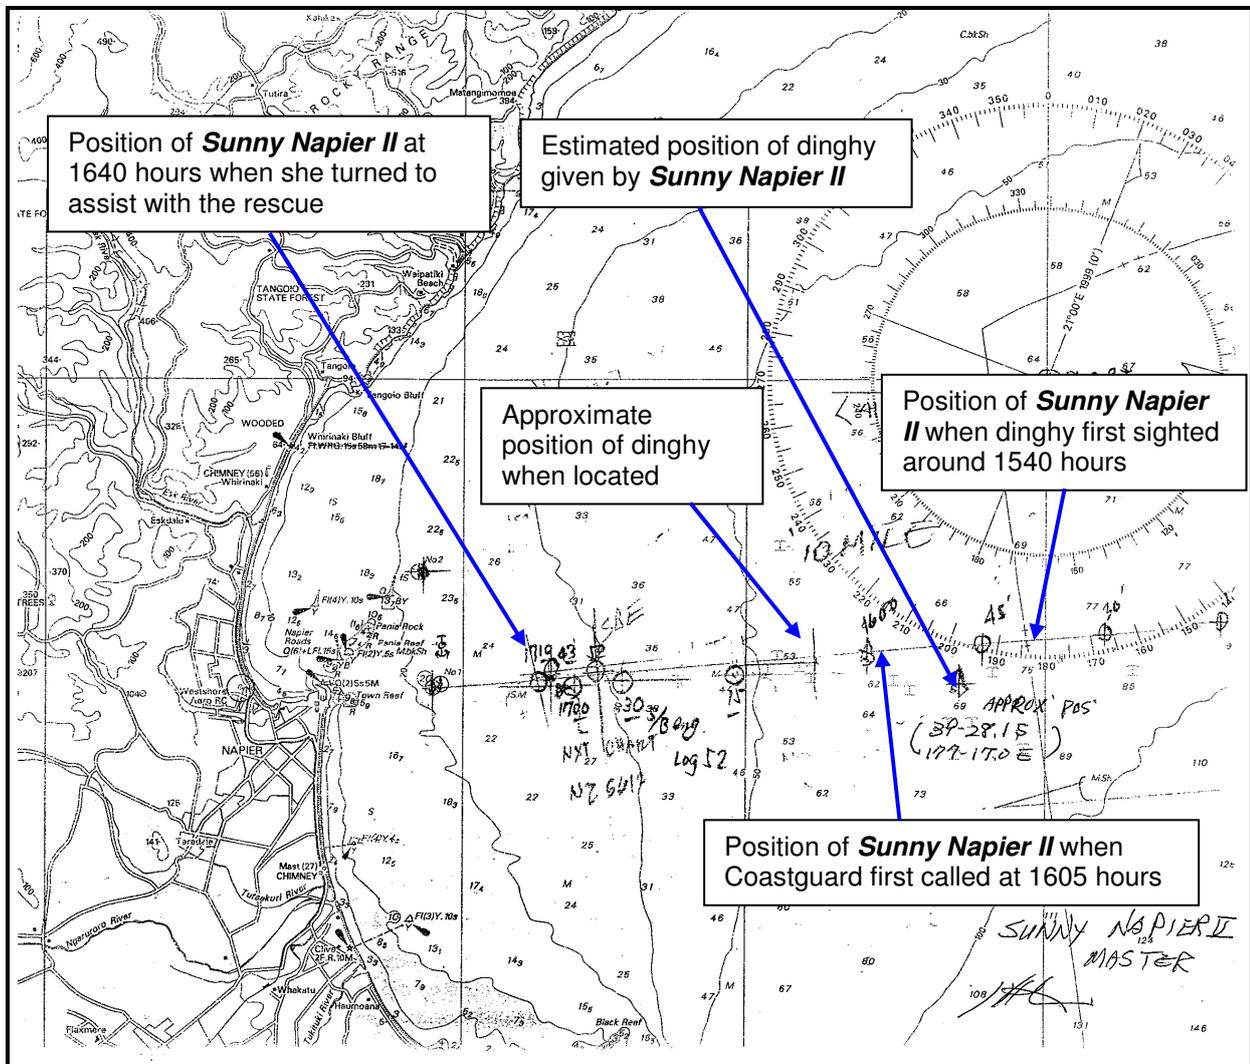
43. The following chart taken from the **Sunny Napier II** shows the position and timings of the vessel.

Figure 9 Positions noted on a copy of the chart taken from **Sunny Napier II**

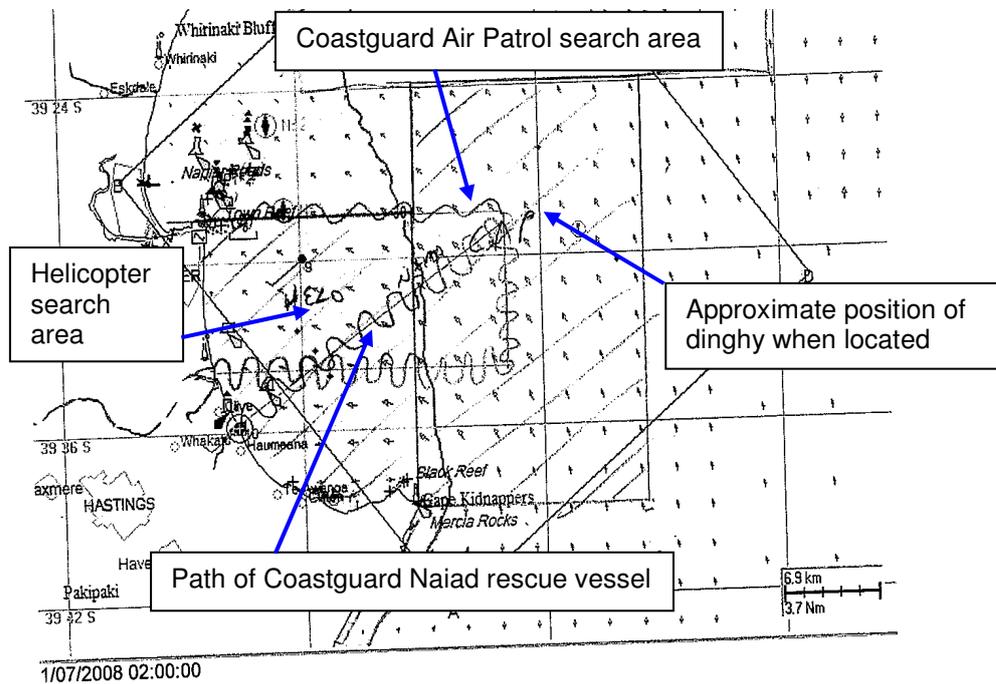
Figure 10 Copy of original search plan from RCCNZ

44. The following chart shows the original search plan as prepared by RCCNZ.

45. There was approximately 1 hour of light left when the dinghy was located. It is most likely that either the Coastguard Air Patrol or the Coastguard Naiad would have located the dinghy before dark, regardless of whether or not **Sunny Napier II** had given an estimate of the dinghy's position. The above chart shows that the Coastguard Naiad was on a course towards the dinghy.
