Class B Accident Report

Capsize & Double Fatality

Waipaoa River on 26 September 2004

REPORT No.: - 04 1127

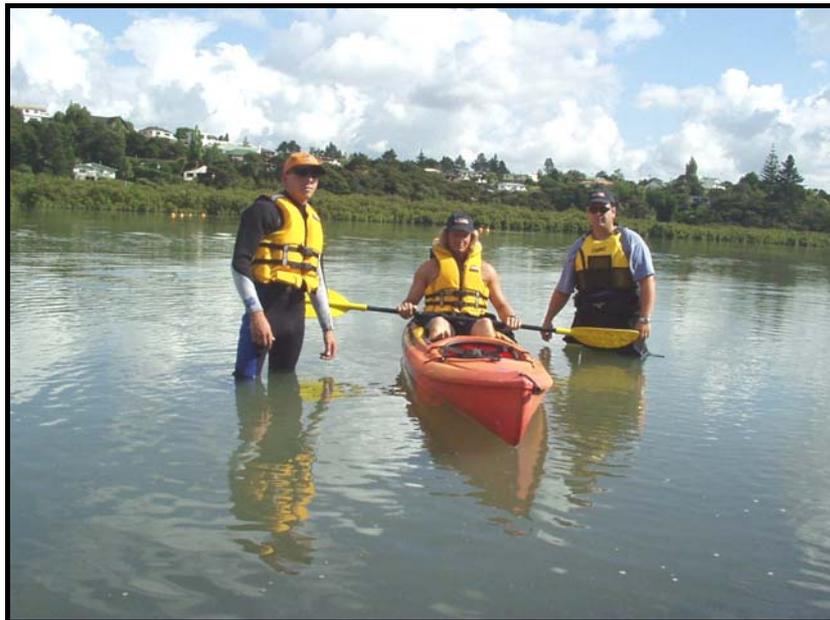
PHOTO 2 – KAYAK SHOWING DESIGNED FREEBOARD

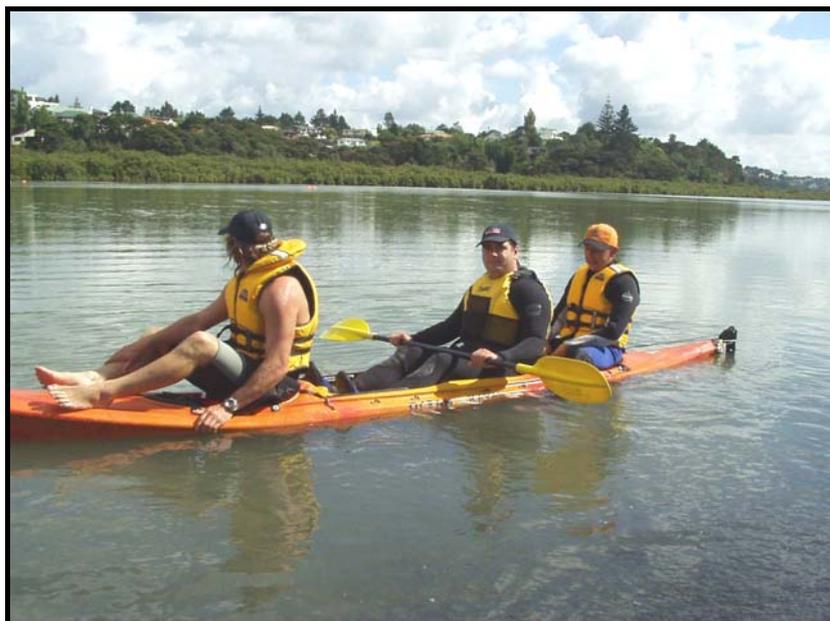
The two crew members then joined the Skipper on the kayak. They sat facing forward over each of the hatch openings with their legs hanging overboard in the water. Their added weight caused the freeboard of the kayak to reduce to about 4 cm. The sack containing the net was held by the after crewmember. With the other two men paddling, it was his task to feed the net from the sack over the port quarter of the kayak, ensuring it did not snag on the rudder or its fittings. The Skipper in the cockpit used a double paddle while his companion forward had a single paddle.

PHOTO 3 – SHOWING REDUCED FREEBOARD DUE TO OVERLOAD

7. When any vessel is overloaded, the additional weight pushes the vessel lower in the water leading to a loss of freeboard. Sufficient freeboard is critical to stability. Reduction of freeboard below that calculated by the designer removes the ability of the vessel to return to the upright when the vessel heels. In this accident the additional weight of two persons reduced the freeboard to a point where it was almost non-existent.
